STUDY OF DETONATION GUN COATED ALLOYS FOR RESISTANCE TO EROSION AND CORROSION

A THESIS

METALLURGICAL AND MATERIALS ENGINEERING

This thesis investigates the erosion and corrosion performance of Al_2O_3 -3 wt % TiO_2 thermal spray coatings deposited by detonation gun technique. As-sprayed coatings were characterized by using the combined techniques of optical microscopy, microhardness testing, X-ray diffractometry (XRD) and scanning electron microscopy/energy-dispersive analysis (SEM/EDX). The corrosion performance was evaluated in oxidising and molten salt environment and also in actual working conditions of boiler. The erosion performance was evaluated at room temperature conditions as well as under high temperature conditions, high erodent velocity, and actual boiler conditions. The corrosion behavior and morphological development were investigated by weight change kinetics, metallographs, depths of attack, metal thickness losses, and XRD analyses.

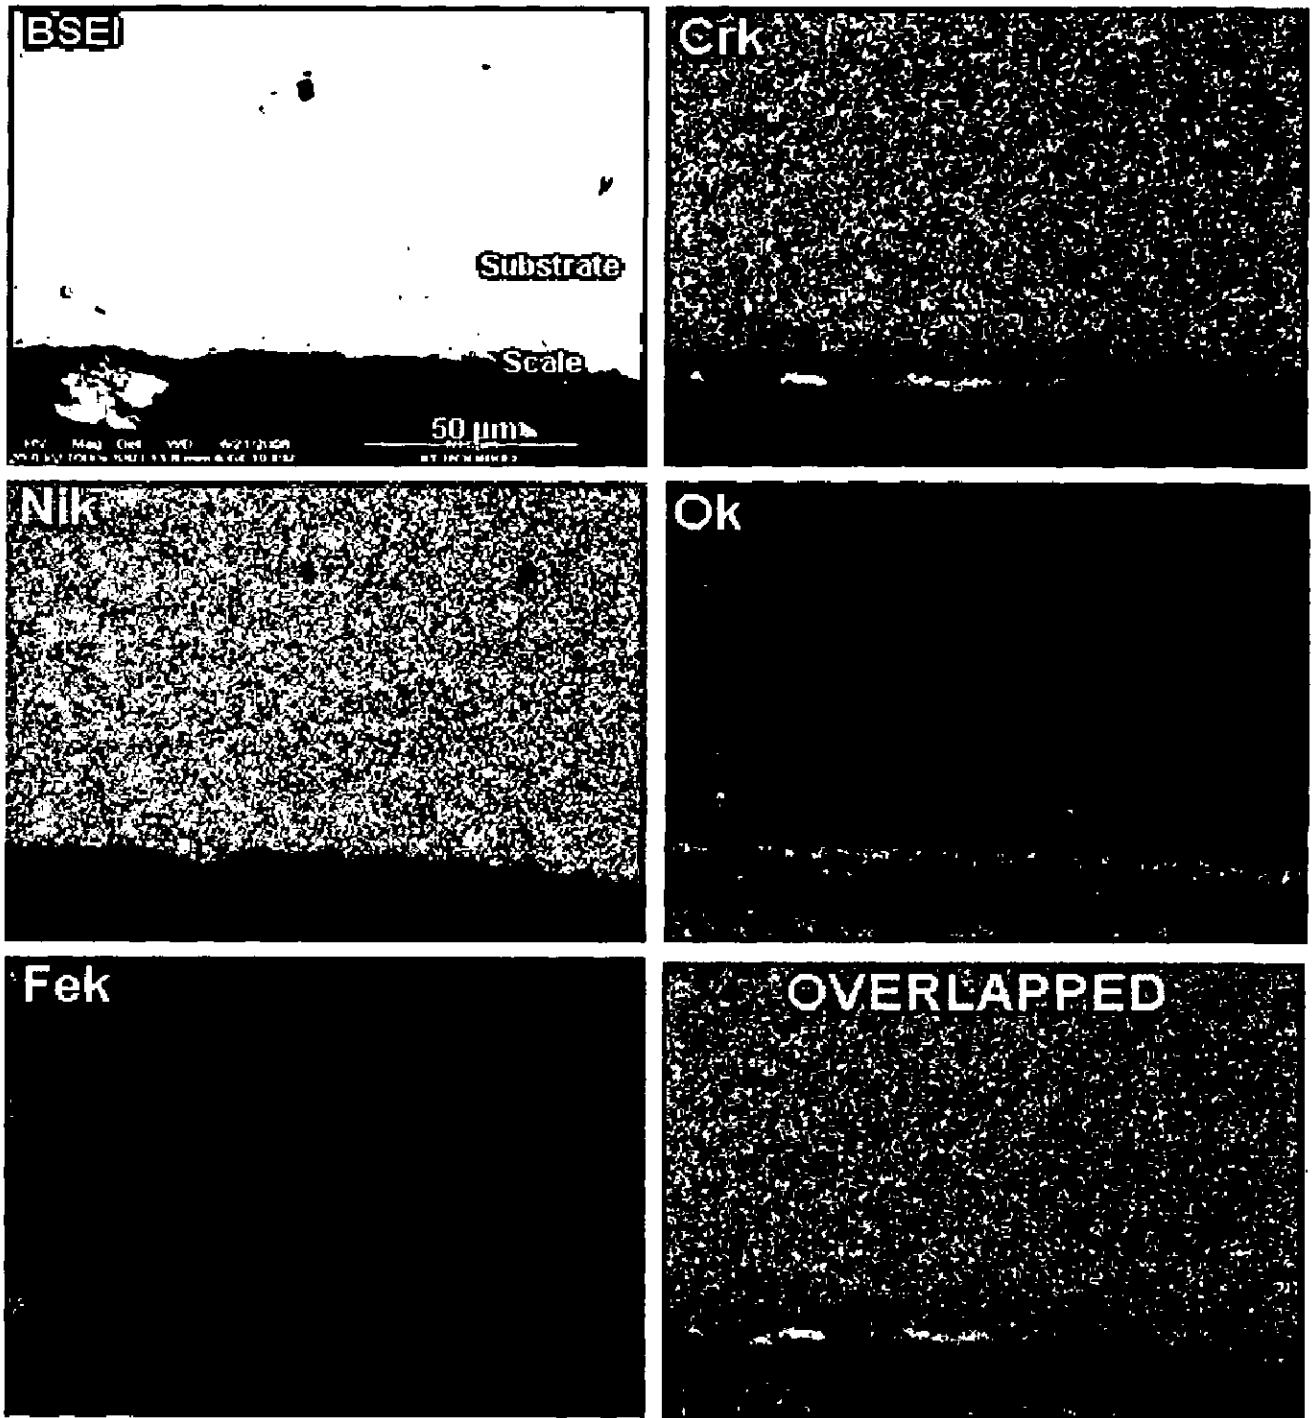
Fig.6.19: BSEI and X-ray mapping of the cross-section of superalloy Superni 718 subjected to cyclic oxidation in air at 900°C for 50 cycles.

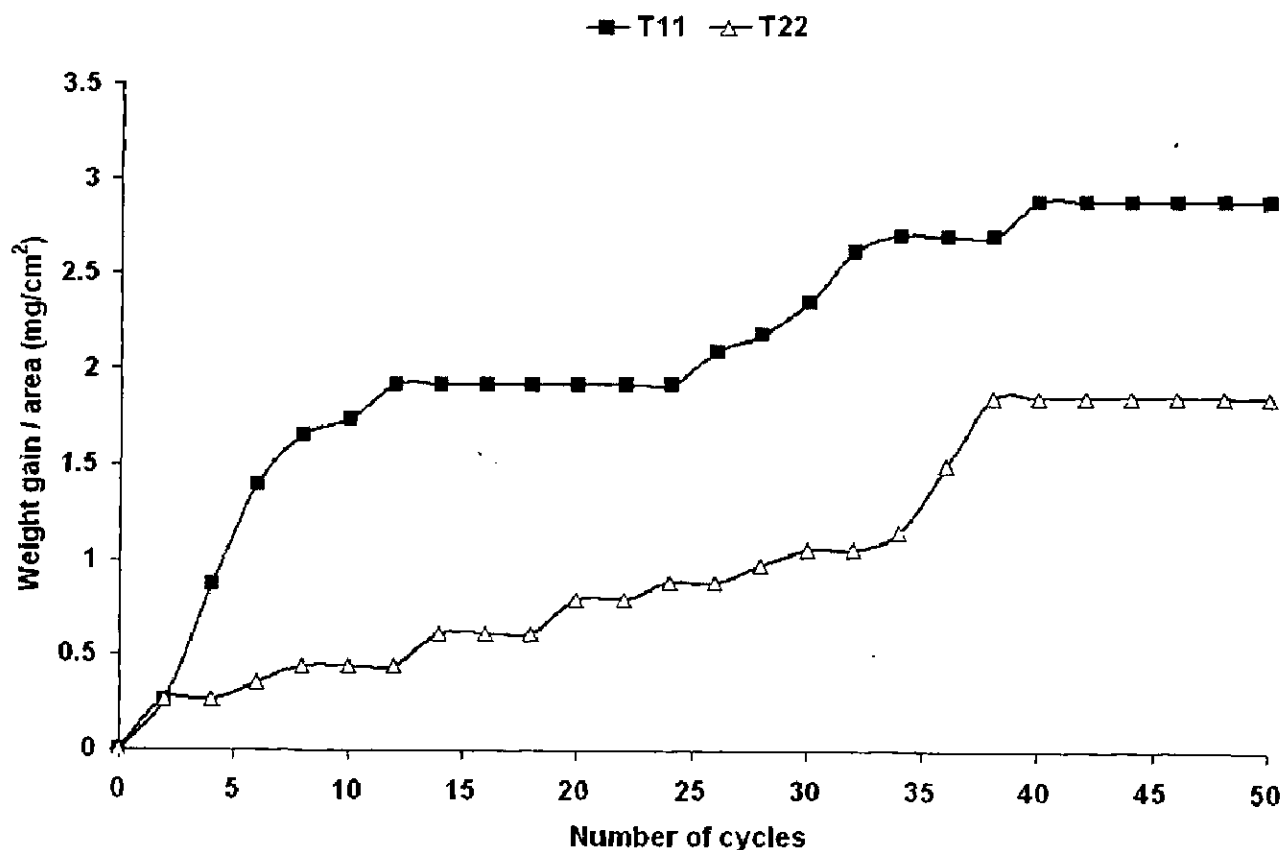
Fig. 6.22: Weight gain plot for Al_2O_3 - 3 wt% TiO_2 coated boiler steels T11 and T22 exposed to air at 900°C for 50 cycles.

Weight gain per unit area expressed in mg/cm^2 is plotted as a function of time expressed in number of cycles for oxidized $\text{Al}_2\text{O}_3 - 3 \text{ wt}\% \text{ TiO}_2$ coated T11, T22 boiler steels is shown in Fig. 6.22 and for superalloys Superni 600, superni 718 and Superfer 800 superalloys is shown in Fig. 6.24.

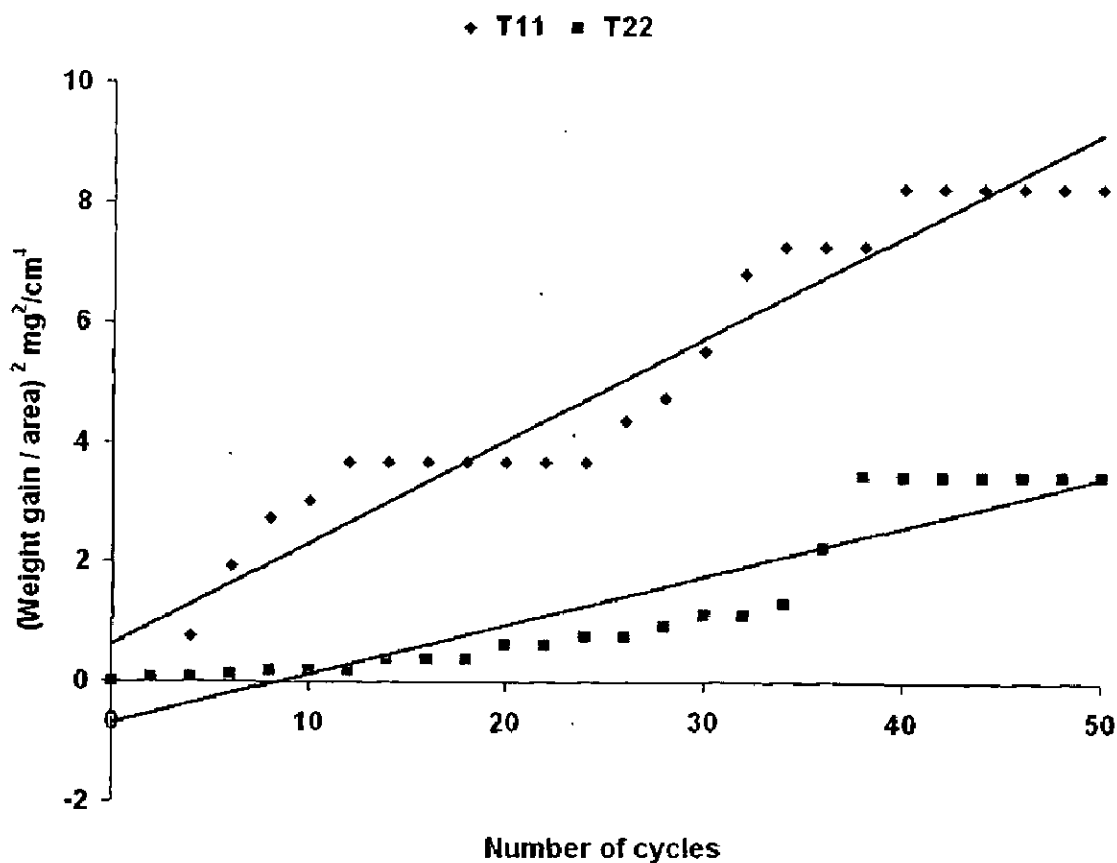
Fig.6.23: Weight gain square (mg^2/cm^4) plot for Al_2O_3 - 3 wt% TiO_2 coated boiler steels T11 and T22 exposed to air at 900°C for 50 cycles.

Weight gain square (mg^2/cm^4) plotted as a function of time (number of cycles) in Fig. 6.23, from where it can be inferred that there is a scatter in the data as observed in the plots and the data can not be approximated by a parabolic relationship. If the scatter in the measurements is not considered, the values of parabolic rate constant (K_p) for the coated boiler steels T11 and T22 are 4.747×10^{-11} and $2.28 \times 10^{-11} \text{ g}^2 \text{ cm}^{-4} \text{ s}^{-1}$ respectively.

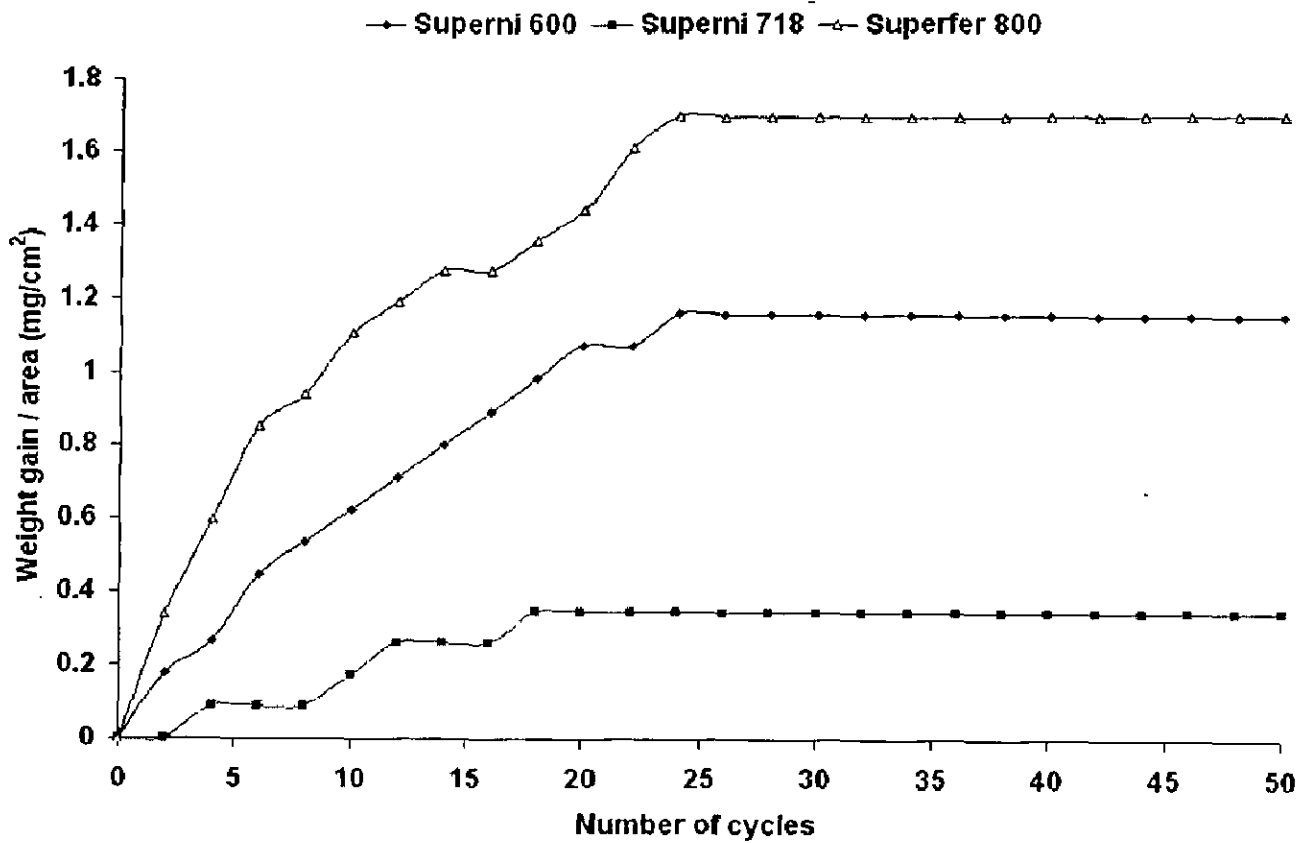
Fig. 6.24: Weight gain plot for Al_2O_3 - 3 wt% TiO_2 coated superalloys Superni 600, Superni 718, Superfer 800 exposed to air at 900°C for 50 cycles.

In case of $\text{Al}_2\text{O}_3 - 3 \text{ wt}\% \text{ TiO}_2$ coated superalloys; coated superfer 800 (Fig. 6.24) showed maximum weight gain as compared to other two coated superalloys Superni 600 and superni 718. In coated superfer 800, initially there is rapid weight gain upto 14th cycle, and then there is some constant weight gain for two cycles and then again there is weight gain upto 24th cycle and afterwards it is constant. In superni 600, upto 20th cycle there is weight gain and afterwards it is almost constant. In case of coated superni 718, weight gain is very small. Initially for first two cycles there is no weight gain and then there is small weight gain from 2nd to 4th cycle and then again it has become constant upto 8th cycle, afterwards there is some weight gain upto 12th cycle. Then it remained constant upto 16th cycle. Then there is small weight gain upto 18th cycle and afterwards it has become constant. In case of coated superalloys viz. Superni 600 and superni 718, rapid oxidation rate has not been observed and very small weight gains have been observed and

steady state has been reached with the progress of exposure time, in spite of the fact that some minor deviations are observed in between. The total weight gain at the end of 50 cycles for the superalloys Superni 600, 718 and Superfer 800 is 1.16, 0.35 and 1.71 mg/cm² respectively. This shows that the weight gain in case of oxidised Al₂O₃-3wt% TiO₂ coated Superni 718 is lowest, whereas it is highest in case of Al₂O₃-3 wt% TiO₂ coated Superfer 800.

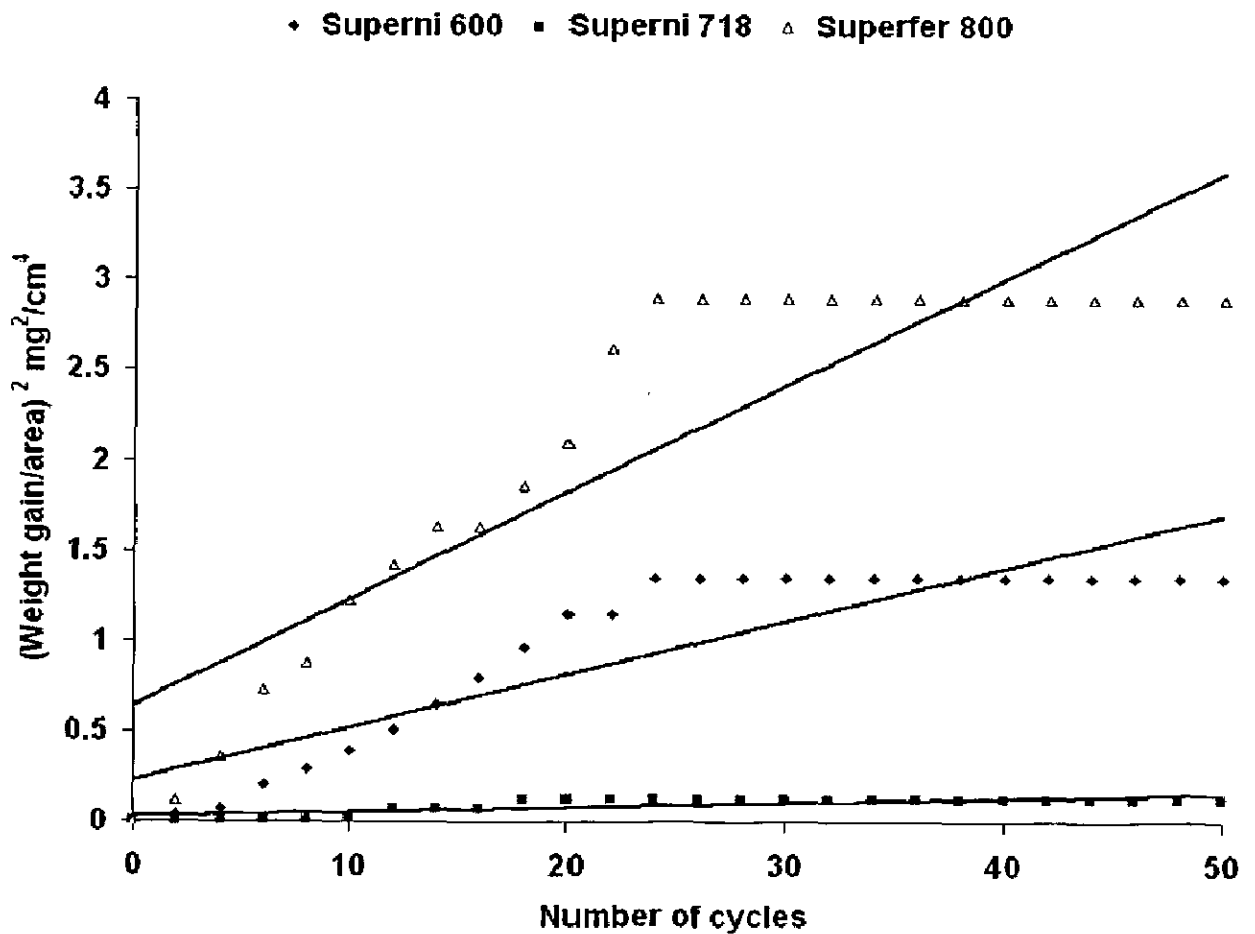
Fig. 6.25: Weight gain square (mg^2/cm^4) plot for Al_2O_3 - 3 wt% TiO_2 coated superalloys Superni 600, Superni 718, Superfer 800 exposed to air at 900°C for 50 cycles.

In Fig. 6.25, the (weight gain/unit area)² versus number of cycles for all the coated superalloys are plotted to determine the conformance with the parabolic rate law. The curve for coated Superni 718 is parabolic. While in case of superni 600 and superfer 800, scatter in the data can be observed in the plots and the data can not be approximated by a parabolic relationship. If the scatter in the measurements is not considered, the values of parabolic rate constant (K_p) for the superalloys Superni 600, 718 and Superfer 800 are calculated as 8.19 X 10⁻¹², 7.22X10⁻¹³ and 1.65x10⁻¹¹ g² cm⁻⁴ s⁻¹ respectively.

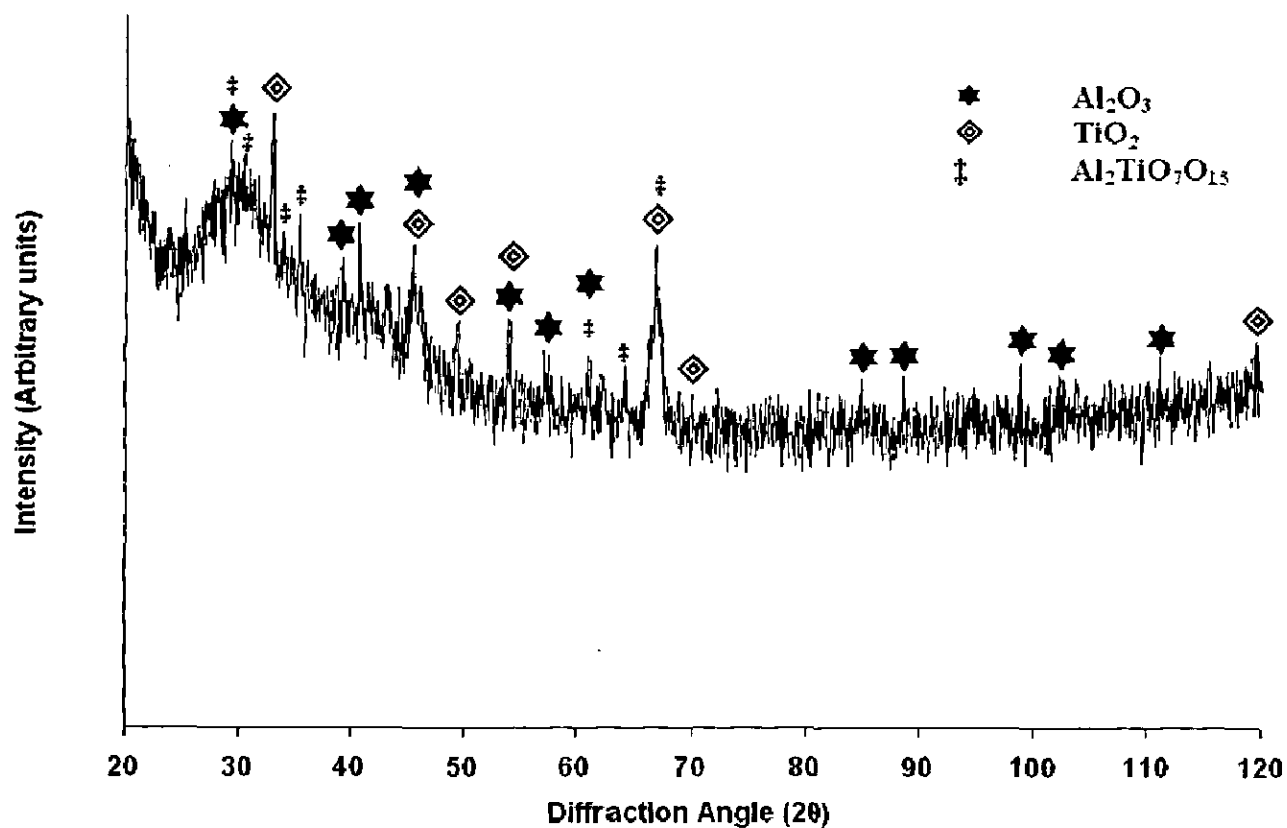
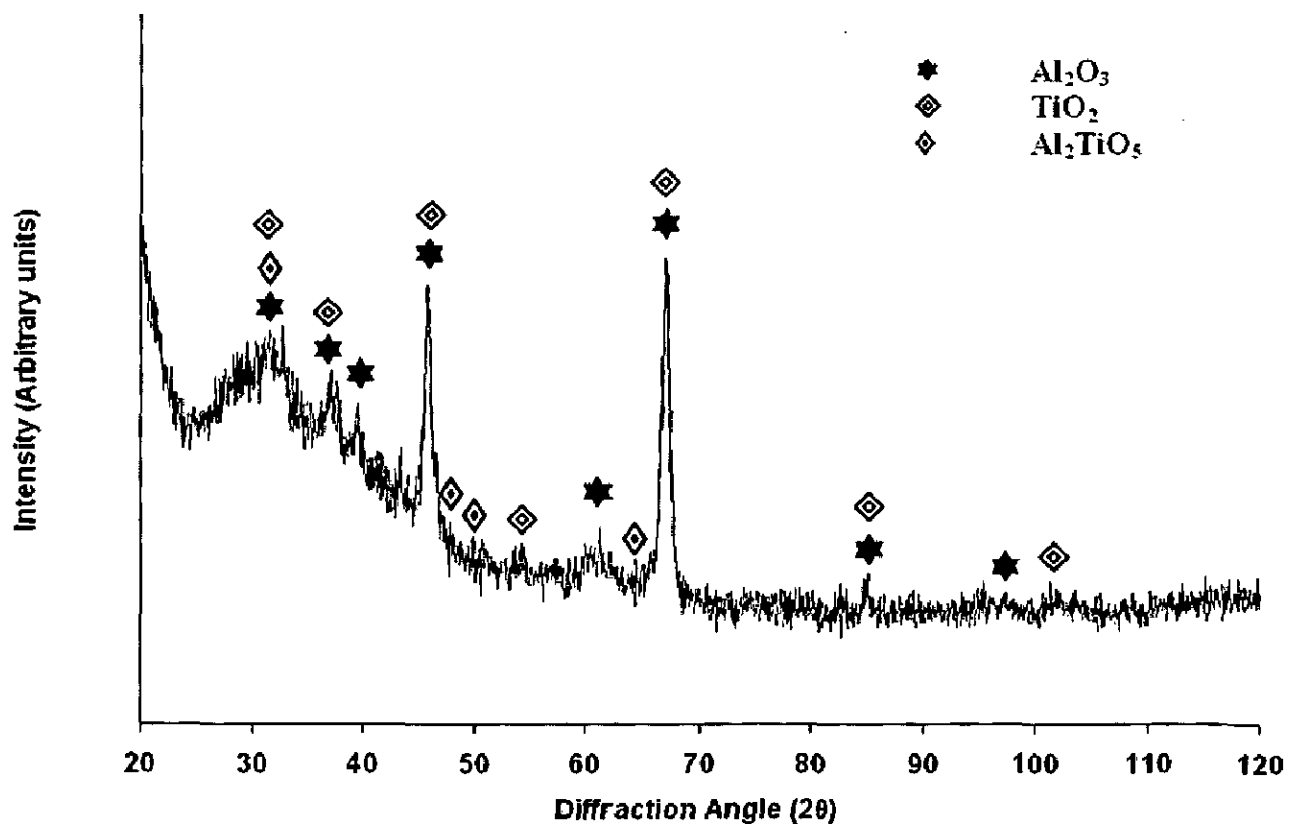
Fig. 6.26: X-ray diffraction profiles for Al_2O_3 -3 wt% TiO_2 coated boiler steels subjected to cyclic oxidation in air at 900°C for 50 cycles.

(a) T11

(b) T22

X-ray diffraction profiles for Al₂O₃-3 wt% TiO₂ coated boiler steels subjected to cyclic oxidation in air at 900⁰C for 50 cycles are shown in Fig. 6.26. Both the coated boiler steels have Al₂O₃ and TiO₂ as the main constituent. After the oxidation process some peaks Al₂TiO₇O₁₅ of were observed in coated T11 and Al₂TiO₅ was observed in coated T22 steel. The X-ray diffractograms for the coated superalloys after exposure to air at 900⁰C for 50 cycles is shown in Figs. 6.27 and 6.28. Al₂O₃ and TiO₂ along with minor phases of Al₂TiO₅ and Al₂TiO₇O₁₅ were found to be present in all the oxidised coated superalloys.

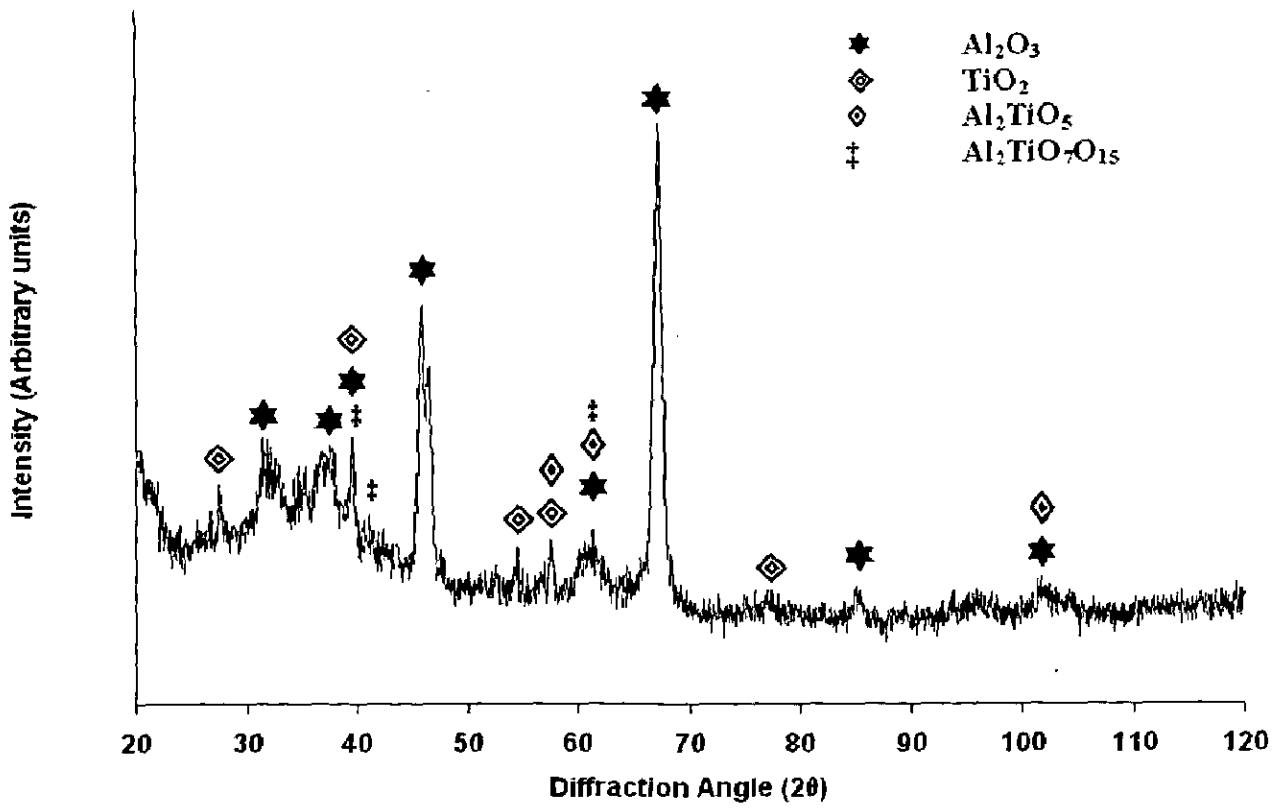
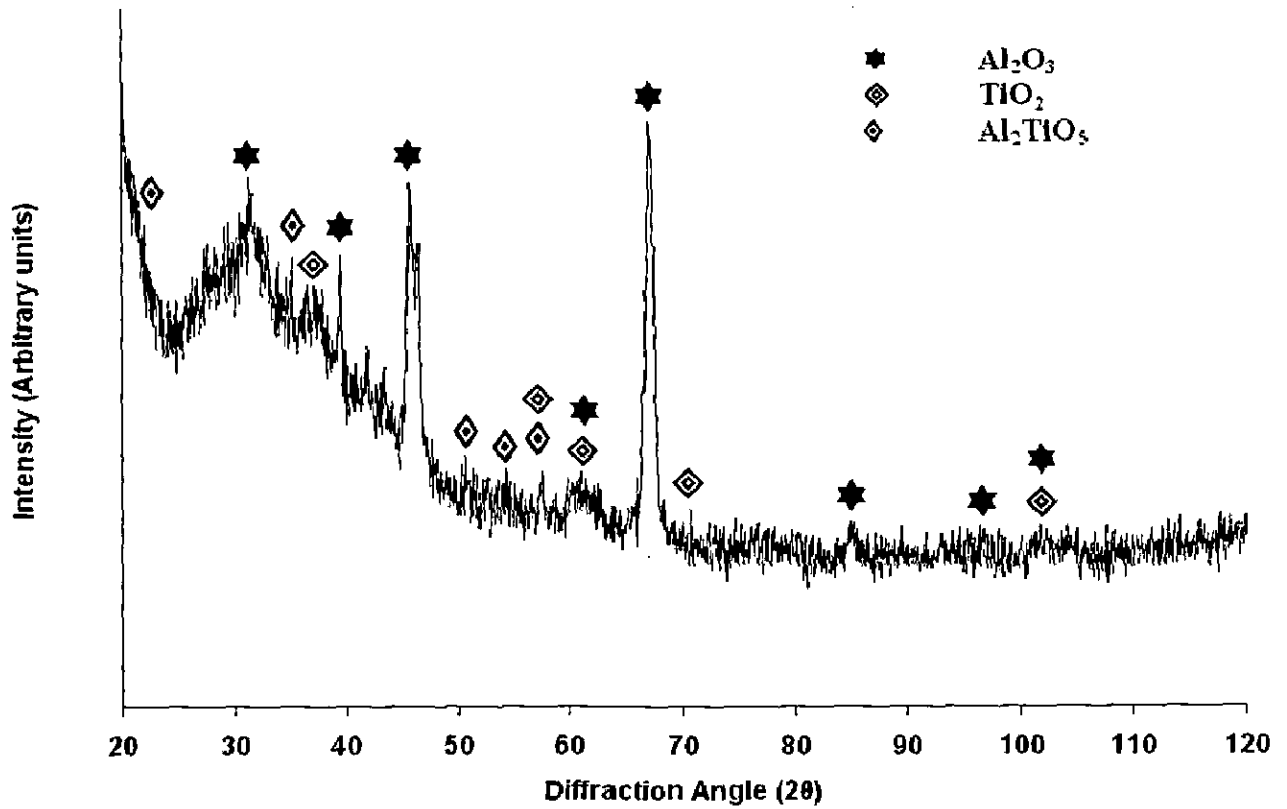
Fig. 6.27: X-ray diffraction profiles for Al_2O_3 -3 wt% TiO_2 coated superalloys subjected to cyclic oxidation in air at 900°C for 50 cycles.
 (a) Superni 600 (b) Superni 718

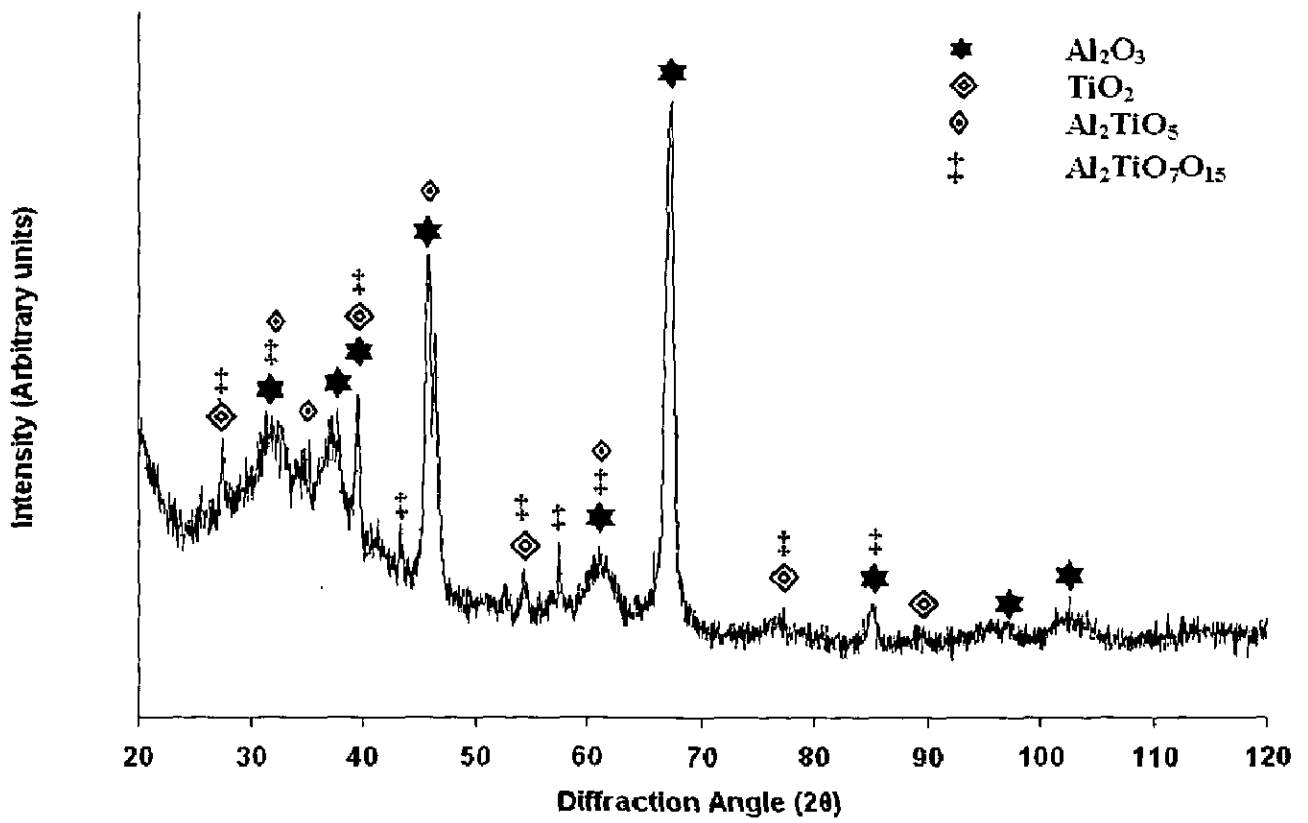
Fig. 6.28: X-ray diffraction profiles for Al₂O₃-3 wt% TiO₂ coated superalloy Superfer 800 subjected to cyclic oxidation in air at 900°C for 50 cycles.

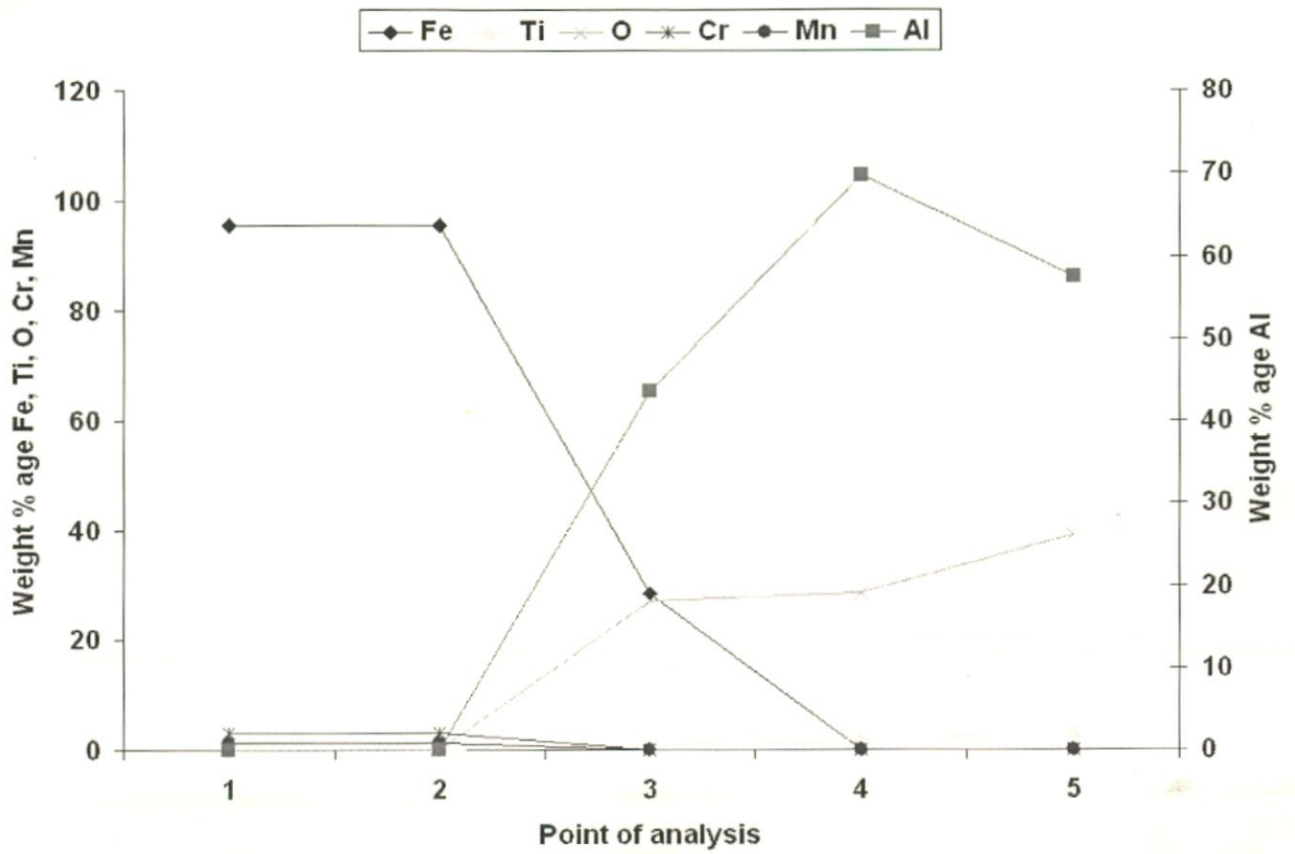
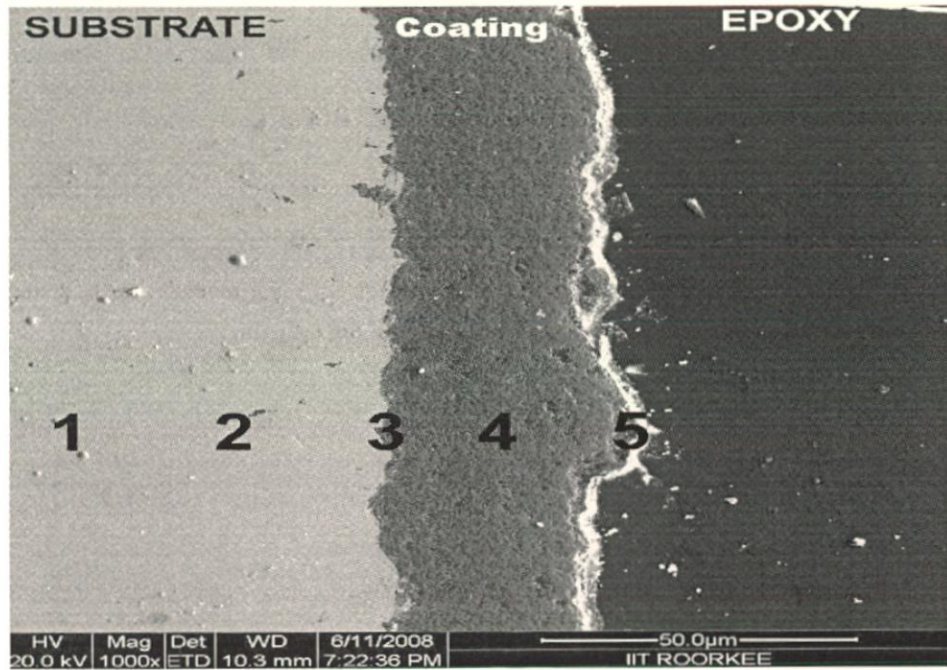
Fig. 6.31: Cross sectional morphology and elemental composition variation across the cross-section of $\text{Al}_2\text{O}_3\text{-3wt\%TiO}_2$ coated boiler steel T11 exposed to air at 900°C for 50 cycles, 1000 X.

The BSE image and the EDX analysis across the cross section on Al_2O_3 -3 wt% TiO_2 coated alloys are shown in Fig.6.31 to Fig. 6.35. The results of the cross-section analysis for oxidised T11 and T22 boiler steels are plotted and shown in Fig. 6.31 and 6.32 along with micrographs. By viewing the cross sectional micrograph and the corresponding EDX analysis of coated T11, it is quite clear that coating is firm and intact and there is no deterioration of coating and hence coating has protected the surface very well. There is no penetration of oxygen in the substrate during the entire exposure of the coated specimen. As we approach from substrate to coating, at point 4 and point 5 there is no indication of presence of elements other than present in the coating and same is in case of coated T22.

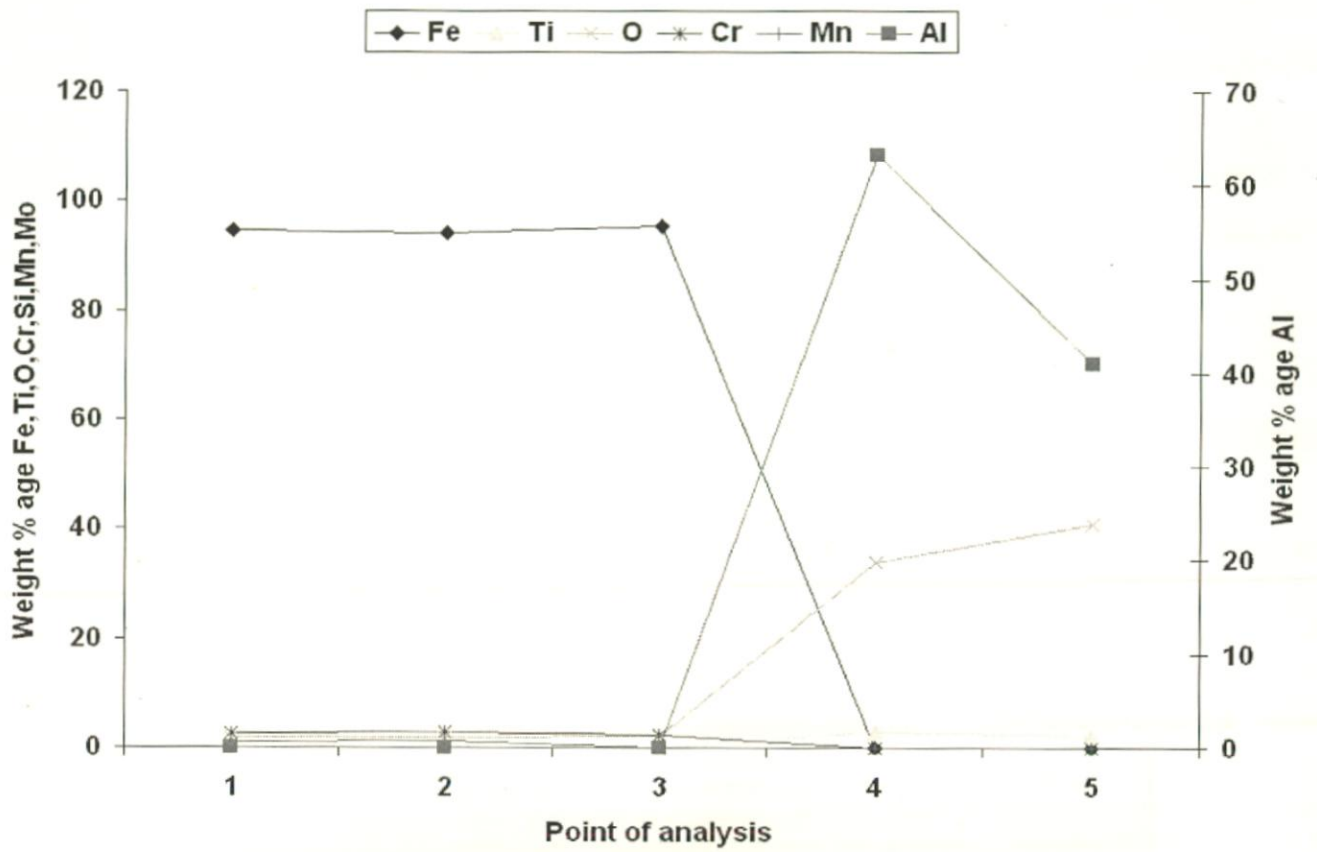
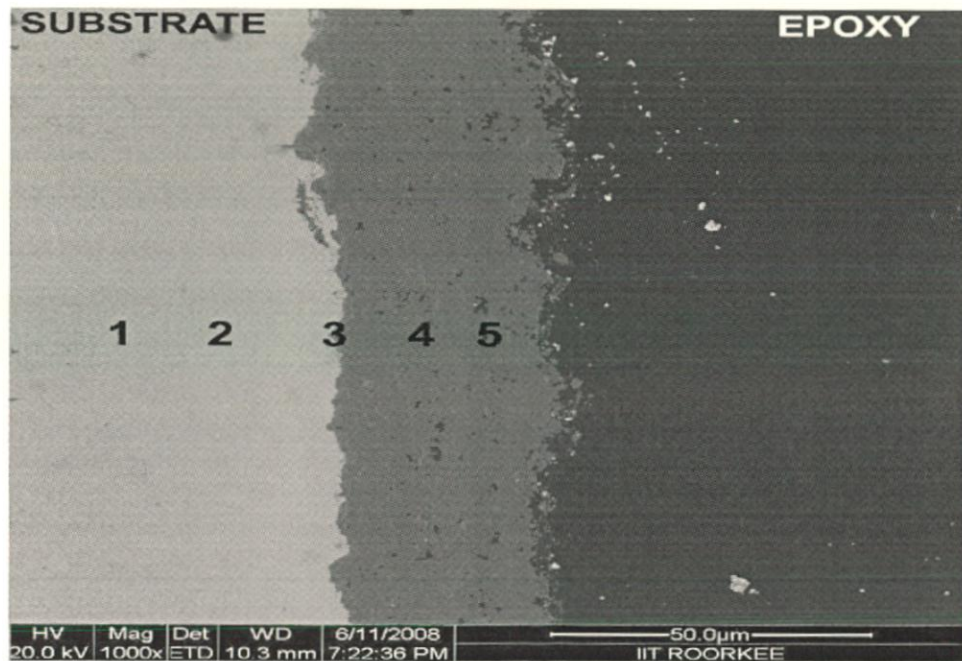
Fig 6.32: Cross sectional morphology and elemental composition variation across the cross-section of $\text{Al}_2\text{O}_3\text{-3wt\%TiO}_2$ coated boiler steel T22 exposed to air at 900°C for 50 cycles, 1000 X.

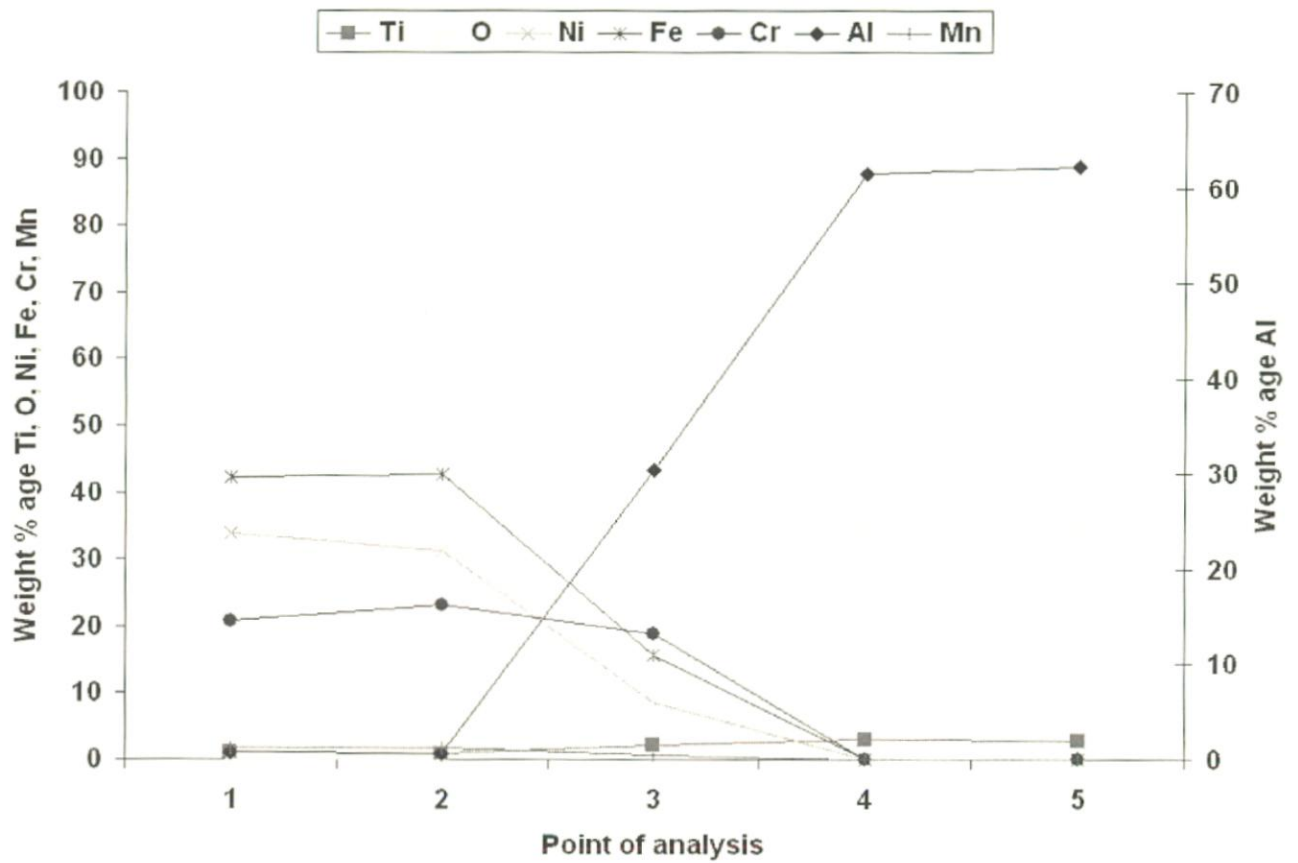
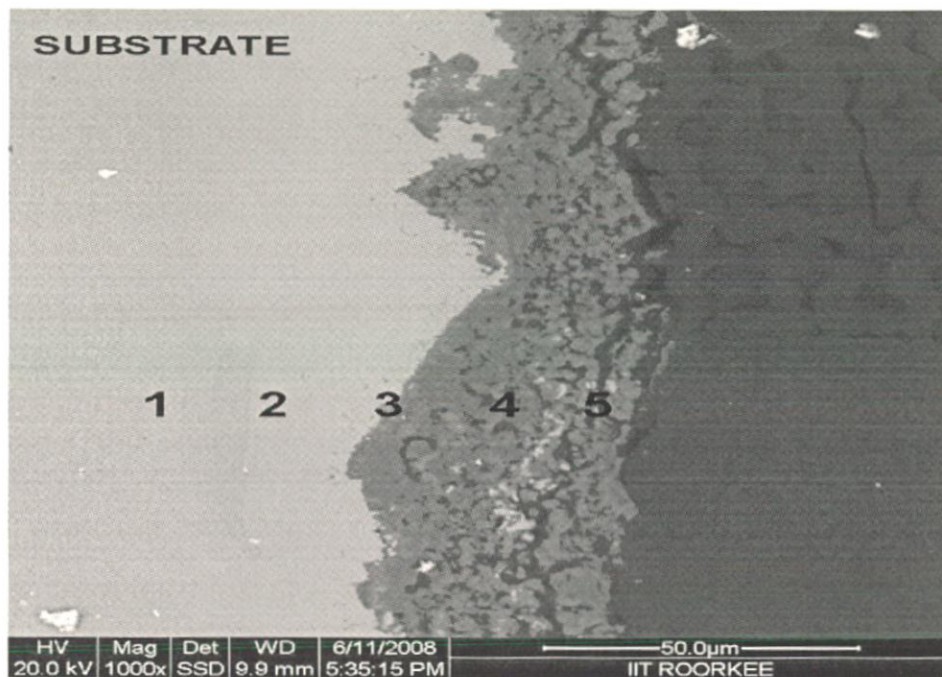
Fig. 6.33: Cross sectional morphology and elemental composition variation across the cross-section of $\text{Al}_2\text{O}_3\text{-3wt\%TiO}_2$ coated superalloy Superni 600 exposed to air at 900°C for 50 cycles, 1000 X.

Also in case of coated superalloys, EDX analysis has revealed that the scale mainly consisted of Al and Ti oxides. Oxide scale morphology along with variation of elemental composition across the cross-section of superalloy coated Superni 600 subjected to cyclic oxidation in air at 900°C after 50 cycles has been depicted in Fig. 6.33. The plots of elemental composition variation show that the scale mainly consists of aluminum and titanium along with oxygen. There is no penetration of oxygen into the substrate through the coating. In coated Superni 718, (Fig. 6.34) coating is intact and adherent and there is no oxidation of substrate beneath the coating. In coated Superfer 800, Fig. 6.35, the coating has major portion of aluminium oxide

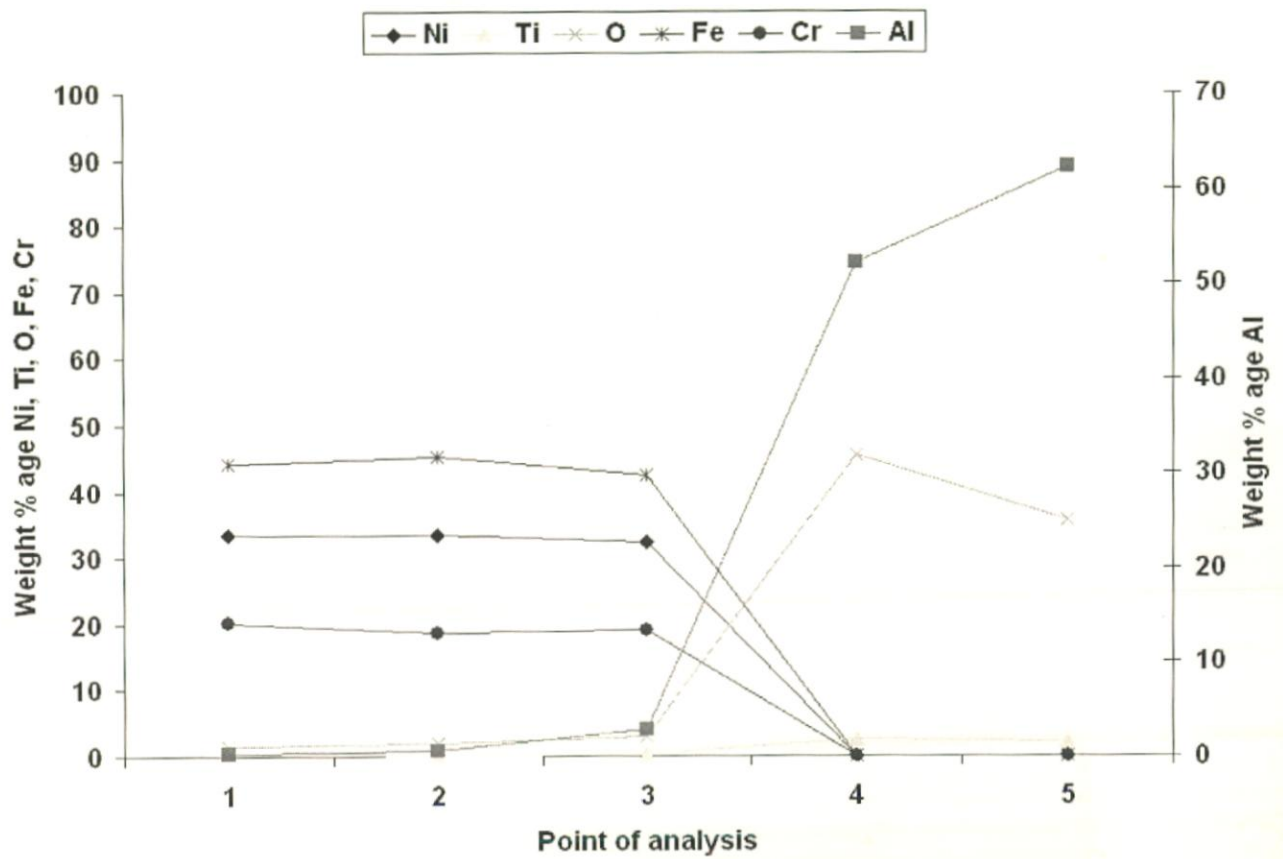
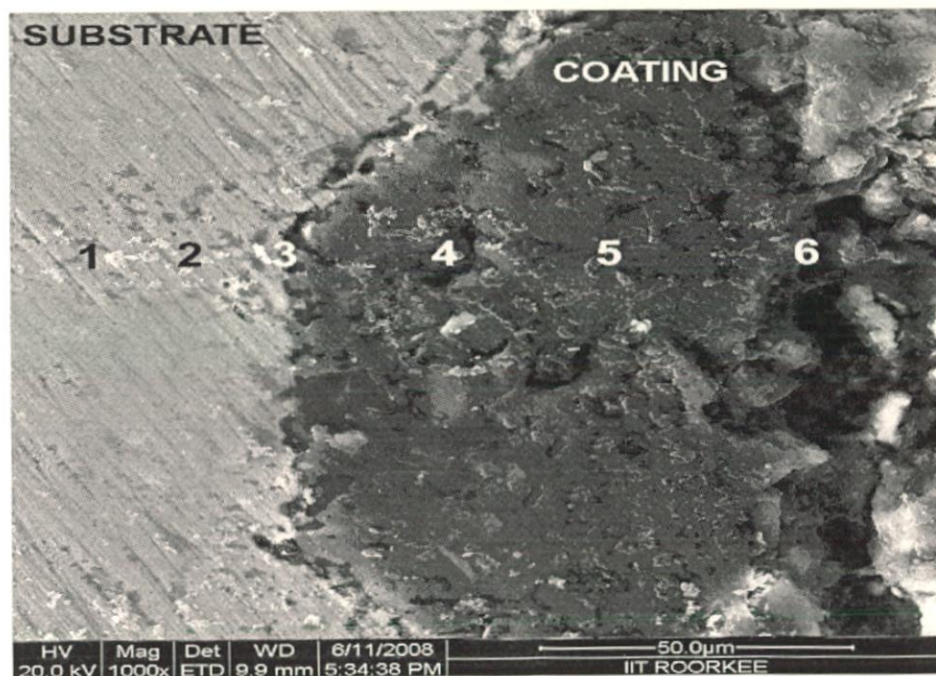
Fig. 6.34: Cross sectional morphology and elemental composition variation across the cross-section of $\text{Al}_2\text{O}_3\text{-3wt\%TiO}_2$ coated superalloy Superni 718 exposed to air at 900°C for 50 cycles, 1000 X.

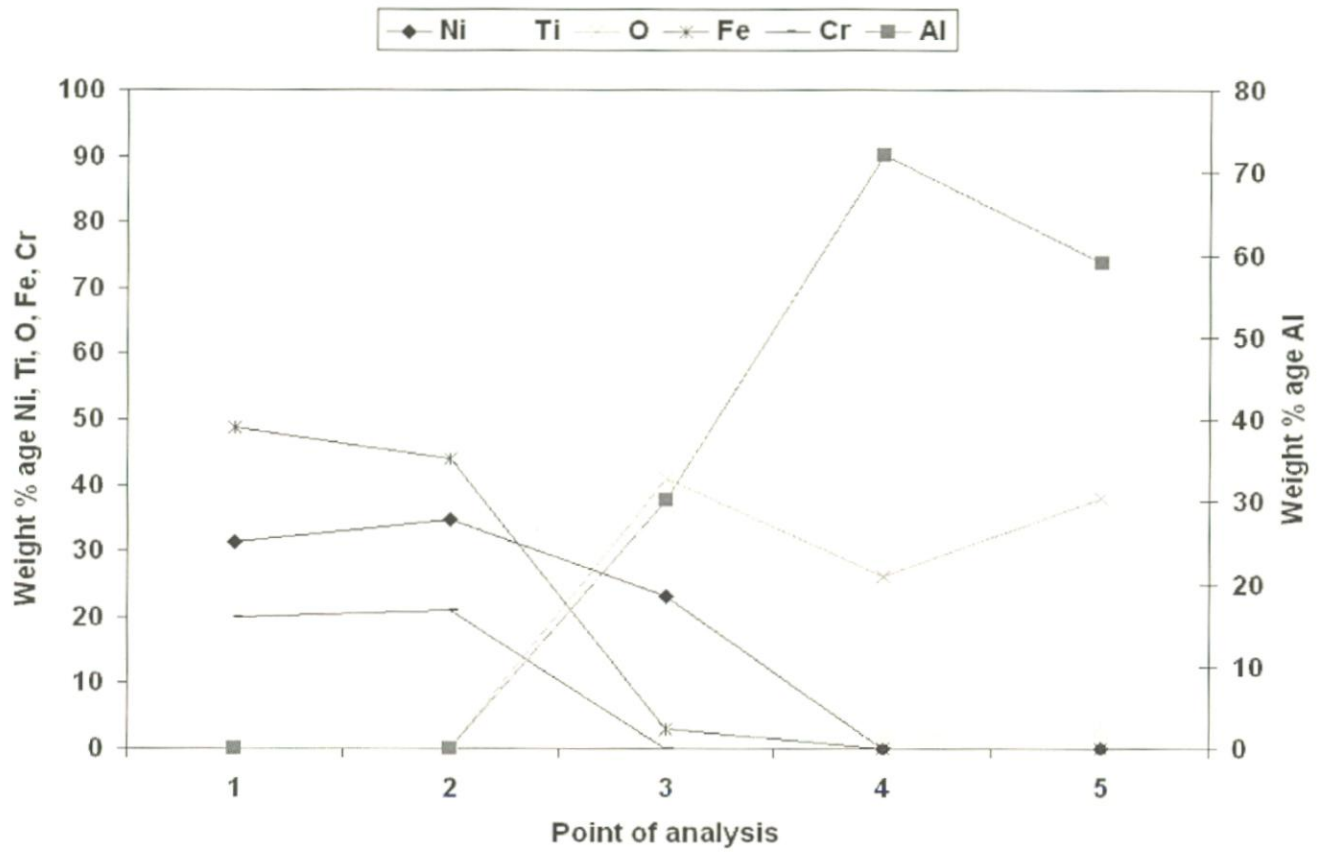
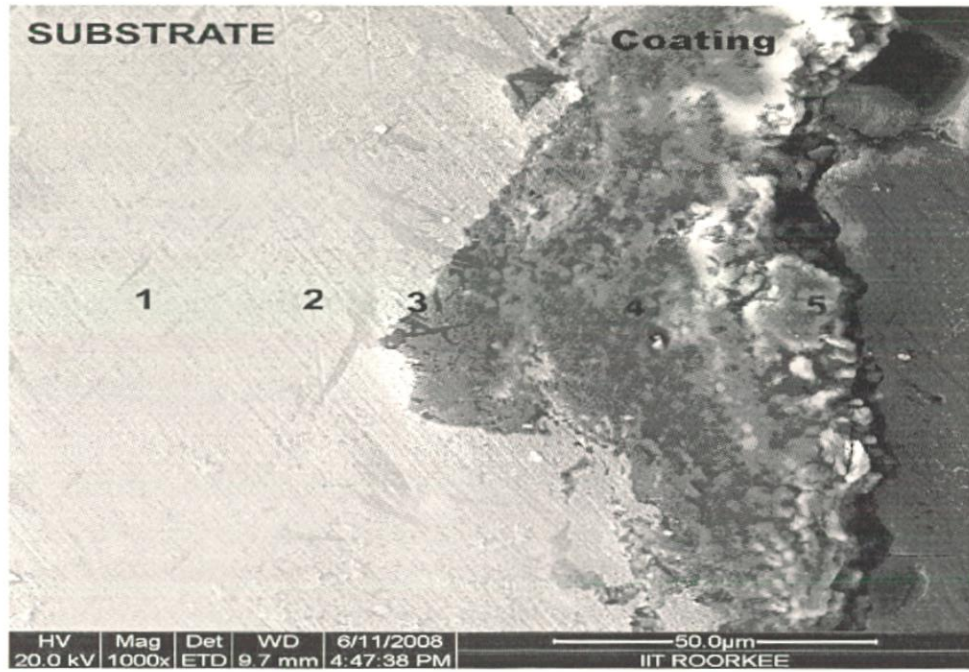
Fig. 6.35: Cross sectional morphology and elemental composition variation across the cross-section of $\text{Al}_2\text{O}_3\text{-3wt\%TiO}_2$ Coated superalloy Superfer 800 exposed to air at 900°C for 50 cycles, 1000 X.
