STUDY OF DETONATION GUN COATED ALLOYS FOR RESISTANCE TO EROSION AND CORROSION

A THESIS

METALLURGICAL AND MATERIALS ENGINEERING

This thesis investigates the erosion and corrosion performance of Al_2O_3 -3 wt % TiO_2 thermal spray coatings deposited by detonation gun technique. As-sprayed coatings were characterized by using the combined techniques of optical microscopy, microhardness testing, X-ray diffractometry (XRD) and scanning electron microscopy/energy-dispersive analysis (SEM/EDX). The corrosion performance was evaluated in oxidising and molten salt environment and also in actual working conditions of boiler. The erosion performance was evaluated at room temperature conditions as well as under high temperature conditions, high erodent velocity, and actual boiler conditions. The corrosion behavior and morphological development were investigated by weight change kinetics, metallographs, depths of attack, metal thickness losses, and XRD analyses.

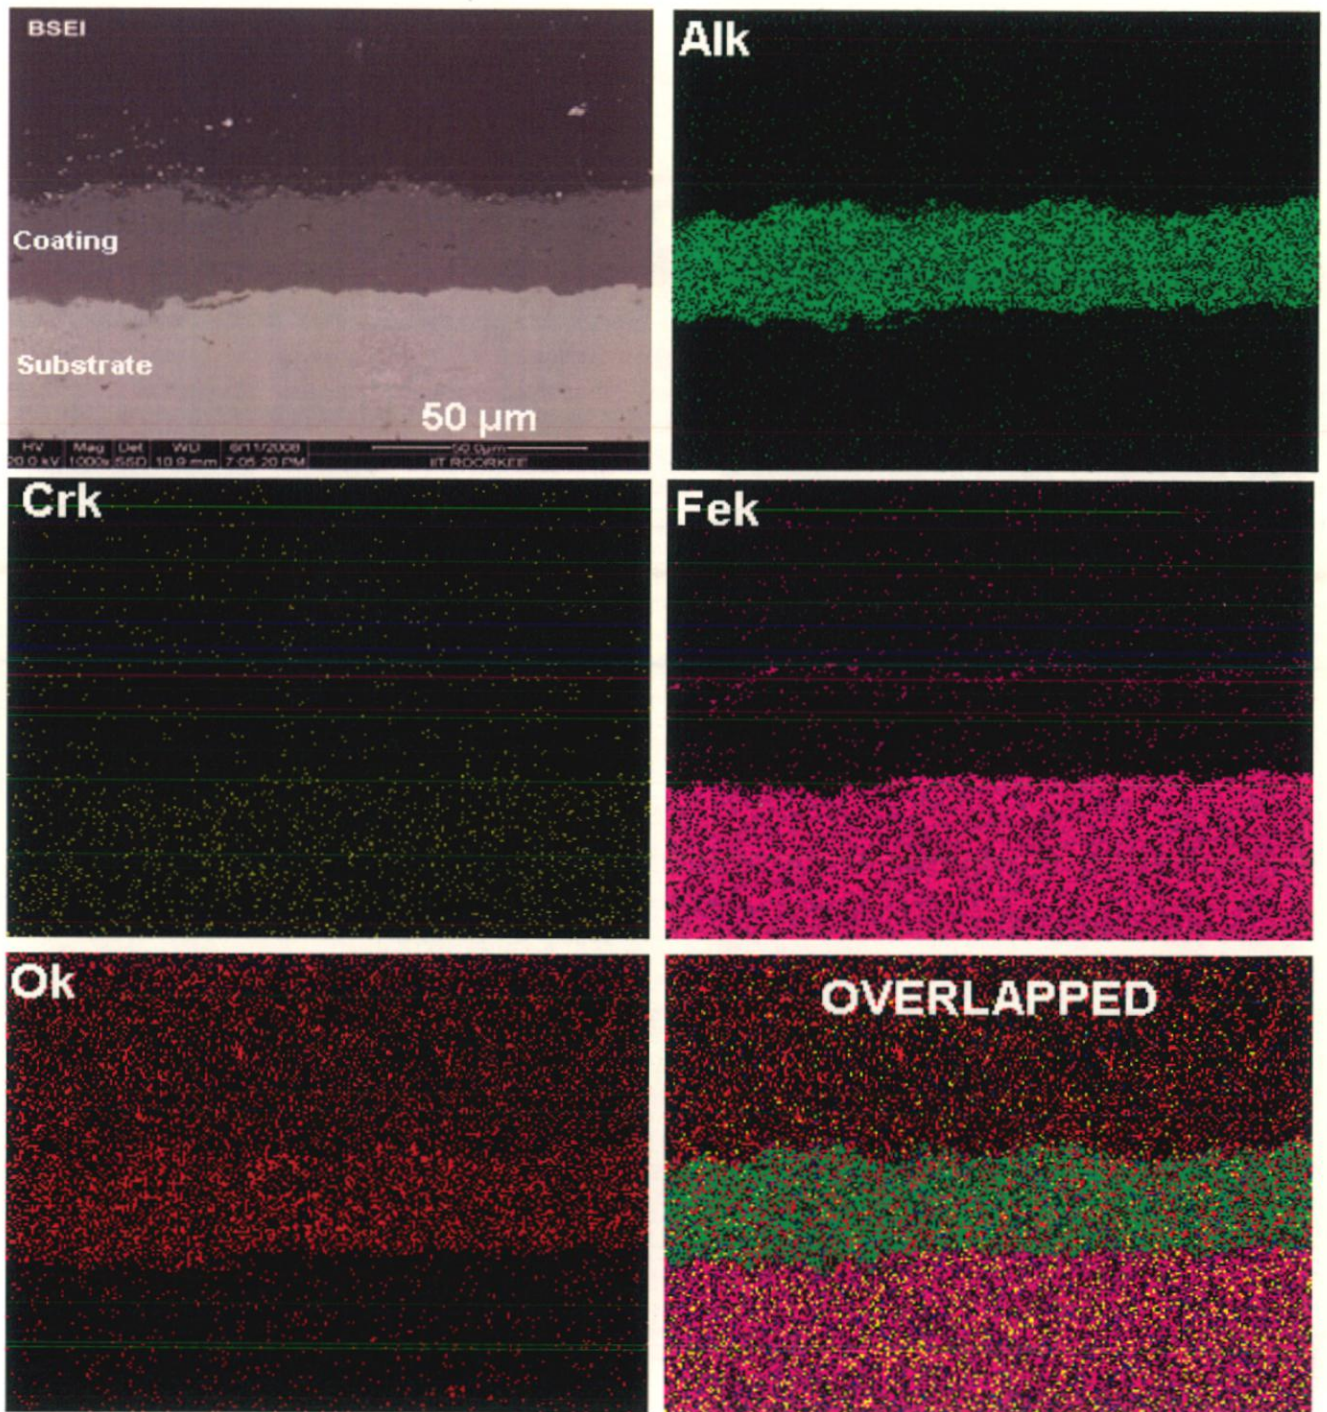
Fig. 6.37: BSEI and X-ray mapping of the cross-section of Al_2O_3 -3 wt% TiO_2 coated boiler steel T22 subjected to cyclic oxidation in air at 900°C for 50 cycles.

Back Scattered Electron Image of cross-section of Al_2O_3 -3 wt% TiO_2 coated substrate alloys (T11, T22, Superni 600, Superni 718 and Superfer 800) and corresponding X-ray mapping after oxidation in air at 900°C after 50 cycles is shown in Fig. 6.36 to 6.40 respectively. In all the coated alloys coatings has acted as a barrier and thus have prevented oxidation of substrate by inhibiting the penetration of oxygen. There is no spalling of coating throughout the testing. In coated boiler steels T11 and T22 (Fig.6.36 and 6.37), main constituent is aluminium oxide and there is no inward

penetration of any element into the substrate. In coated T22 steel very thin layer of Fe_2O_3 is seen at the outer edge of the coating (Fig.6.37)

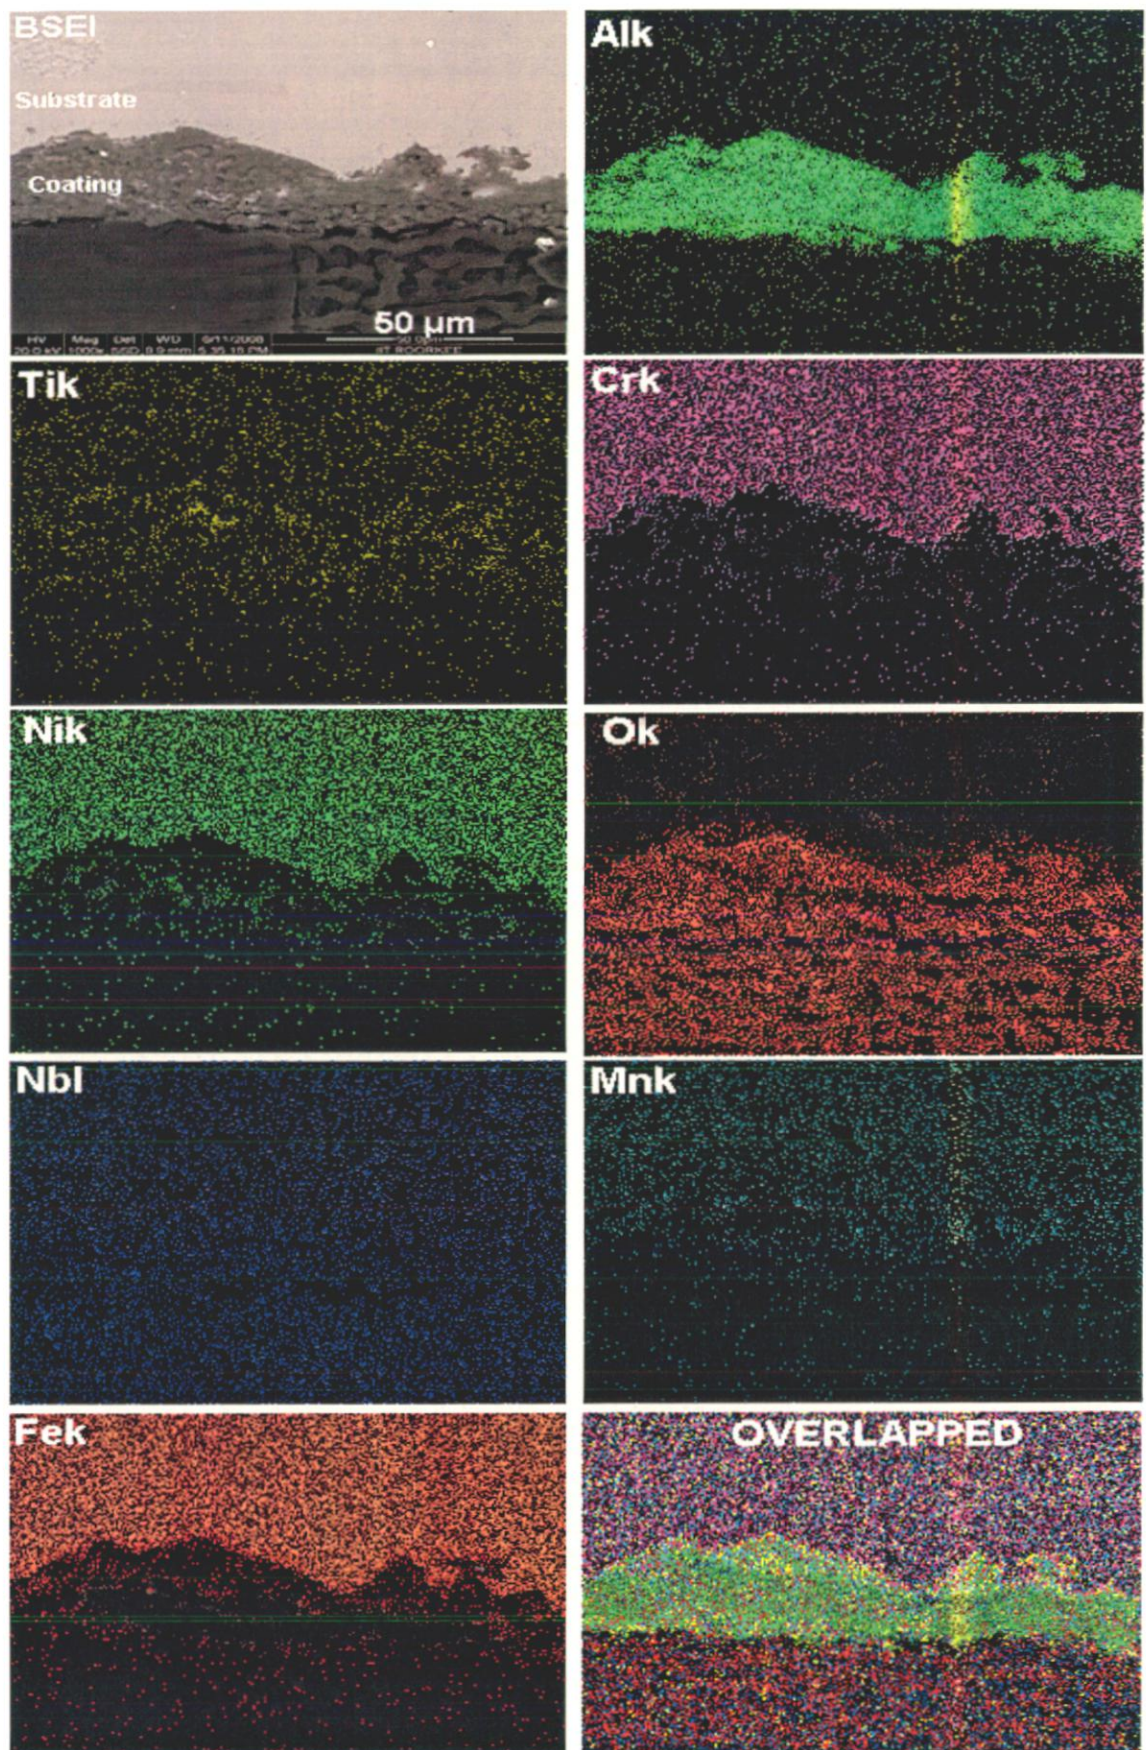
Fig.6.38: BSEI and X-ray mapping of the cross-section of Al_2O_3 -3 wt% TiO_2 coated superalloy Superni 600 subjected to cyclic oxidation in air at 900°C for 50 cycles.

In coated Superni 600, Fig.6.38 coating remained intact. TiO_2 is seen concentrated as a streak at the interface and is also dispersed throughout the coating. Iron and Nickel have diffused into the coating but are not oxidised. In coated Superni 718, Fig.6.39 coating is intact and iron from substrate has diffused into the coating. A clear titanium rich band is seen along the interface and also a parallel band of titanium is present in the coating. TiO_2 is also seen at the top surface of the coating. In coated Superfer 800, Fig.6.40 Iron, Nickel and chromium have diffused from substrate into the coating and is present around Al_2O_3 grain. Some Cr has diffused from base alloy to the interface of the coating as is visible from the overlapped maps. Cr_2O_3 band has been formed at the coating substrate interface. The coating is intact and has prevented the penetration of oxygen from the atmosphere into the substrate. Thin streak of iron is also visible in the exposed coating

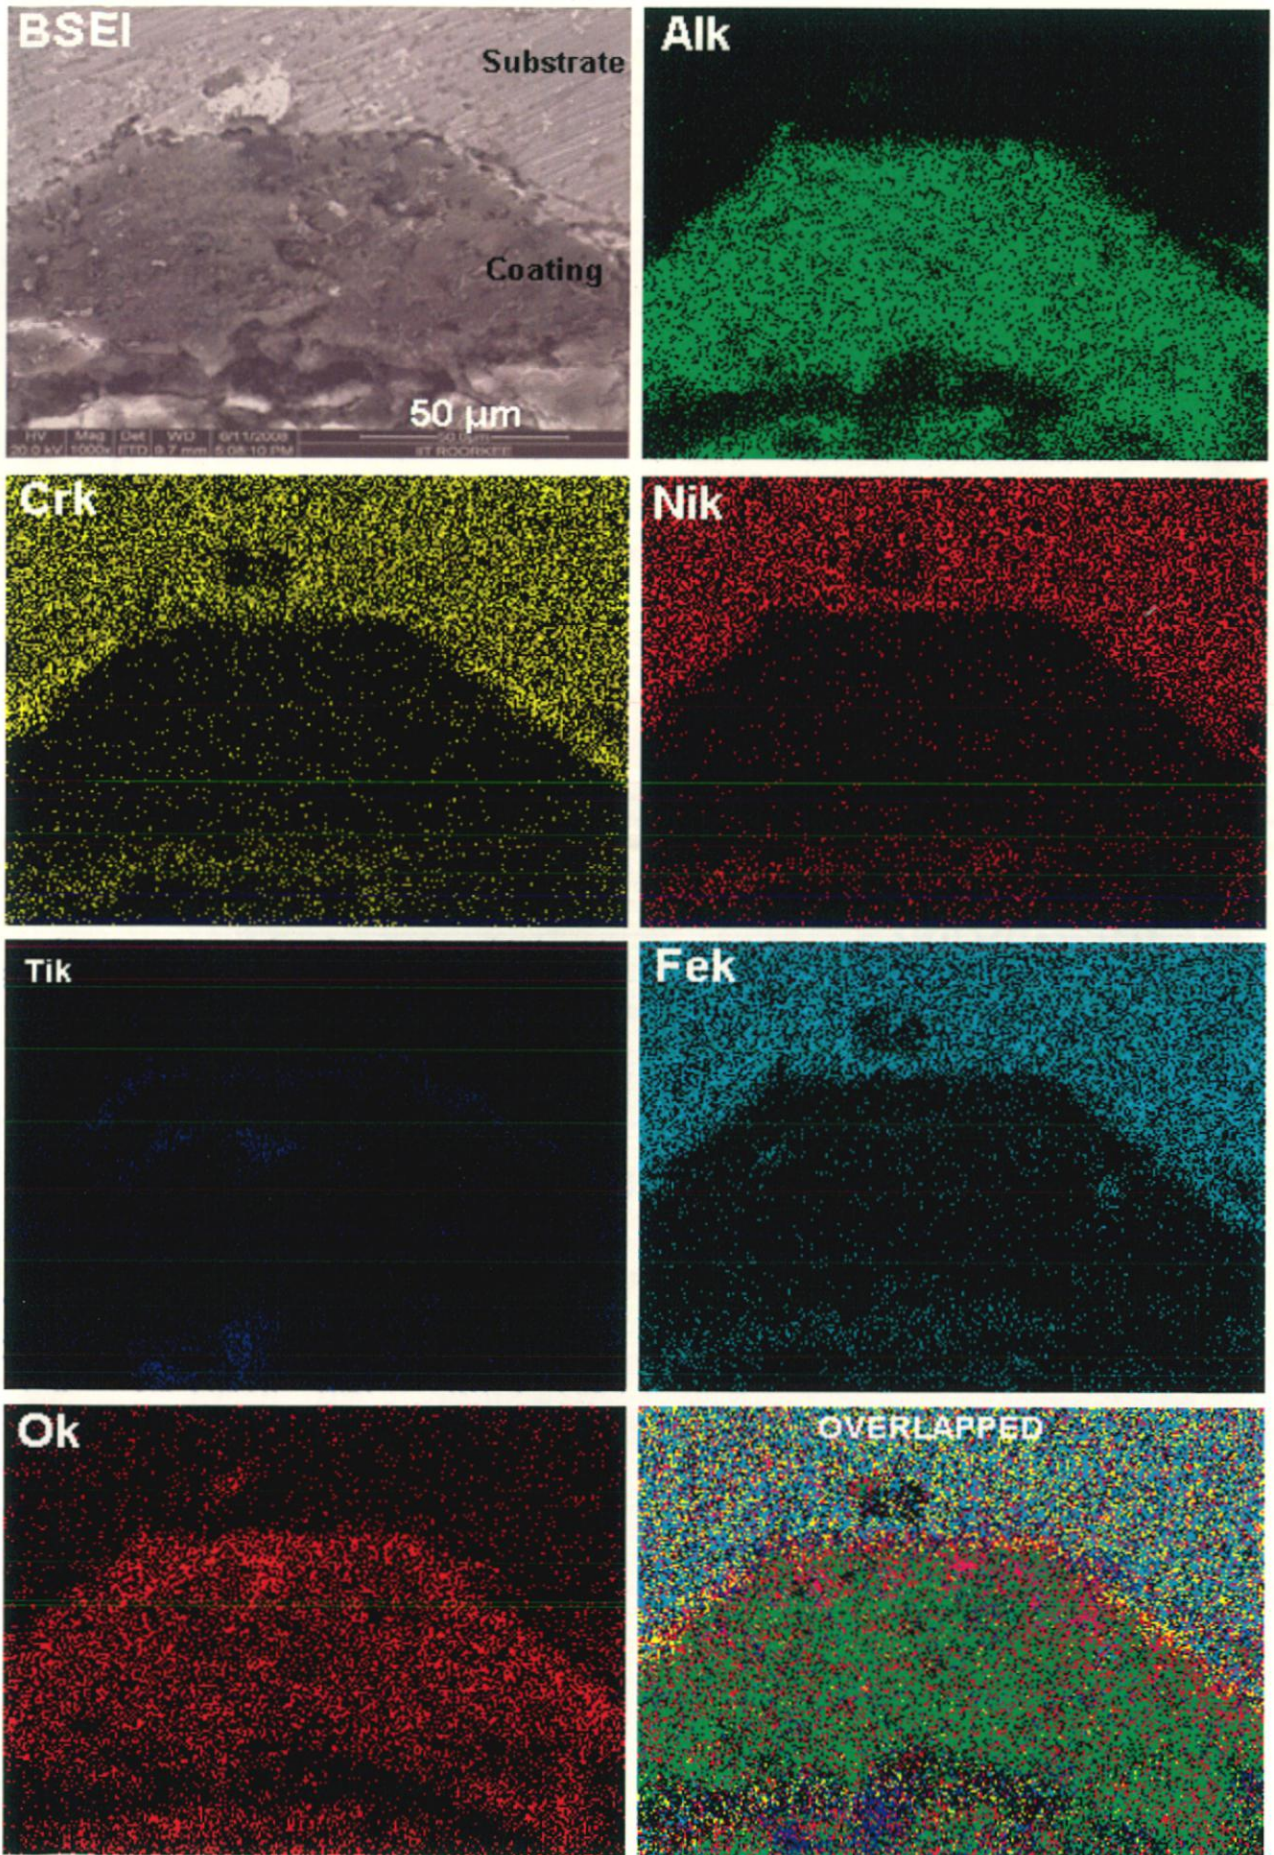
Fig. 6.39: BSEI and X-ray mapping of the cross-section of Al_2O_3 -3 wt% TiO_2 coated superalloy Superni 718 subjected to cyclic oxidation in air at 900°C for 50 cycles.

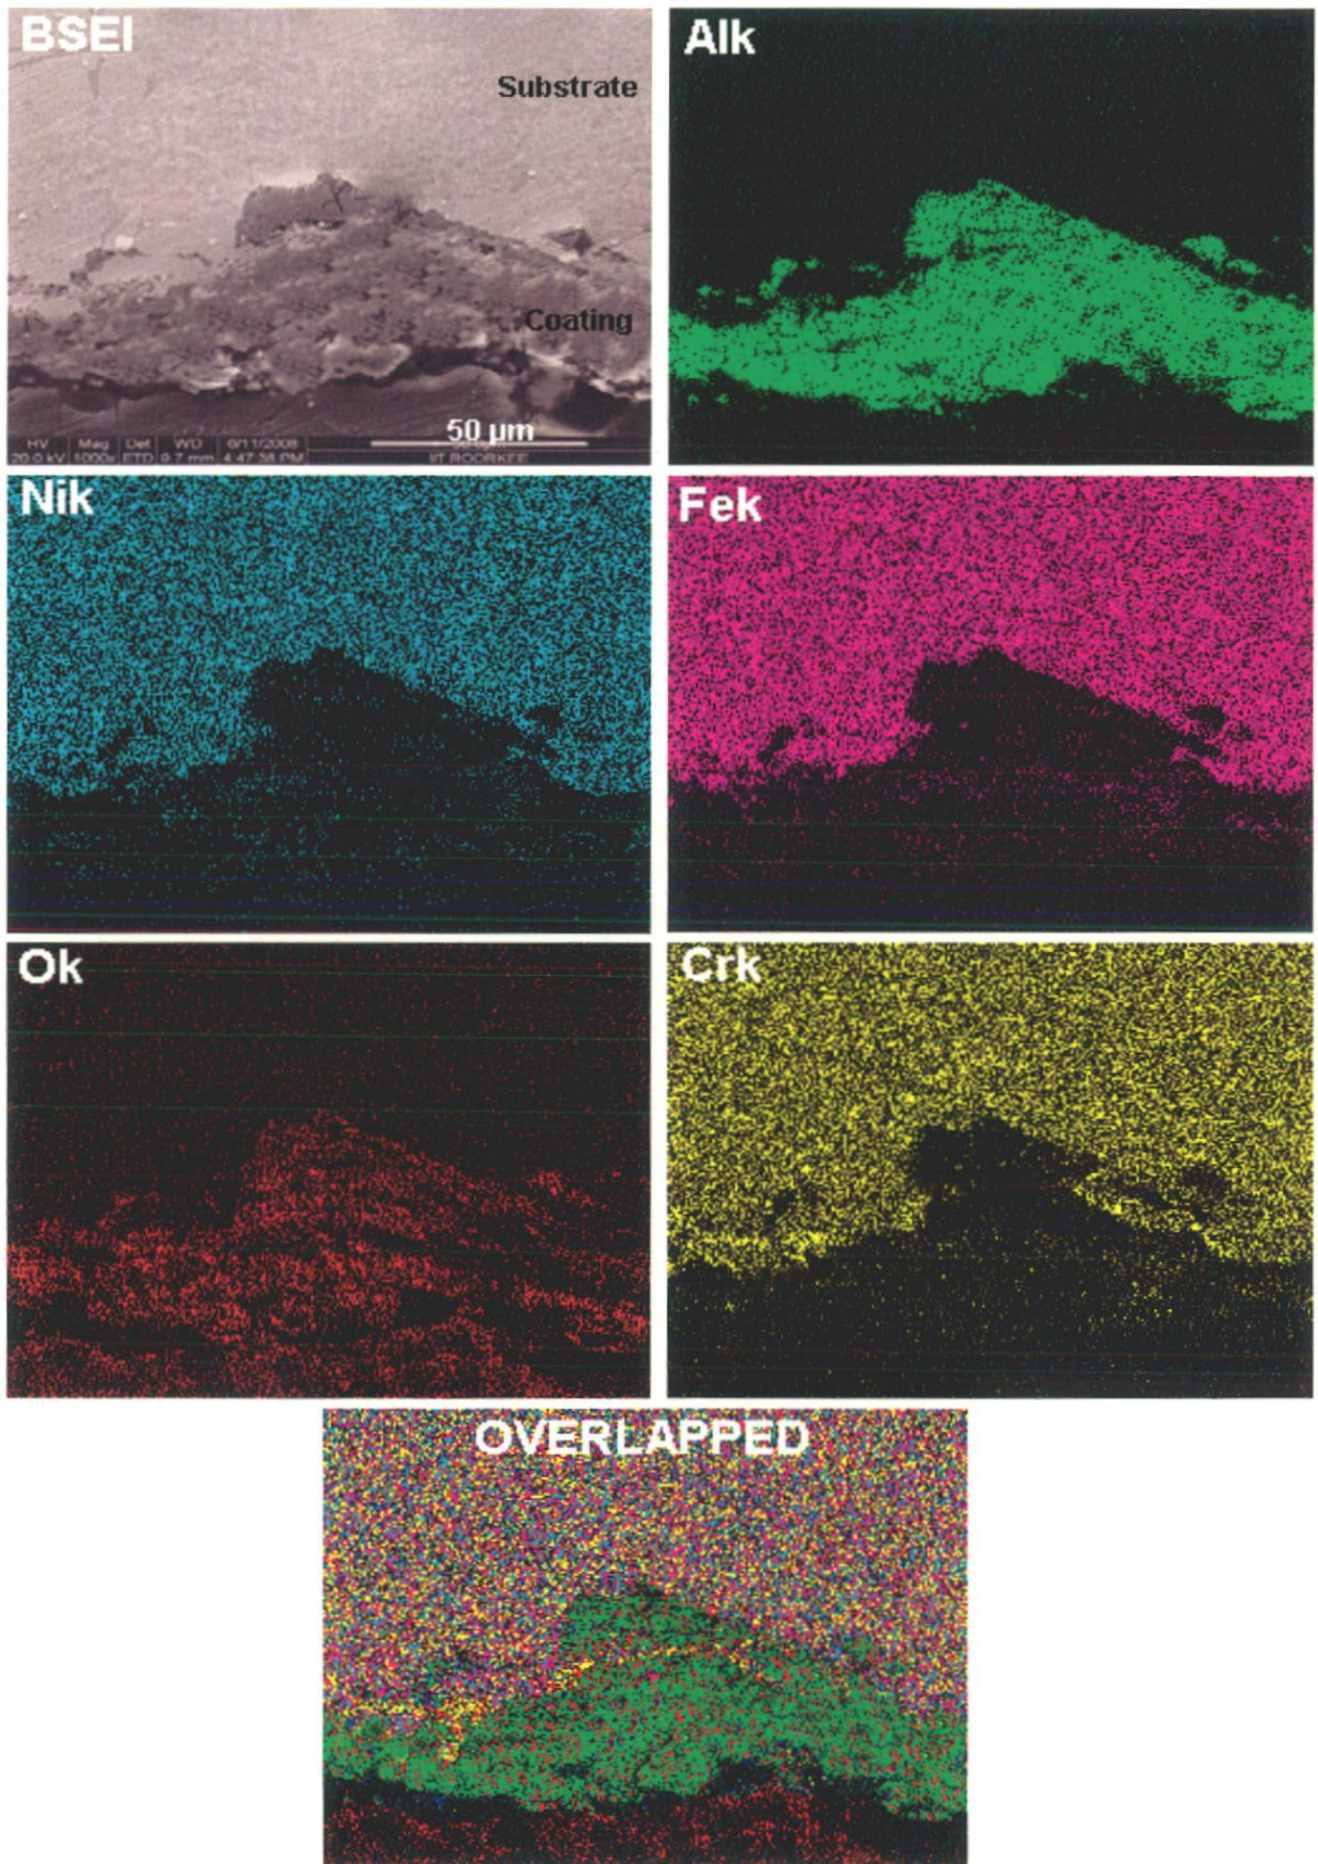
Fig. 6.40: BSEI and X-ray mapping of the cross-section of Al_2O_3 -3 wt% TiO_2 coated superalloy Superfer 800 subjected to cyclic oxidation in air at 900°C for 50 cycles.

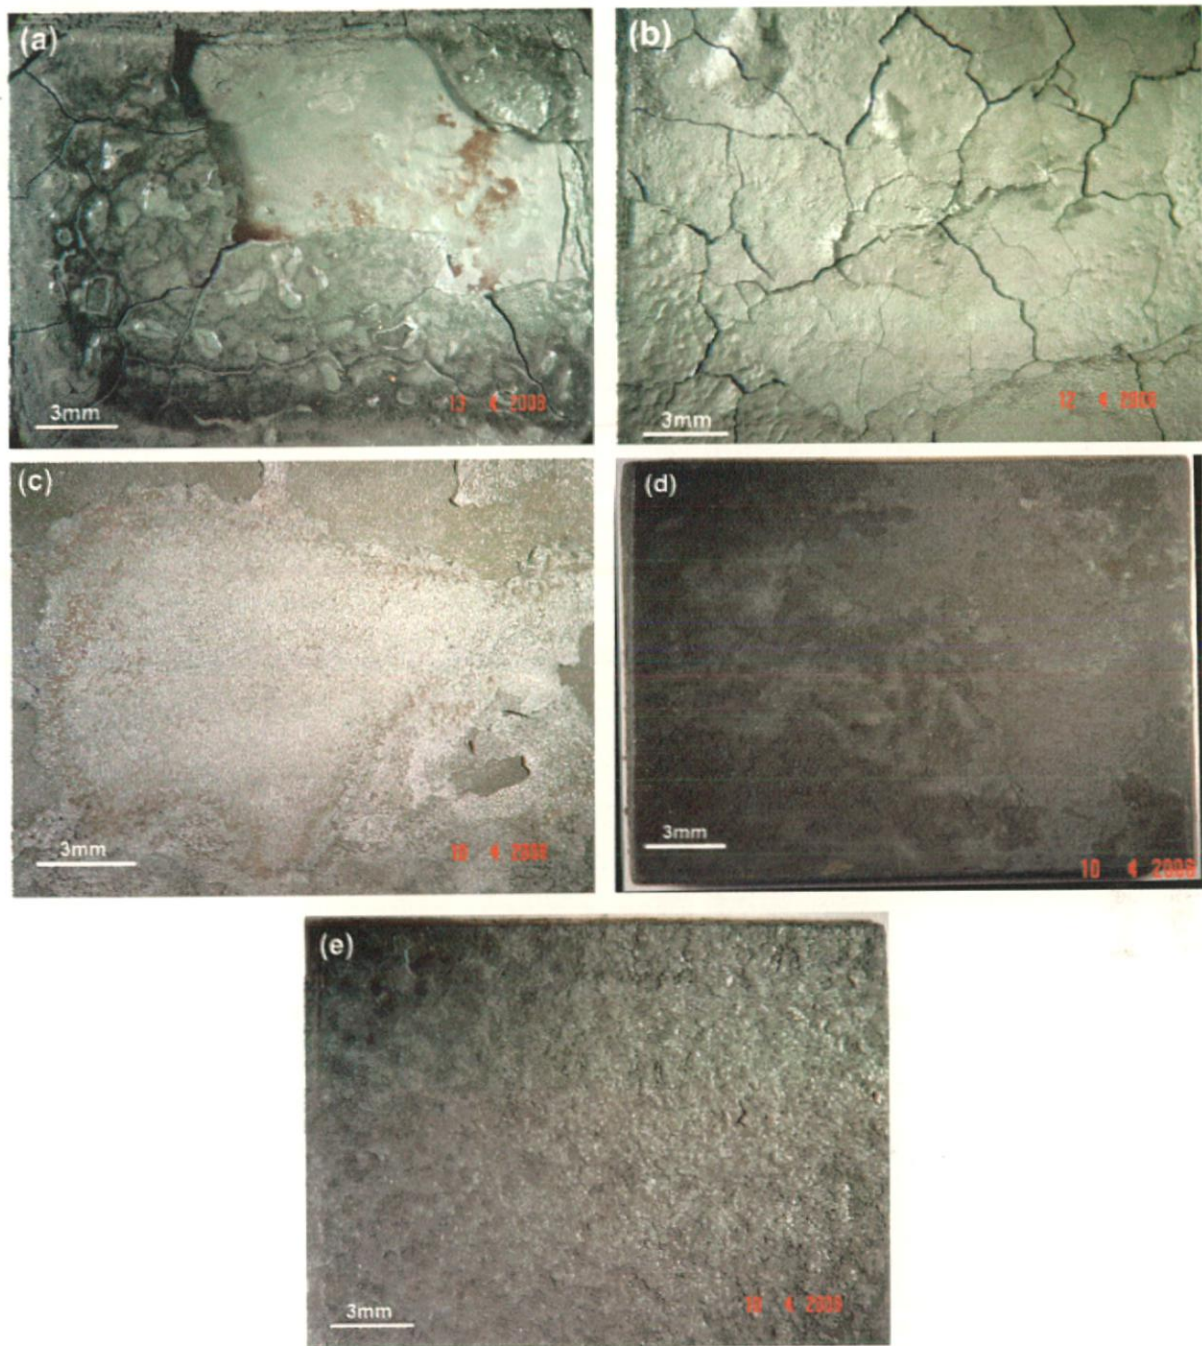
Fig.6.41: Macrographs of substrate alloys after cyclic hot corrosion in $\text{Na}_2\text{SO}_4\text{-60\%V}_2\text{O}_5$ at 900°C for 50 cycles
 (a) T11 (b) T22 (c) Superni 600 (d) Superni 718 (e) Superfer 800

The macrographs of base alloys T11, T22, Superni 600, superni 718 and Superfer 800 after hot corrosion in an aggressive environment of molten salt (Na_2SO_4 -60% V_2O_5) at 900°C under cyclic conditions for 50 cycles are shown in Fig. 6.41. It can be seen from the macrograph that intense spalling has occurred for T11 and T22 steels. The scales formed are massive and have cracked.

In case of T11 steel, exposed to molten salt environment, light grey scale appeared during first few cycles which turned to grayish black as the cycles progressed. After first cycle the sample started turning grey and with passing cycles, some black spots appeared in the centre of the specimen. Spalling of the scale was observed with each passing cycle. After 5th cycle, outer edges of the specimen were shining grey while the interior was black. Spalling started from the central position after 6th cycle. Then the grayish appearance moved from edges towards the centre. Then appearance of the scale was dual colour in nature i.e. it got dark grey in center and light grey at the edges. The dark coloured region in the centre then turned to black and spalled. After 21st cycle, the surface seemed to be composed of three regions; shining grey at edges, dull grey and black at the centre. After 22nd cycle, grain boundary like structure appeared on the surface. Then thick layer formed on the edges. After 32nd cycle, cracking of top layer of scale started in centre. After 2 cycles, cracks became wide and deep and extremely black surface beneath cracks is visible. After 35th cycle the top scale broke away exposing the internal surface.

In T22 steel, surface became grey after first cycle followed by formation of black spots further exposure it became shining grey. Needle like structure was formed on the surface while edges became dull grey with black spots. After 7th cycle, thin layers from all the surface started peeling off. After 10th cycle, severe spalling resulted in multi layered cracking which continued throughout the study. Spalling was so severe that thick layers were formed and separated out after each cycle.

The scale was fragile and started spalling in the early cycles in both boiler steels. Once there was formation of the cracks then there was gradual increase in the width of cracks for every subsequent cycle.

In case of T11 base steel, the scale was lustrous dark black. Whereas fragile and dark grey colour scale was there for T22 base steel. Intense spalling was observed through out the experimentation. As soon as subscale forms the top layer of scale breaks away from it and the separated multiple layers overlapping each other were seen.

In superalloys, a very thin scale appeared on the surfaces from 1st cycle onwards. In superni 600, after first cycle, the surface turned brown and light brownish grey coloured scale appeared after 5th cycle. Then onwards a fragile scale could be seen on the surfaces of the specimen with tiny cracks at the edges. The fragile scale separated out from the surfaces in the form of small and thin flakes and by the end of 17th cycle detachment of scale was observed followed by intensive spalling. After 21st cycle small cracks were clearly visible on the surface and very rough and uneven surface appeared. Then spalling and crack formation continued throughout the study. After 46th cycle there was a severe cracking and visible deterioration of the surface.

In superni 718, surface became totally black after first cycle. After 2nd cycle there was appearance of brown and rusty patches throughout the surface and the size of the patches increased in the subsequent cycles and afterwards surface became rough. After 19th cycle there was appearance of some powder precipitates black in colour on the surface. The colour of the scale became jet black in the coming cycles with spalling and minor sputtering (disintegration of the scale accompanied by cracking sound during cooling). Minor spalling and sputtering went on till the end of the 50th cycle.

In Superfer 800 specimen, after first cycle, carbon black coloured scale appeared on the surface and patch formation in the scale started. There was sputtering of small particles after 2nd cycle. The spalling and sputtering intensified as the period of study progressed with lot of corrosion products collected in the boat. After 11th cycle, small cracks were visible on the scale but not much of disintegration was observed. After 34th cycle some shining pits appeared on the surface of scale followed by separating out of small particles. After 42nd cycle, the scale had lustrous appearance with chip like structure in a grey matrix. Then there was surface disintegration in the form of tiny flakes coming out of the surface. The surfaces of the scale become uneven and pits were observed at places from where spalling had taken place.

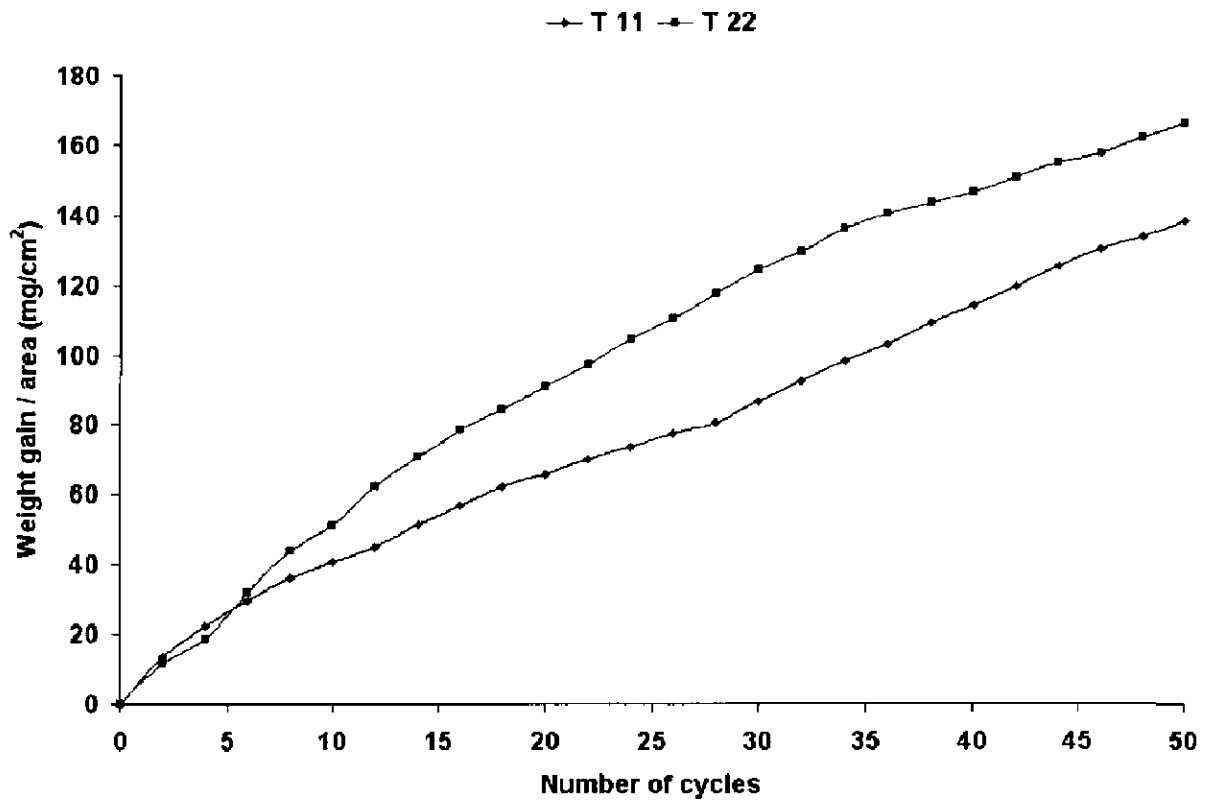
Fig. 6.42: Weight gain plot for uncoated boiler steels T11 and T22 subjected to cyclic hot corrosion in Na₂SO₄-60%V₂O₅ at 900°C for 50 cycles.

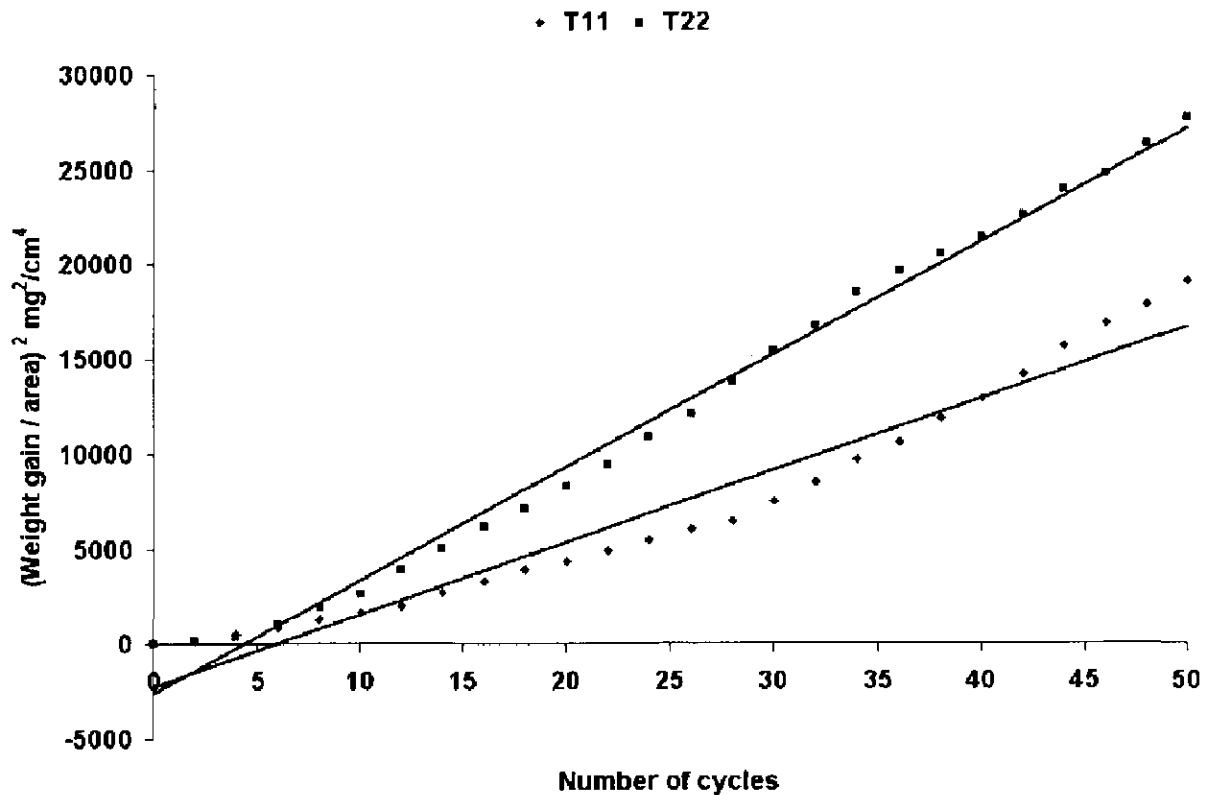
Fig.6.43: Weight gain square (mg²/cm⁴) plot for uncoated boiler steels T11 and T22 subjected to cyclic hot corrosion in Na₂SO₄-60%V₂O₅ at 900°C for 50 cycles.

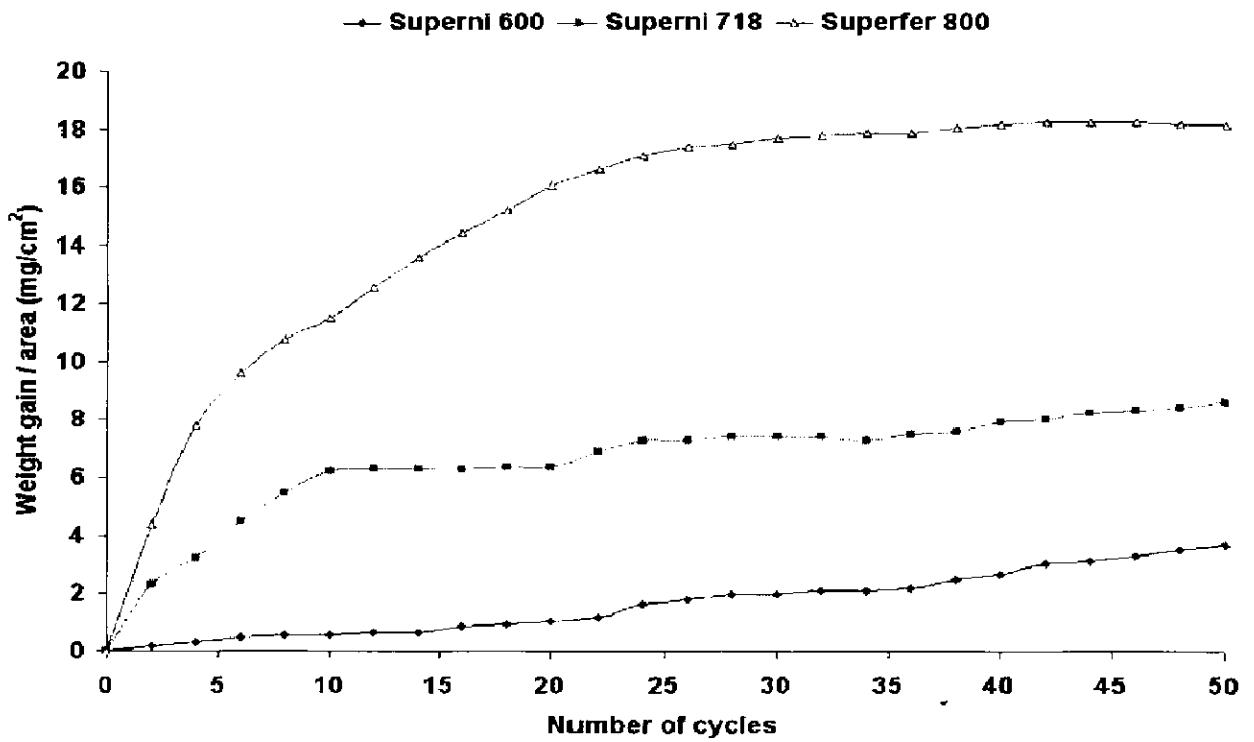
Fig. 6.44: Weight gain plot for uncoated superalloys Superni 600, Superni 718, Superfer 800 subjected to cyclic hot corrosion in $\text{Na}_2\text{SO}_4\text{-60\%V}_2\text{O}_5$ at 900°C for 50 cycles.

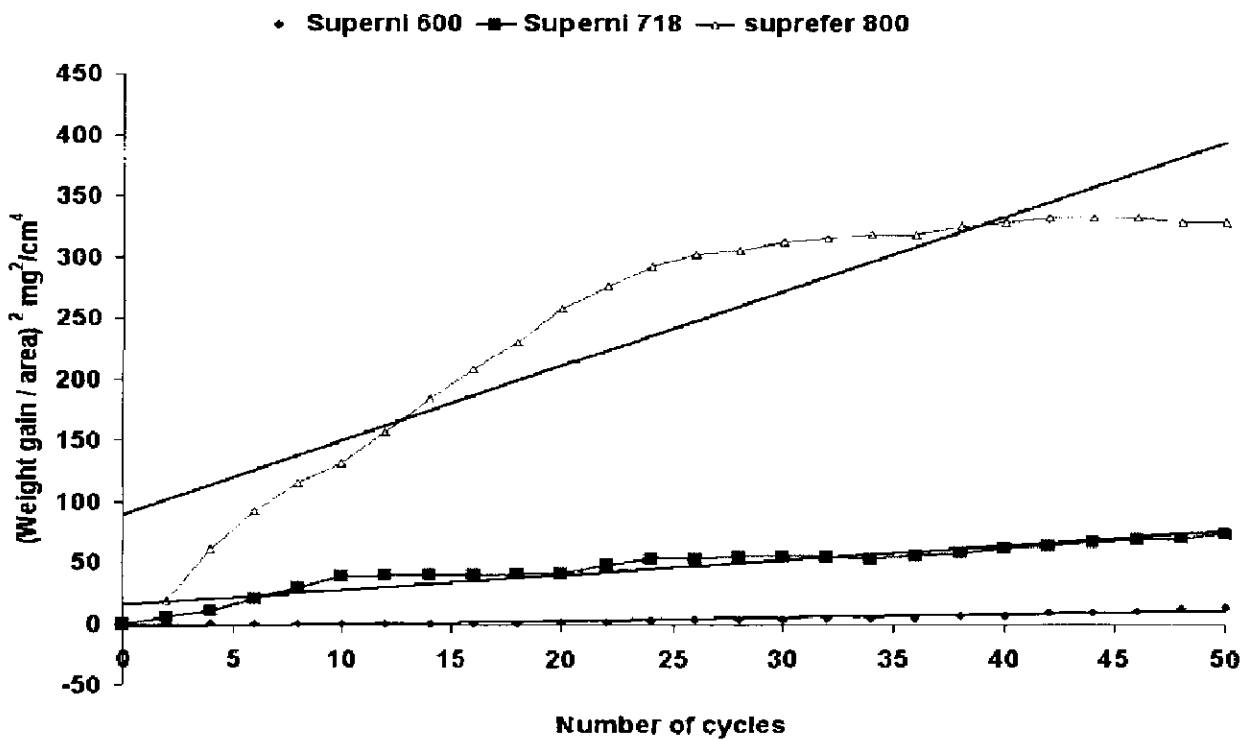
Fig.6.45: Weight gain square (mg^2/cm^4) plot for uncoated Superni 600, Superni 718, Superfer 800 subjected to cyclic hot corrosion in $\text{Na}_2\text{SO}_4\text{-60\%V}_2\text{O}_5$ at 900°C for 50 cycles

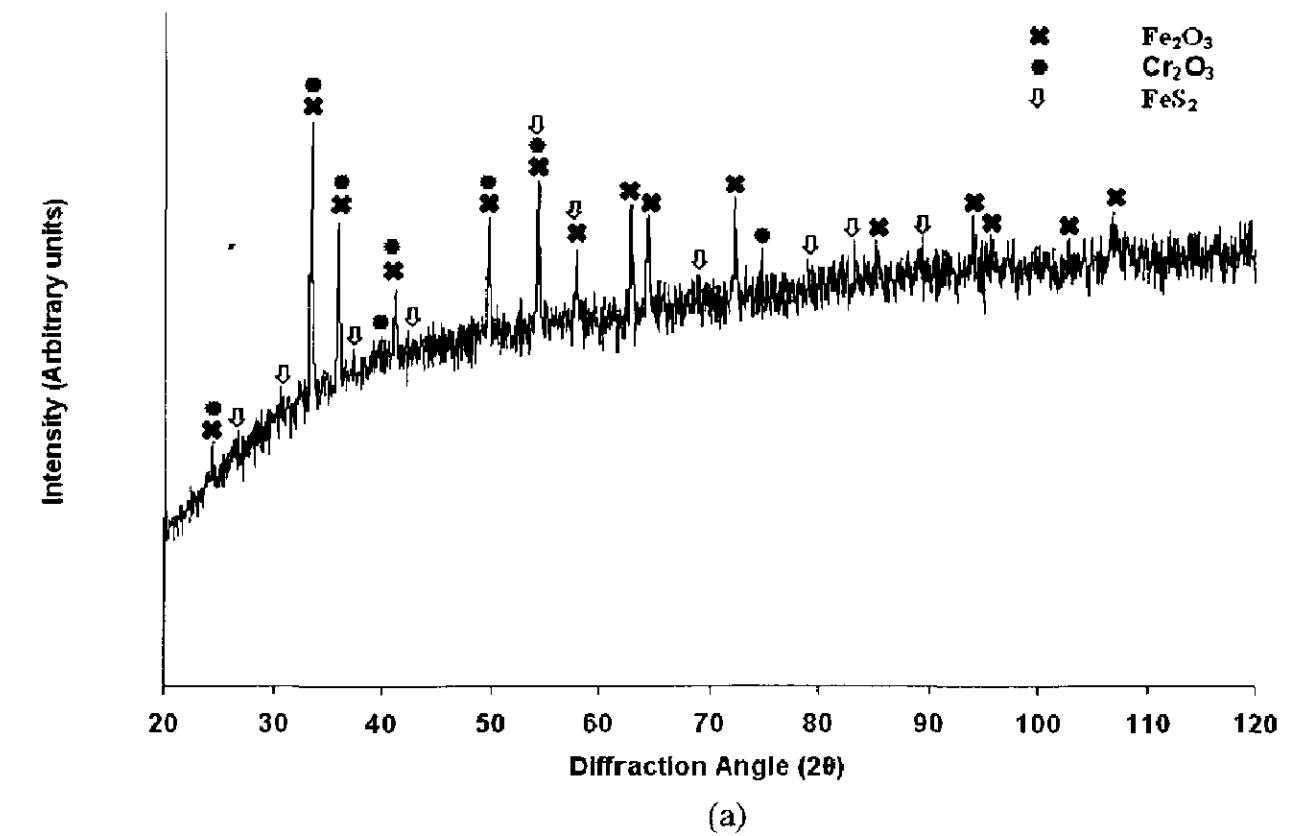
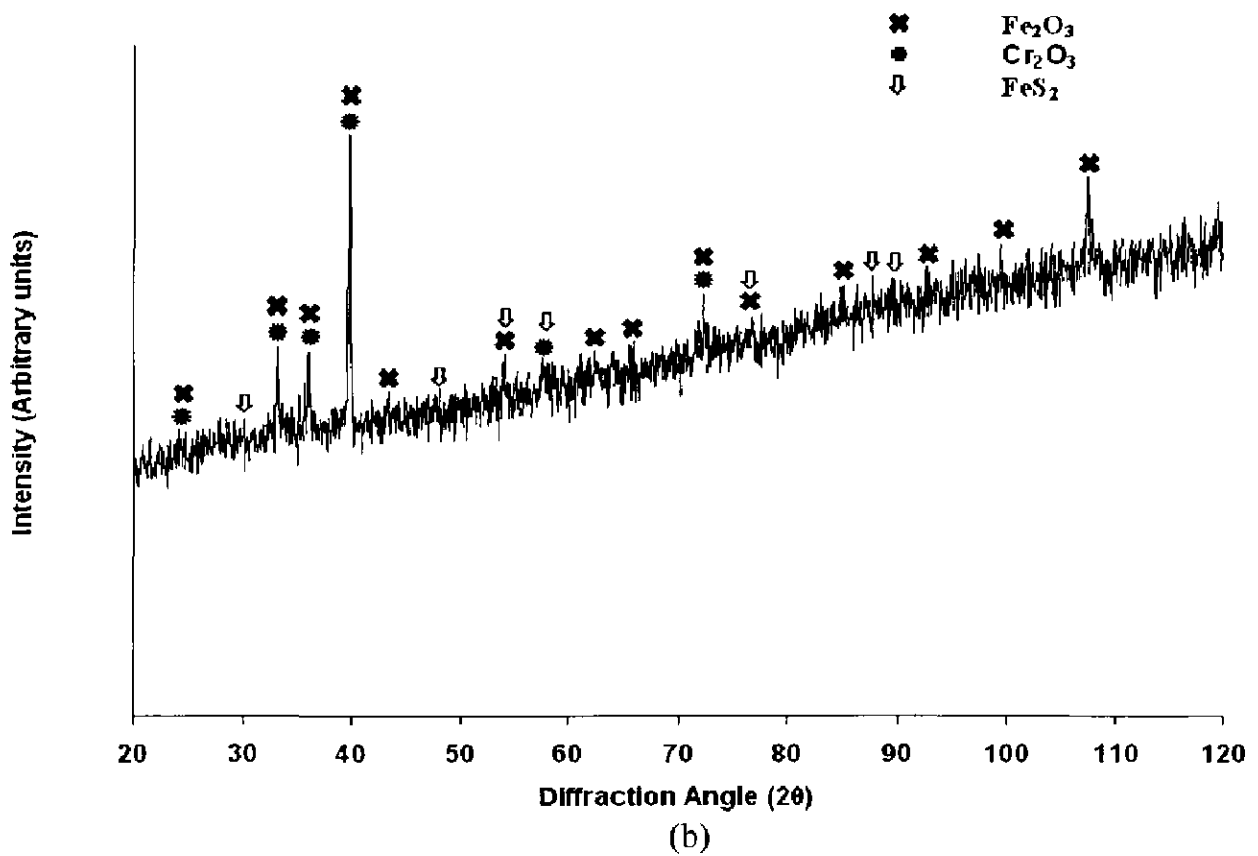
Fig.6.46: X-ray diffraction profiles for boiler steels subjected to cyclic hot corrosion in Na_2SO_4 -60% V_2O_5 at 900°C for 50 cycles.
 (a) T11 (b) T22

during the exposure to molten salt environment, vigorous and intense spalling was observed. Peaks of Cr_2O_3 along with FeS_2 have also been observed in the oxide scale of both the boiler steels T11 and T22.

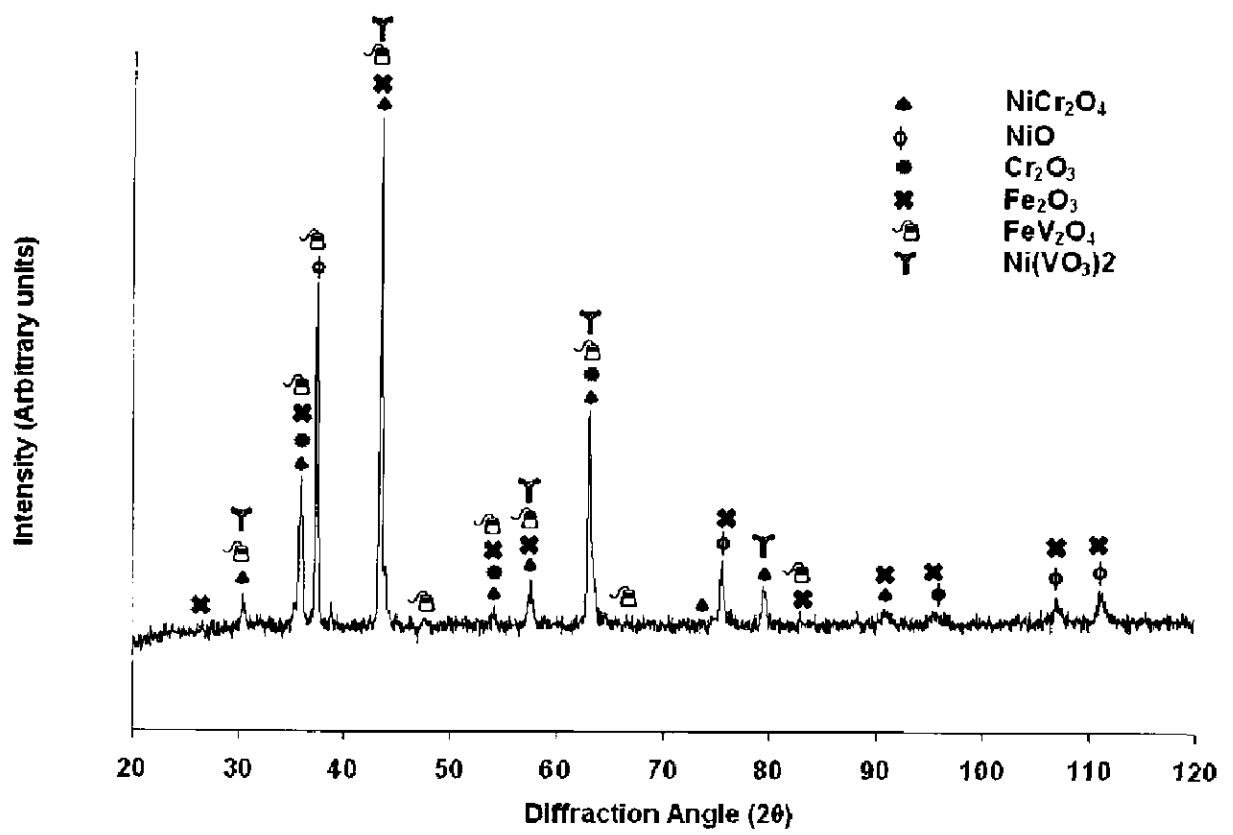
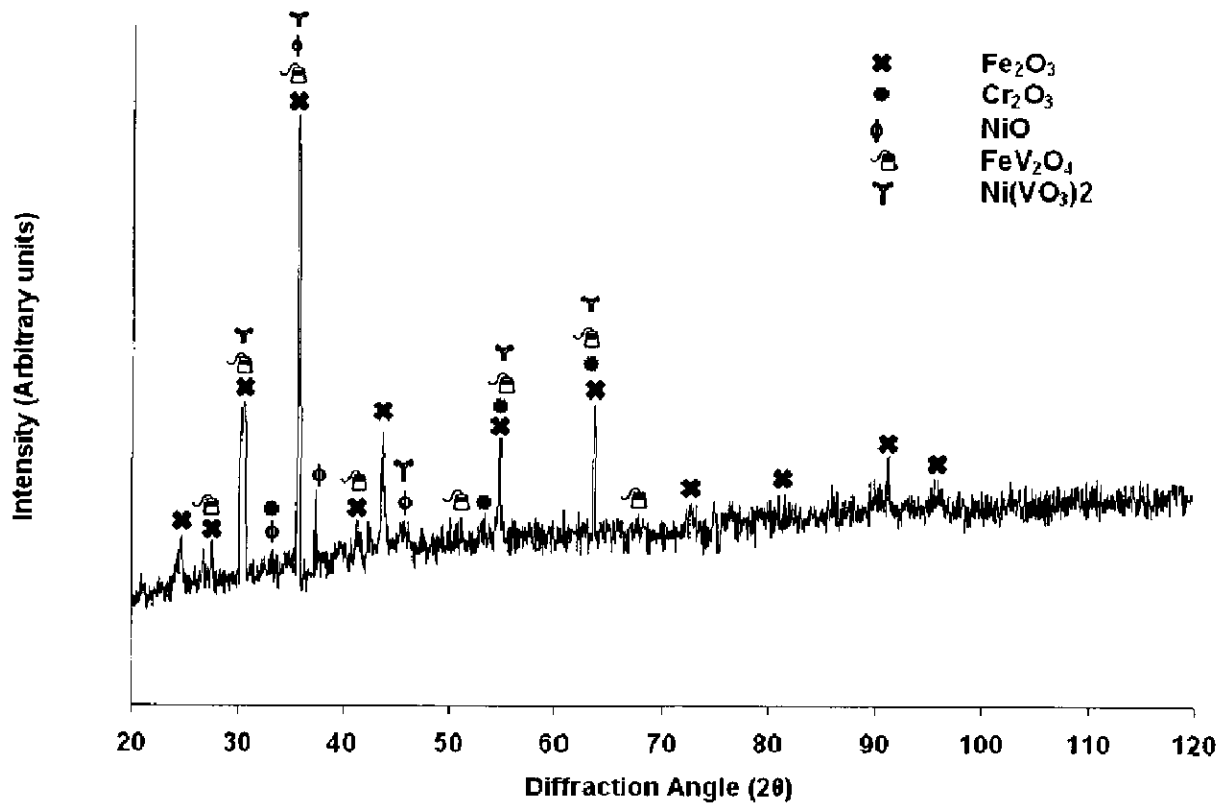
Fig. 6.47: X-ray diffraction profiles for superalloys Superni 600 and Superni 718 subjected to cyclic hot corrosion in $\text{Na}_2\text{SO}_4\text{-60\%V}_2\text{O}_5$ at 900°C for 50 cycles.
 (a) Superni 600 (b) Superni 718

The X-ray diffractograms of the scales for superalloys are reported in Fig. 6.47 and 6.48 after exposure to molten salt ($\text{Na}_2\text{SO}_4\text{-60\%V}_2\text{O}_5$) at 900°C for 50 cycles. It is evident from the diffraction patterns that Superni 600 and Superni 718 have shown formation of similar phases after hot corrosion in the given environment. For these two superalloys NiO , Fe_2O_3 , Cr_2O_3 , FeV_2O_4 and $\text{Ni}(\text{VO}_3)_2$ are common phases while NiCr_2O_4 is extra phase revealed in superni 600. Further in case of hot corroded Superfer 800 phases identified are Fe_2O_3 , NiO , NiCr_2O_4 , and FeV_2O_4 .

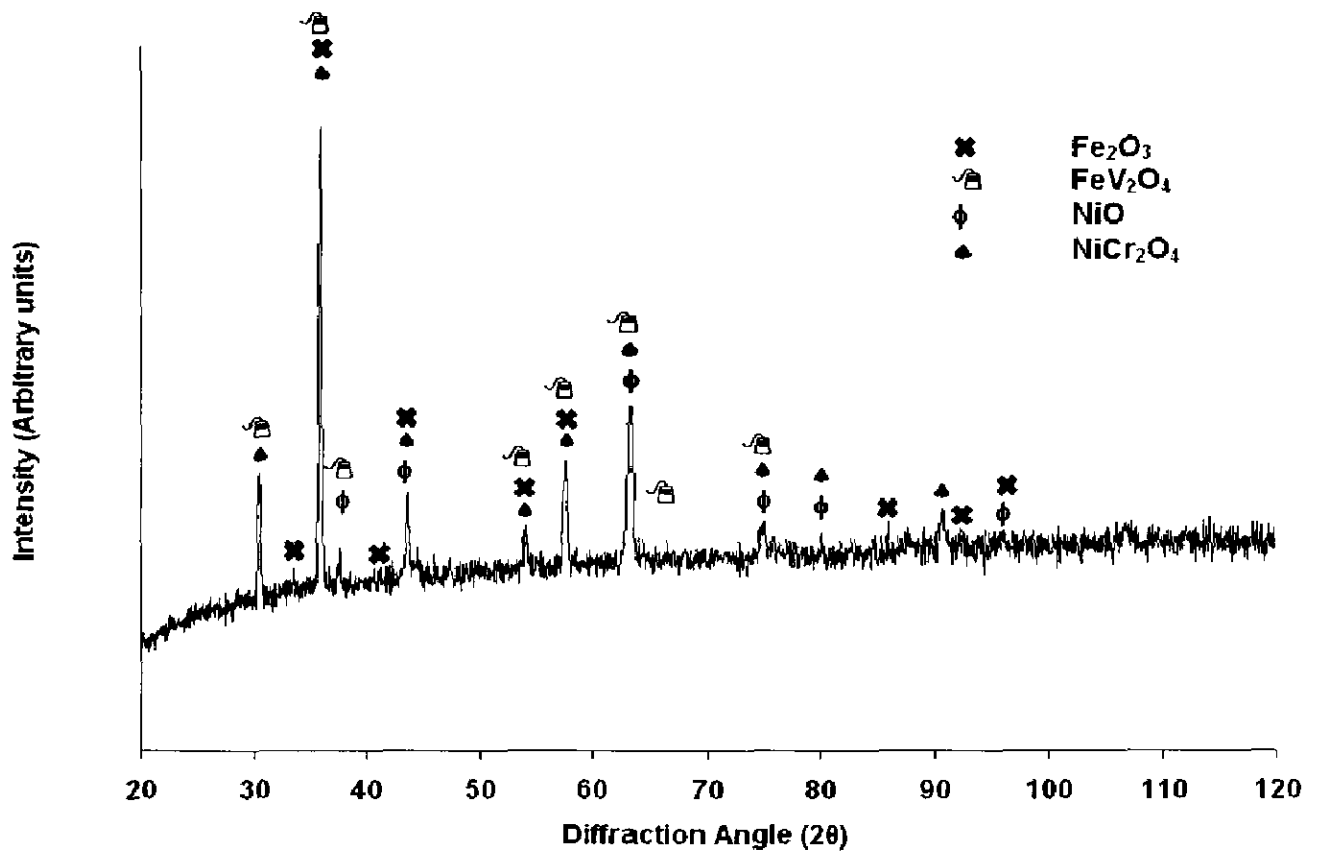
Fig. 6.48: X-ray diffraction profile for superalloy Superfer 800 subjected to cyclic hot corrosion in Na₂SO₄-60%V₂O₅ at 900°C for 50 cycles.
