STUDY OF DETONATION GUN COATED ALLOYS FOR RESISTANCE TO EROSION AND CORROSION

A THESIS

METALLURGICAL AND MATERIALS ENGINEERING

This thesis investigates the erosion and corrosion performance of Al_2O_3 -3 wt % TiO_2 thermal spray coatings deposited by detonation gun technique. As-sprayed coatings were characterized by using the combined techniques of optical microscopy, microhardness testing, X-ray diffractometry (XRD) and scanning electron microscopy/energy-dispersive analysis (SEM/EDX). The corrosion performance was evaluated in oxidising and molten salt environment and also in actual working conditions of boiler. The erosion performance was evaluated at room temperature conditions as well as under high temperature conditions, high erodent velocity, and actual boiler conditions. The corrosion behavior and morphological development were investigated by weight change kinetics, metallographs, depths of attack, metal thickness losses, and XRD analyses.

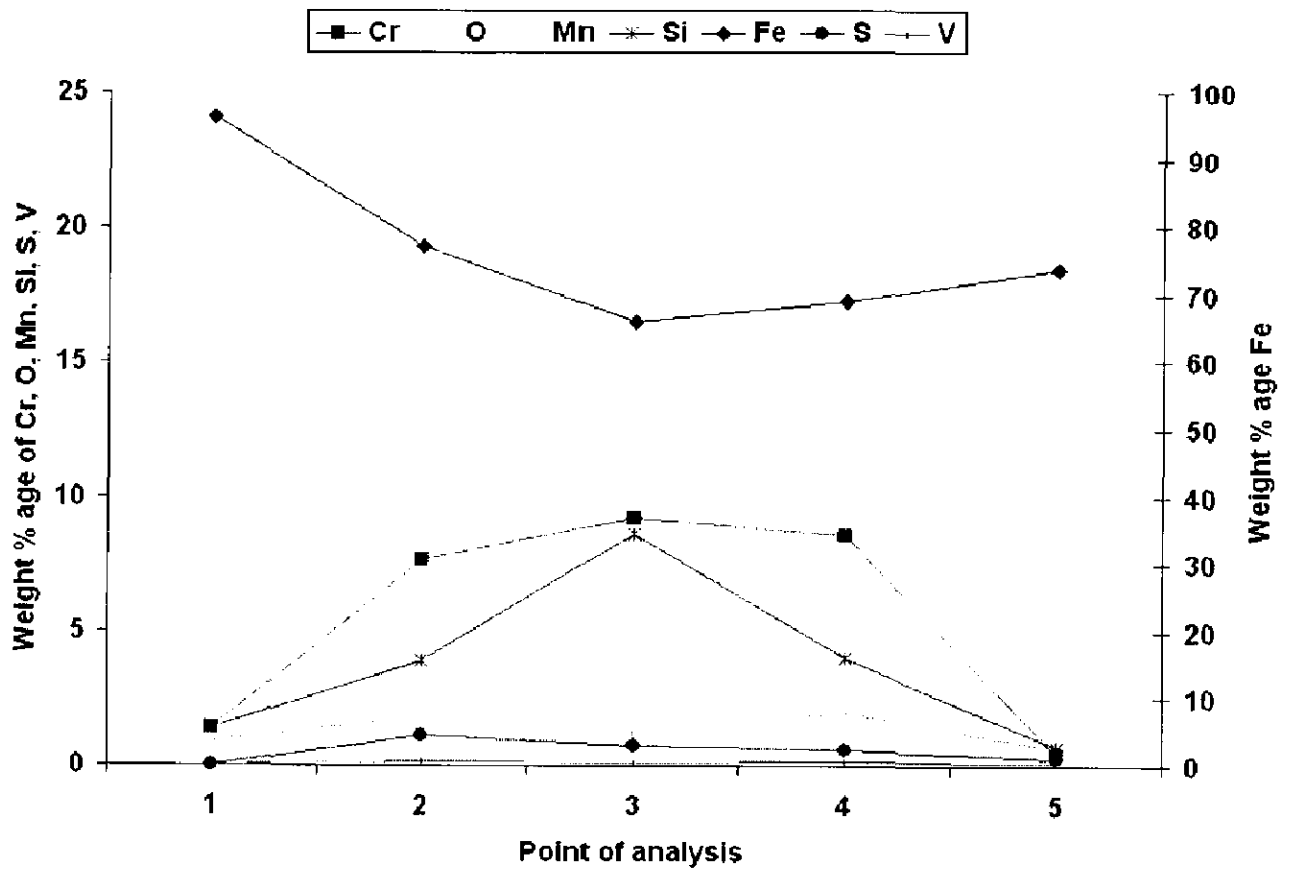
Fig. 6.51: Cross sectional morphology and elemental composition variation across the cross-section of boiler steel T11 exposed to Na_2SO_4 -60% V_2O_5 at 900°C for 50 cycles, 200 X.

Cross sectional morphology and elemental composition variation across the cross-section of substrate alloys exposed to $\text{Na}_2\text{SO}_4\text{-60\%V}_2\text{O}_5$ at 900°C for 50 cycles is shown in Fig. 6.51-6.55. The results of oxide scale analysis across the cross-section for corroded T11 and T22 boiler steels are plotted and shown in Fig. 6.51 and 6.52 along with micrographs. In boiler steel T11 after exposure to molten salt, throughout the scale Fe oxide percentage is high and also considerable amount of chromium oxide is present throughout the scale thickness. Whereas in case of T22 steel, scale was thick. Considerable amount of chromium along with oxygen was present in the scale. Traces of S and V have been revealed in the scale.

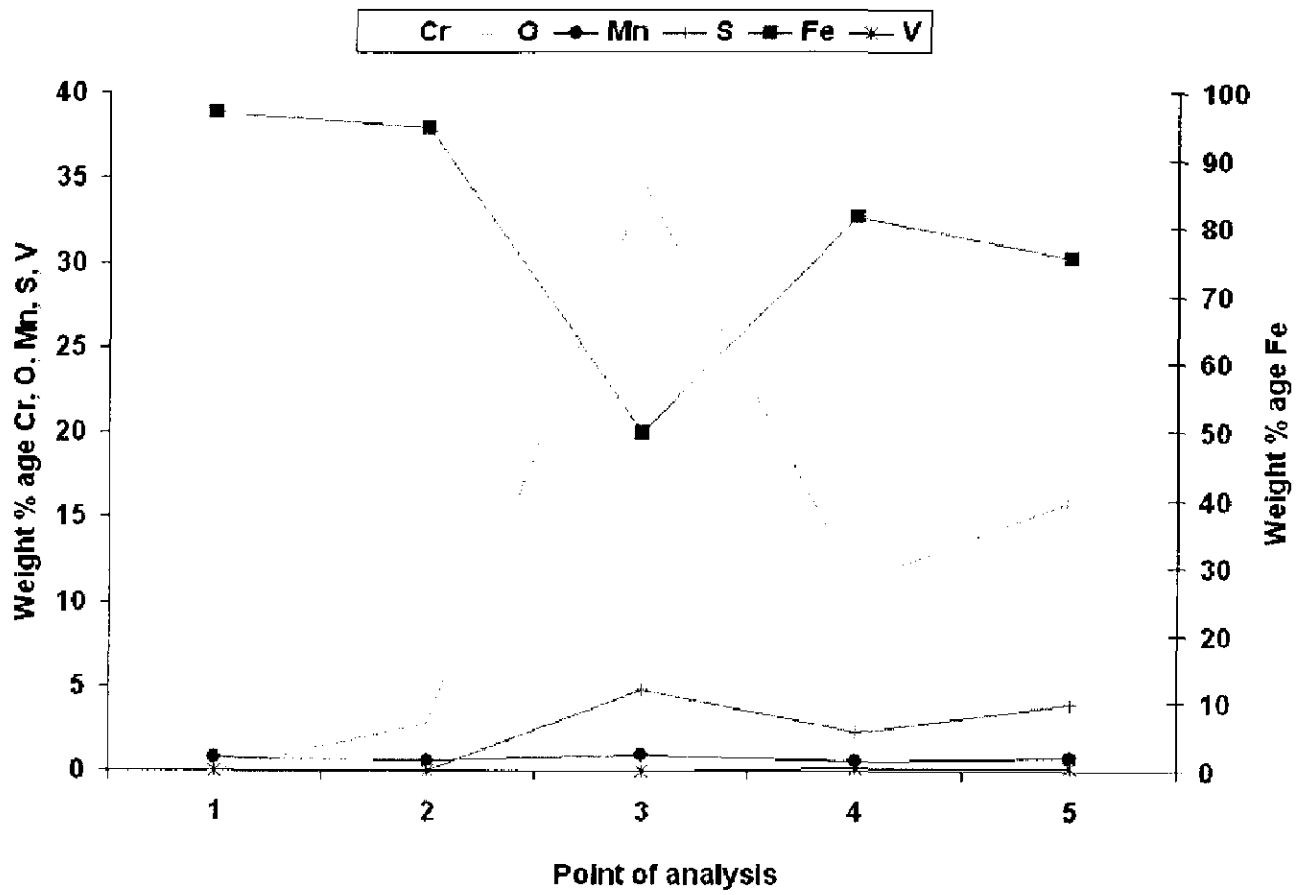
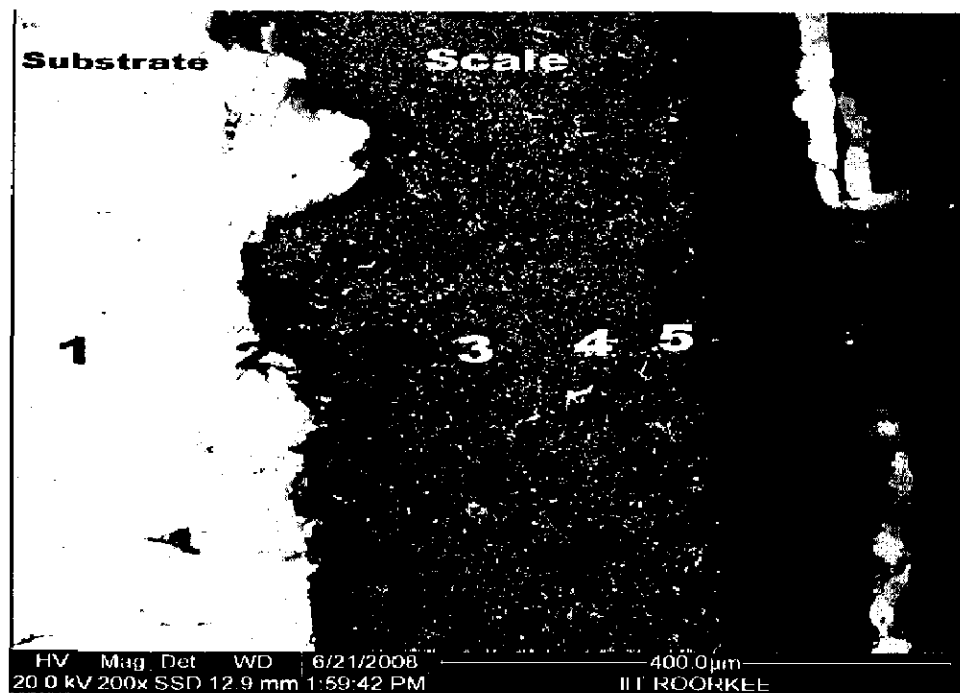
Fig. 6.52: Cross sectional morphology and elemental composition variation across the cross-section of boiler steel T22 exposed to Na_2SO_4 -60% V_2O_5 at 900°C for 50 cycles, 200X.

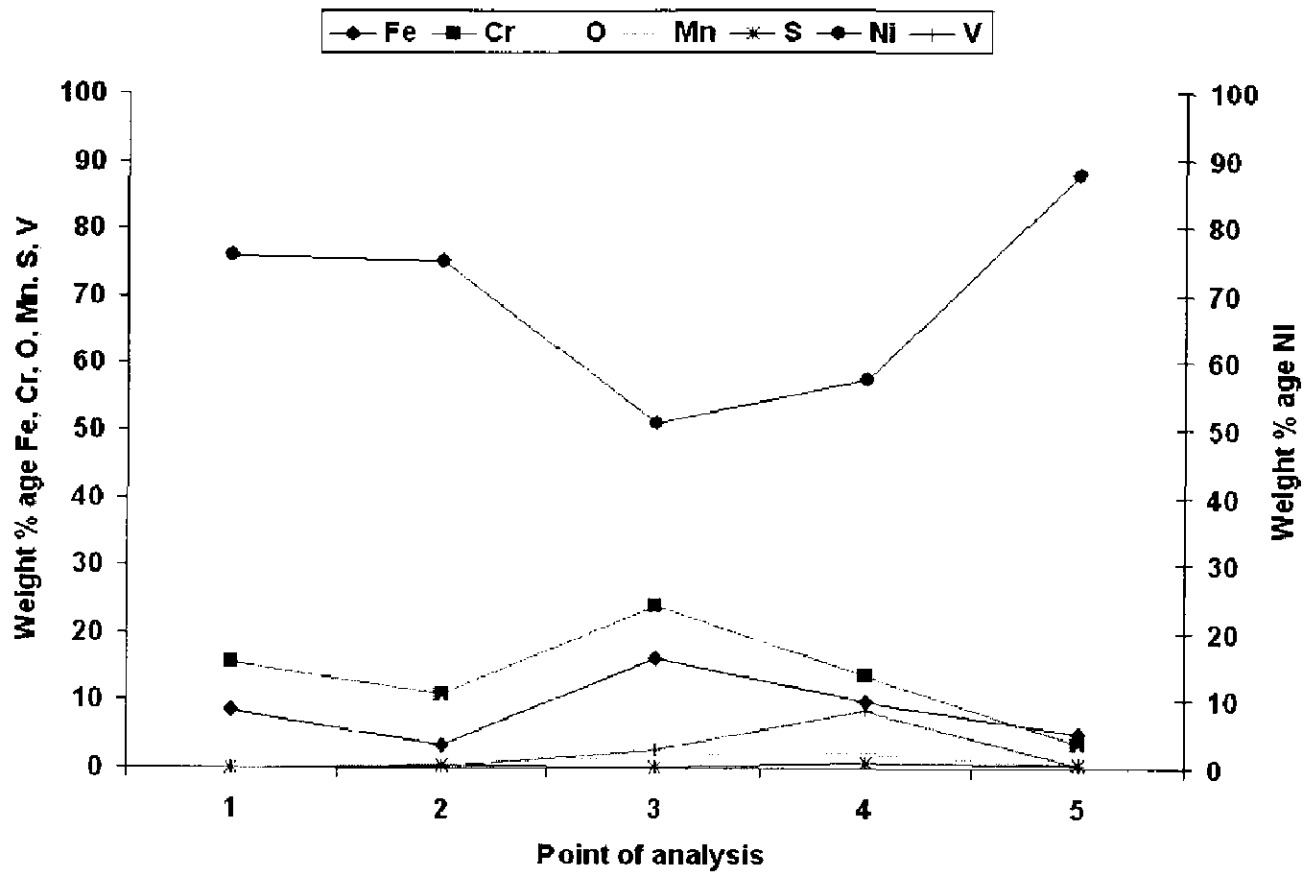
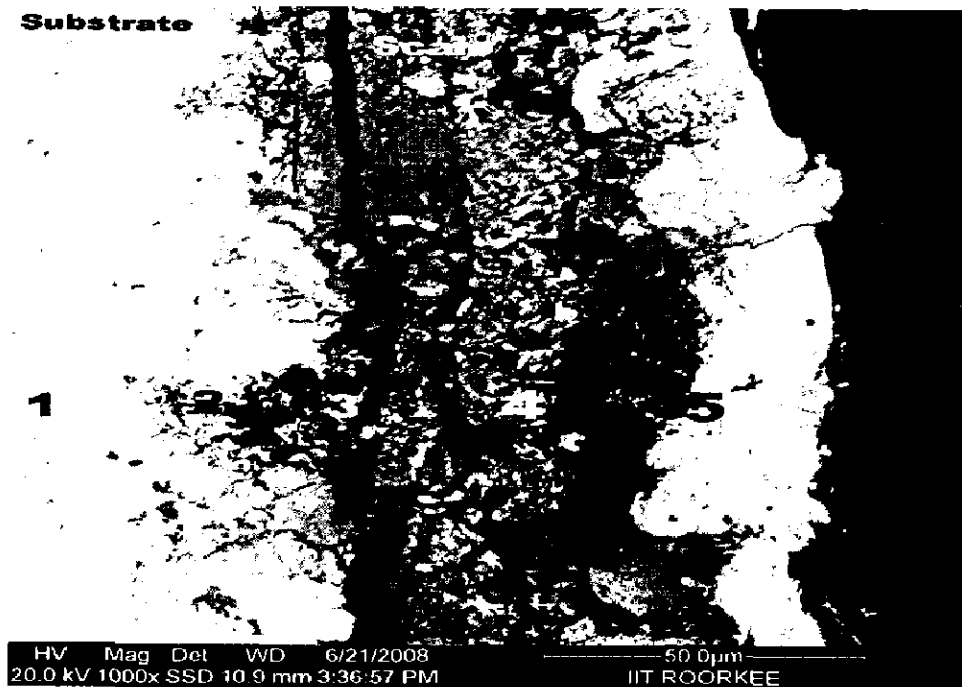
Fig.6.53: Cross sectional morphology and elemental composition variation across the cross-section of superalloy Superni 600 exposed to $\text{Na}_2\text{SO}_4\text{-60\%V}_2\text{O}_5$ at 900°C for 50 cycles, 1000 X.

In case of corroded superalloys, EDX analysis has revealed that the scale mainly consisted of Ni, Cr and Fe along with oxygen. Oxide scale morphology along with variation of elemental composition across the cross-section of superalloy Superni 600 subjected to cyclic hot corrosion in $\text{Na}_2\text{SO}_4\text{-60\%V}_2\text{O}_5$ at 900°C for 50 cycles has been depicted in Fig. 6.53. EDX analysis presents a comparative estimate of elemental compositions at some points in the substrate as well as in the scale. The plots of elemental composition variation show that the scale mainly consisted of iron, nickel and chromium along with oxygen. Oxygen is found to be absent at point 1, i.e. in substrate but is present in small percentage at point 2 and has shown scatterness as one moves into the scale. From this it can be concluded that the oxygen has penetrated into the substrate. Oxygen is present in little higher amount at point 4 and further it has increased at point 5. As one moves from substrate towards scale, the concentration of oxygen is found to increase, also iron has shown small variation in its concentration. In superni 718, a thin scale consisting of iron, nickel and chromium is observed as shown in Fig. 6.54. Considerable amount of chromium oxide is present in the scale. At point 1 there is no oxygen and at interface of substrate and scale i.e. at point 2, there is presence of oxygen indicating the oxidation, Ni percentage has decreased and Cr percentage has increased. At point 4, Cr_2O_3 is more and NiO is less while at point 5, NiO is more and Cr_2O_3 is less. Small traces of V and S were also observed. There is no deep penetration of oxygen into the

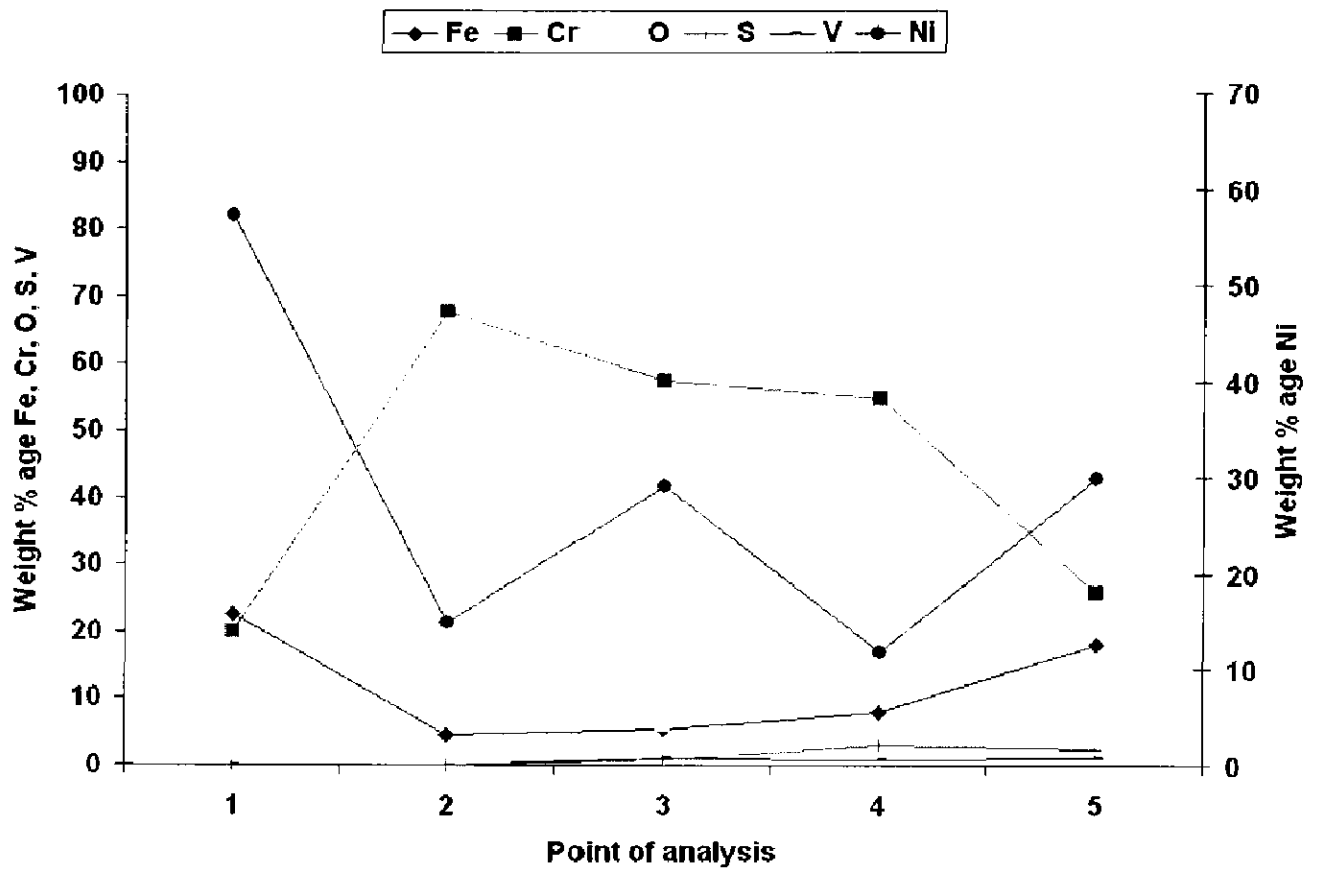
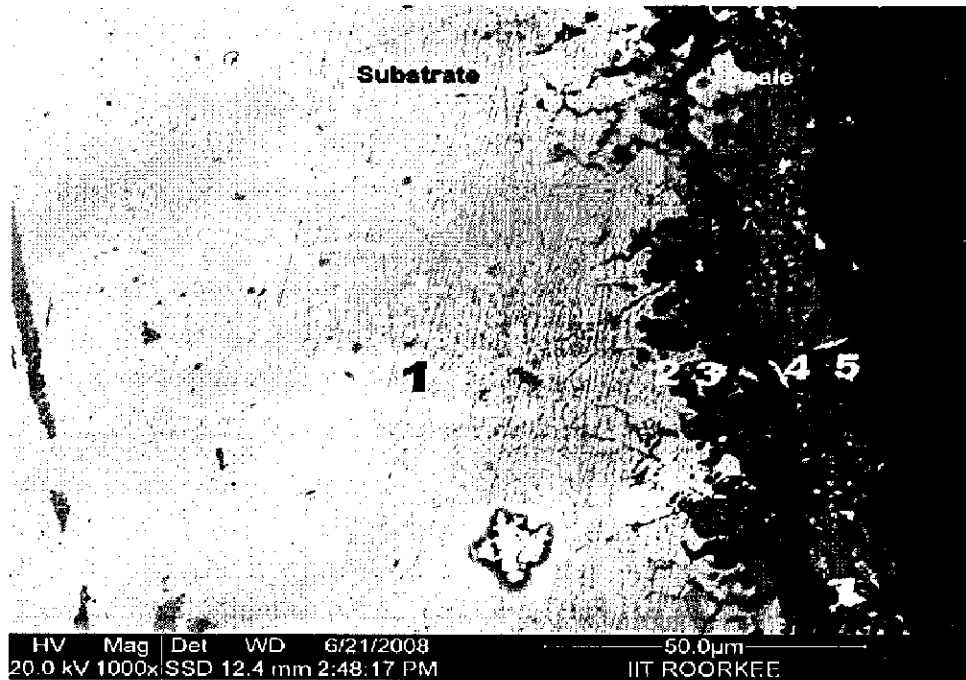
Fig.6.54: Cross sectional morphology and elemental composition variation across the cross-section of superalloy Superni 718 exposed to Na_2SO_4 -60% V_2O_5 at 900°C for 50 cycles, 1000 X.

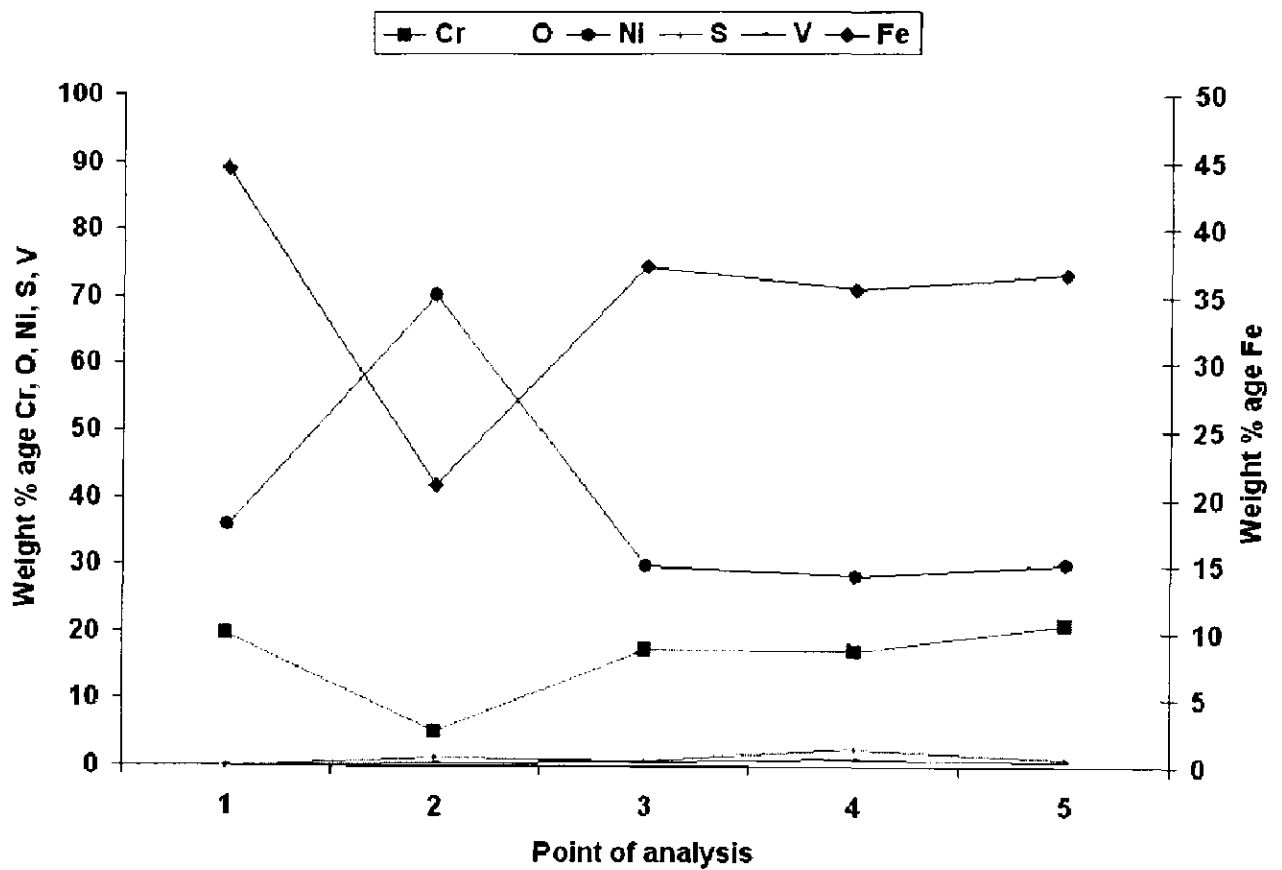
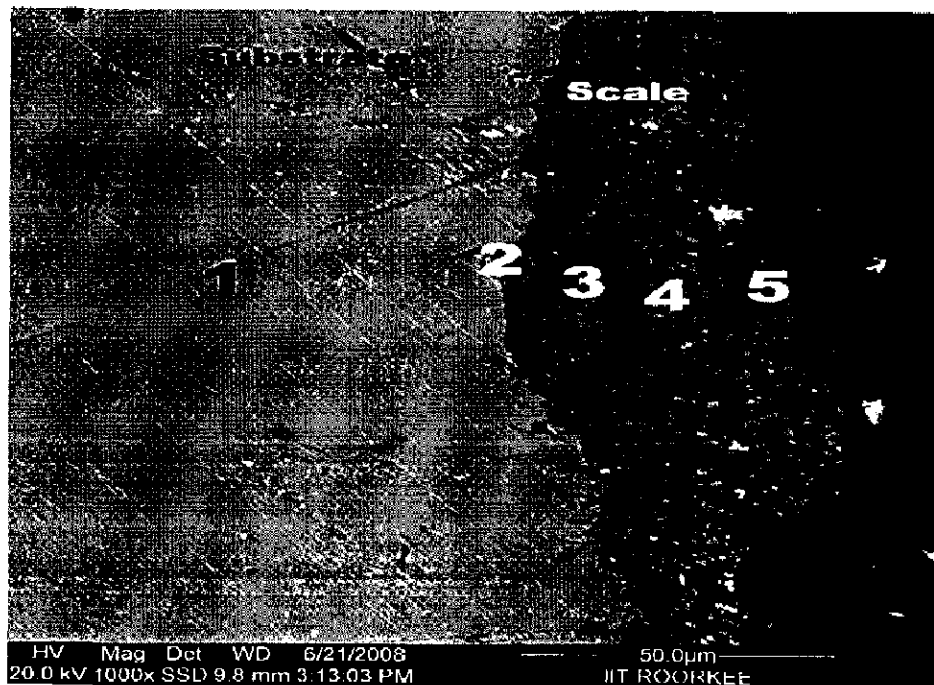
Fig.6.55: Cross sectional morphology and elemental composition variation across the cross-section of superalloy Superfer 800 exposed to $\text{Na}_2\text{SO}_4\text{-60\%V}_2\text{O}_5$ at 900°C for 50 cycles, 1000X.

substrate but it has penetrated locally i.e. near the surface only. In superfer 800, Fig. 6.55. , scale is relatively thicker and has iron oxide as major constituent. Just at interface i.e. at point 2, it is rich in Ni with little bit of iron and little bit of Cr. Iron and Chromium have oxidised to form the scale. At point 3 the amount of Ni has decreased and iron has increased and oxygen is present thereby indicating the formation of Fe_2O_3 and Cr_2O_3 and at point 4 similar composition is there and top of the scale again contains Fe, Ni and Cr oxides. As one moves into the scale, there is decrease of Nickel percentage.

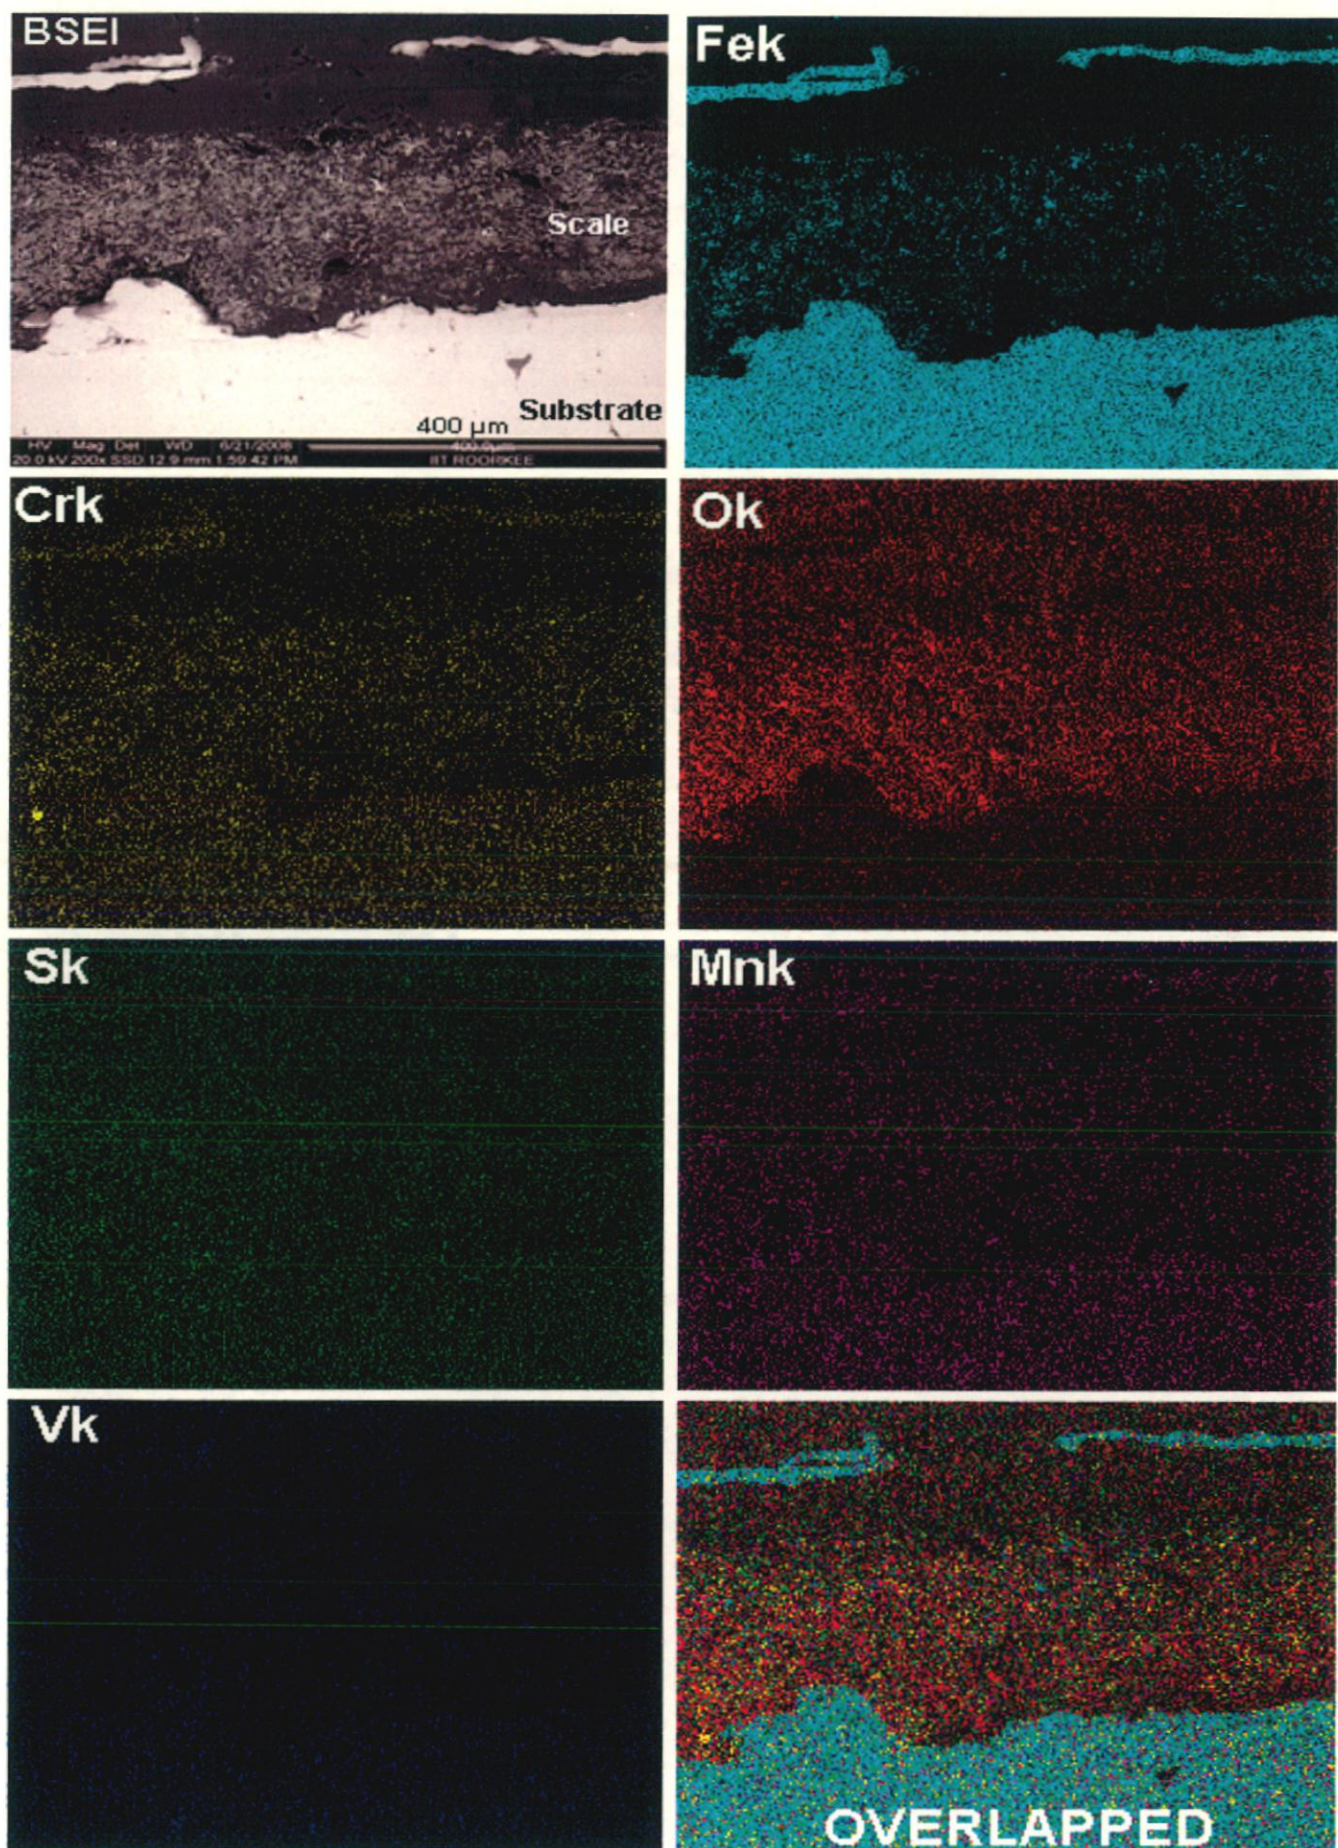
Fig. 6.57: BSEI and X-ray mapping of the cross-section of boiler steel T22 subjected to cyclic hot corrosion in $\text{Na}_2\text{SO}_4\text{-60\%V}_2\text{O}_5$ at 900°C for 50 cycles, 200X.

Back Scattered Electron Image of cross-section of uncoated substrate alloys (T11, T22, superni 600, superni 718 and Superfer 800) and corresponding X-ray mapping after exposure to Na_2SO_4 -60% V_2O_5 environment at 900°C are shown in Fig.6.56 to 6.60 respectively. In boiler steels, there is a severe internal attack as the scale is penetrating deep into the substrate. The scale is porous and quite fragile. Iron from the substrate is forming iron oxide. Continuous spalling of scale layer by layer was observed. In boiler steel T11 (Fig.6.56), main constituent is iron oxide with presence of minor concentration of Mn, Cr, S and V. Sulphur has penetrated into the substrate. Also a very thin Cr_2O_3 band is visible at the scale substrate interface. Alternate bands of Cr_2O_3 and Fe_2O_3 are visible in the scale. In T22 boiler steel, the scale is thick and porous and it mainly consisted of iron oxide as is clear from Fig. 6.57. Cr_2O_3 is also present throughout the scale. Sulphur and vanadium has penetrated into the substrate. A thick flake of iron is visible at the outer edge of the scale but is not continuous this may be a substrate chip which has been impinged into the epoxy interface.

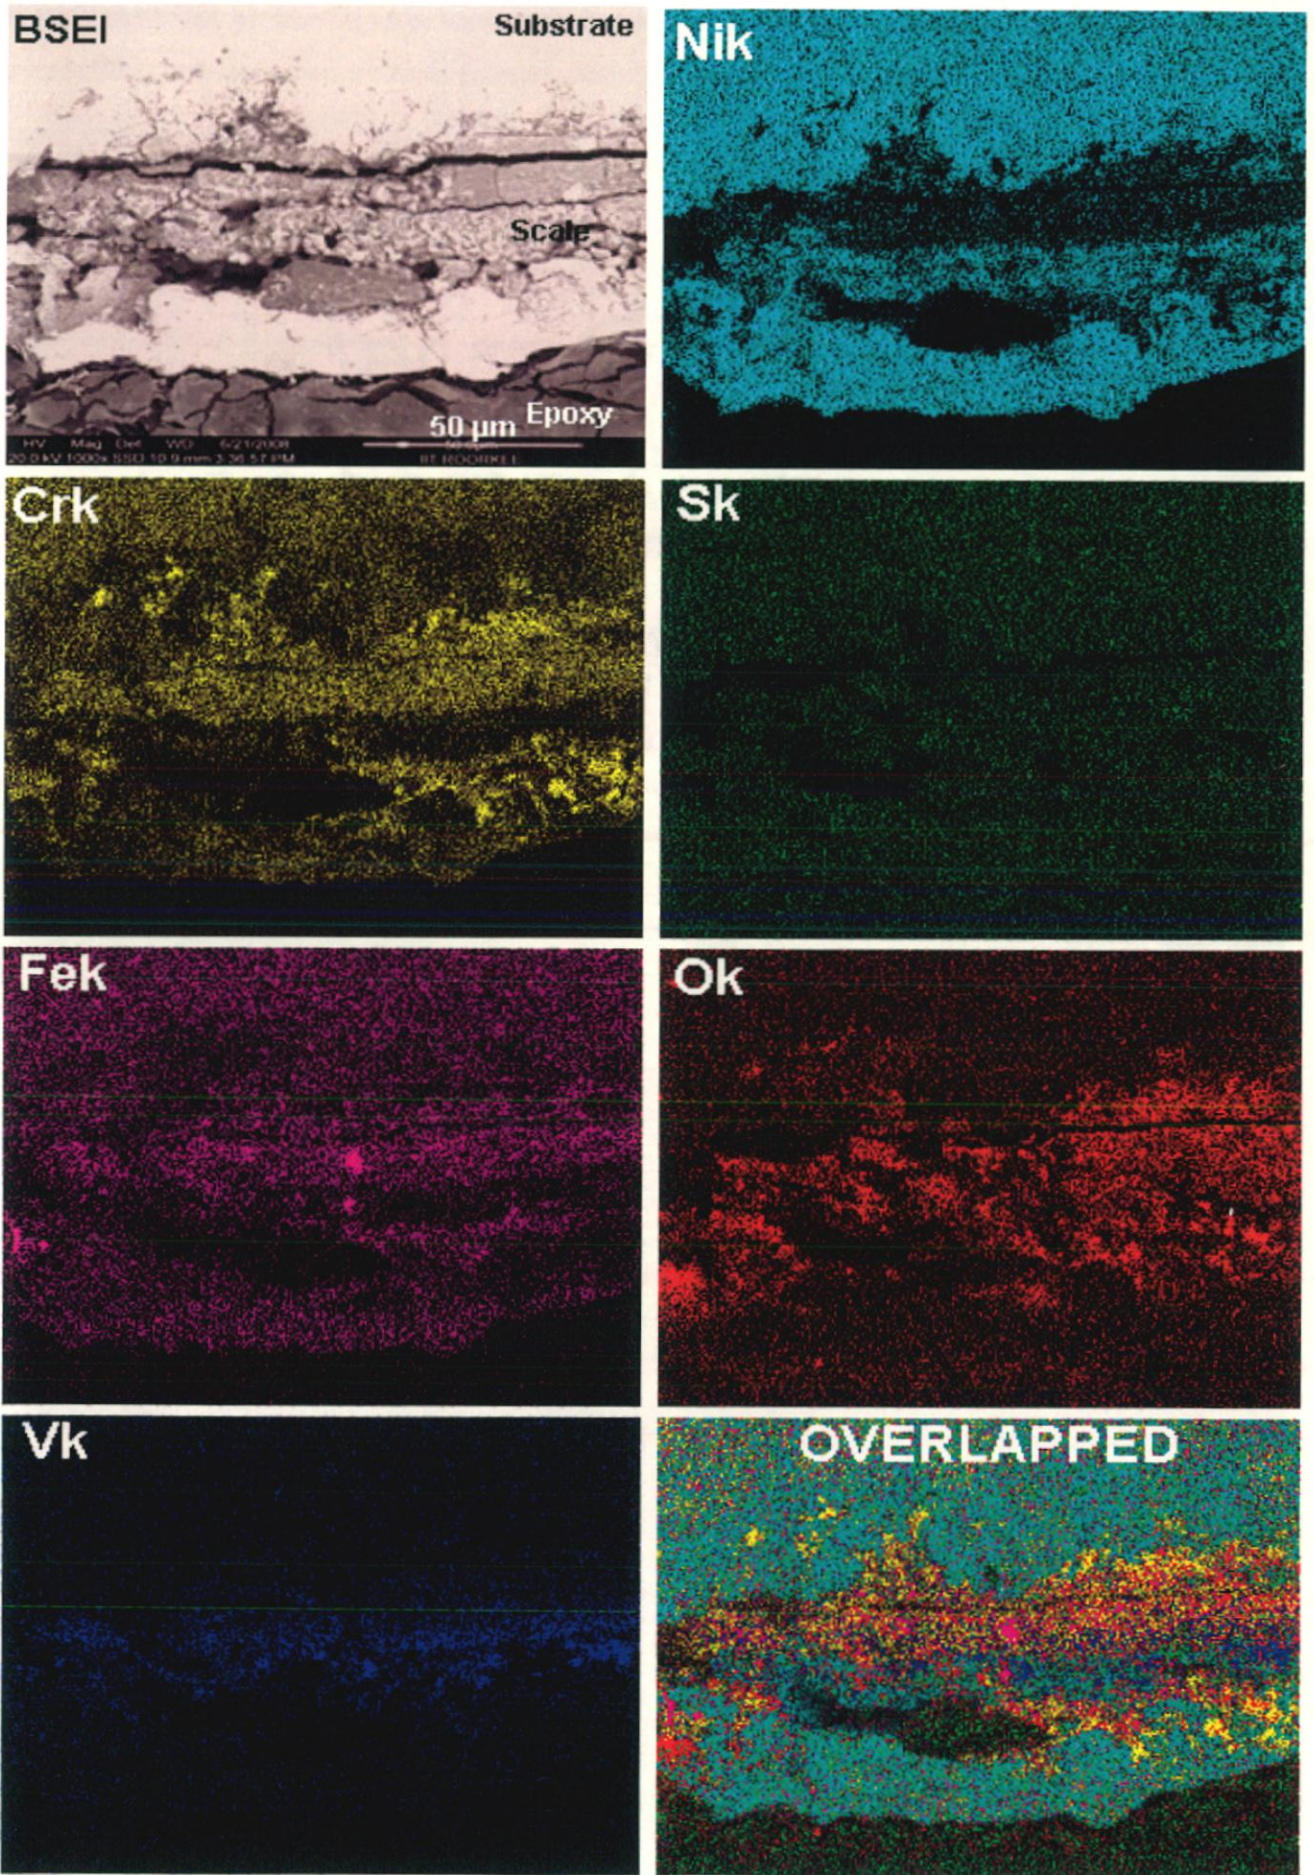
Fig. 6.58: BSEI and X-ray mapping of the cross-section of superalloy Superni 600 subjected to cyclic hot corrosion in $\text{Na}_2\text{SO}_4\text{-60}\%\text{V}_2\text{O}_5$ at 900°C for 50 cycles, 200X.

In superalloy, superni 600, (Fig. 6.58) there is severe internal attack, and scale is quite porous. In scale there is formation of Cr rich band in combination with oxygen. In scale, where Ni is absent, Cr and Fe are present along with oxygen. Through cracks internal penetration has occurred with thick scale formation. Severe internal attack is also visible. As oxygen is present throughout the scale, it can be inferred that there is formation of iron oxide, nickel oxide and chromium oxide throughout the scale.

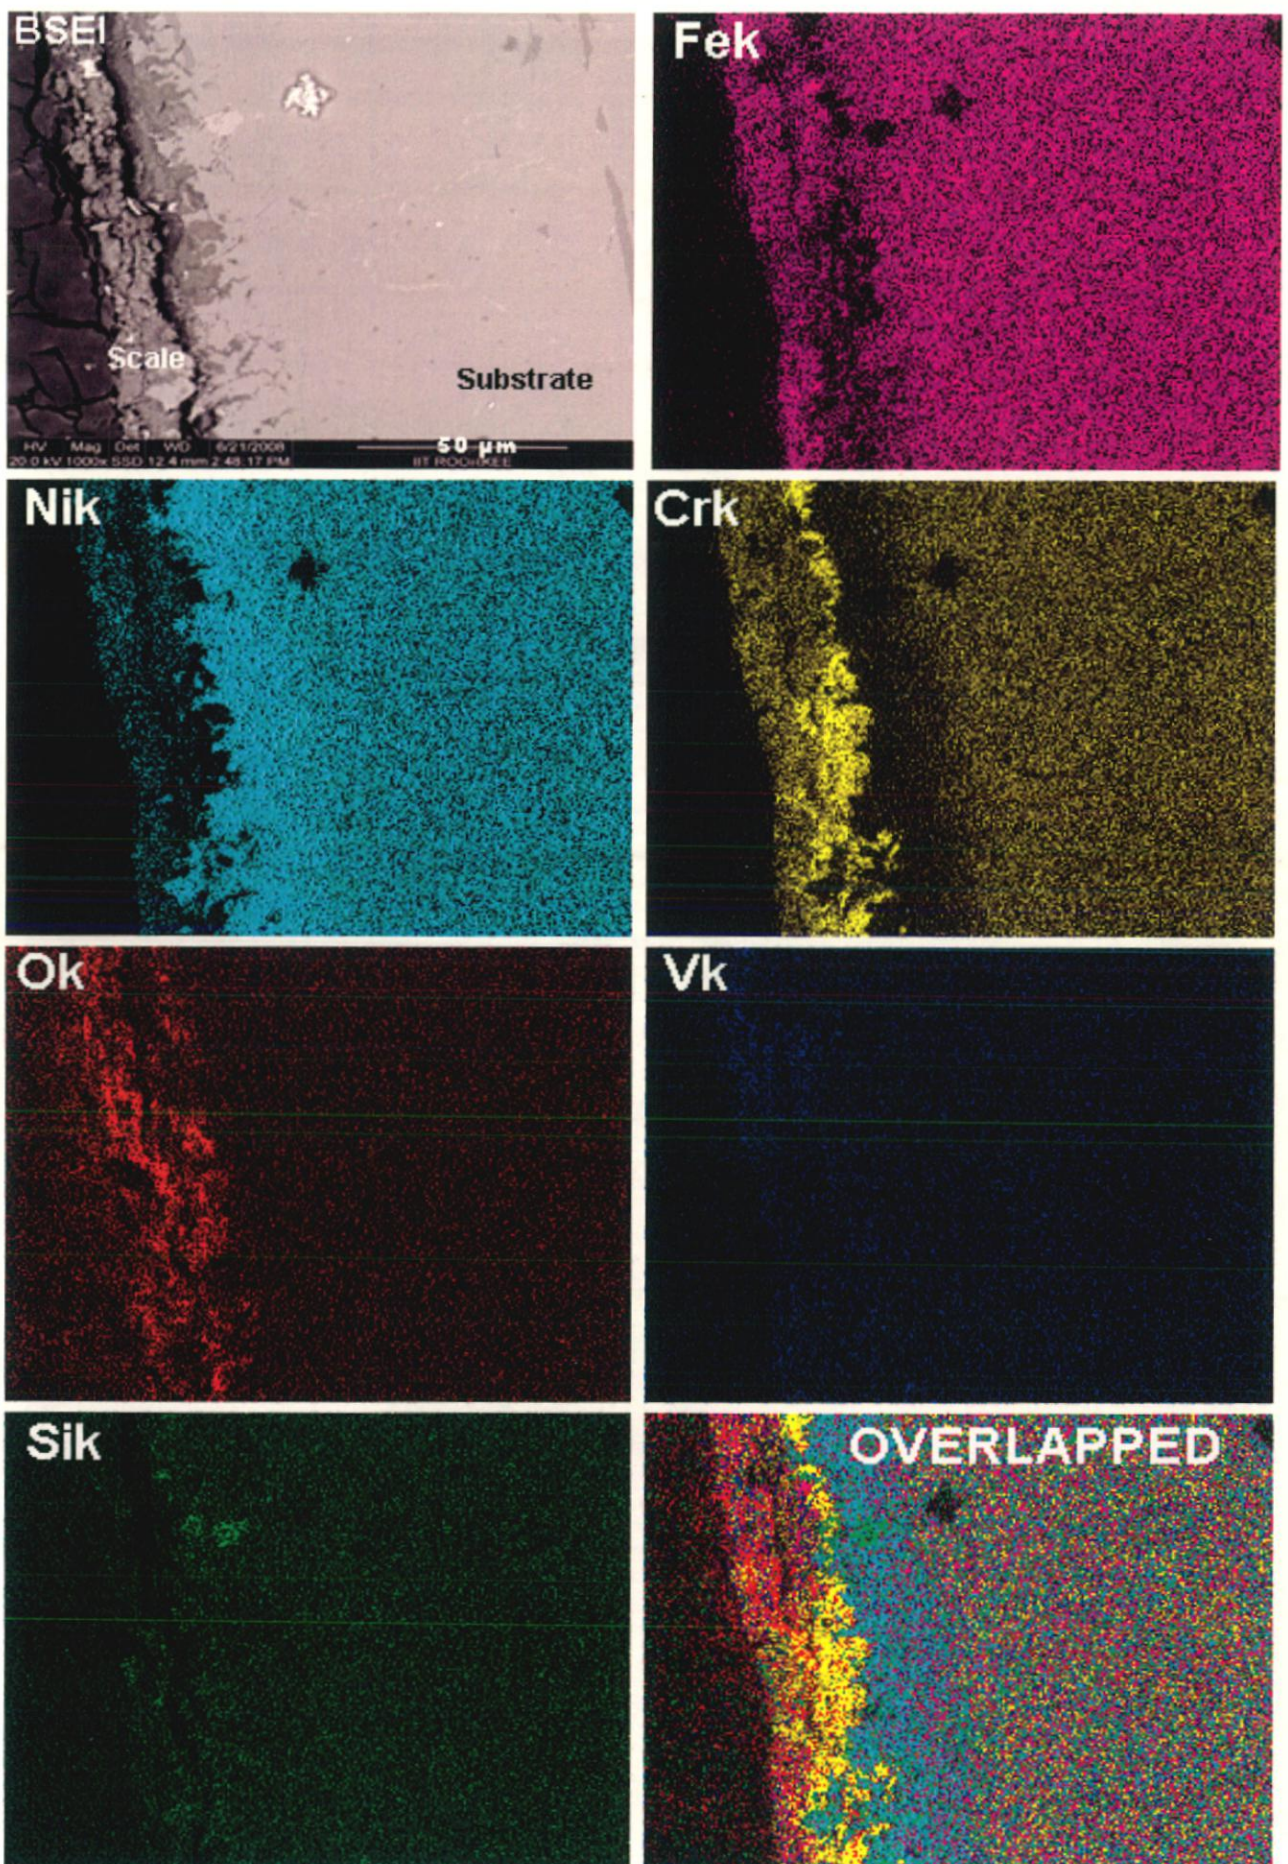
Fig.6.59: BSEI and X-ray mapping of the cross-section of superalloy Superni 718 subjected to cyclic hot corrosion in Na_2SO_4 -60% V_2O_5 at 900°C for 50 cycles, 1000 X.

Cr_2O_3 formed is providing protection for further oxidation. Vanadium band is also visible in the scale in between the substrate and top metallic layer. The oxygen is co-existing with Fe and Cr. Internal oxidation has taken place and outer substrate layer has prevented further oxidation. In Superni 718, Fig.6.59 attack is confined and thin scale is formed. Ni has diffused from the substrate and is concentrated along the substrate scale boundary. At the top of the scale Ni and Cr are present and chromium rich band is clearly visible in the scale. It can be inferred that chromium is coming out from the substrate and forming chromium oxide in the scale. Also Ni rich portion is seen at the scale substrate interface. In Superfer 800, Fig.6.60 scale formed is porous and fragile. In scale higher percentage of Fe_2O_3 is present with some amount of Chromium oxide and Nickel oxide. Nickel concentration has increased in the substrate along substrate scale interface in the shape of thin band which has prevented the further oxidation as Cr has migrated to form the Cr_2O_3 scale. At the interface of substrate and scale, there is thin nickel rich band. Cr_2O_3 is present above this Ni band in the scale. Cr has come from substrate to form irregular Cr_2O_3 band leaving a Ni rich band in the substrate which is clearly visible in the overlapped map. The scale mainly contains iron, nickel, chromium along with oxygen which indicates the formation of Fe_2O_3 , Cr_2O_3 , NiO. Percentage of Fe_2O_3 is higher as compared to other oxides.

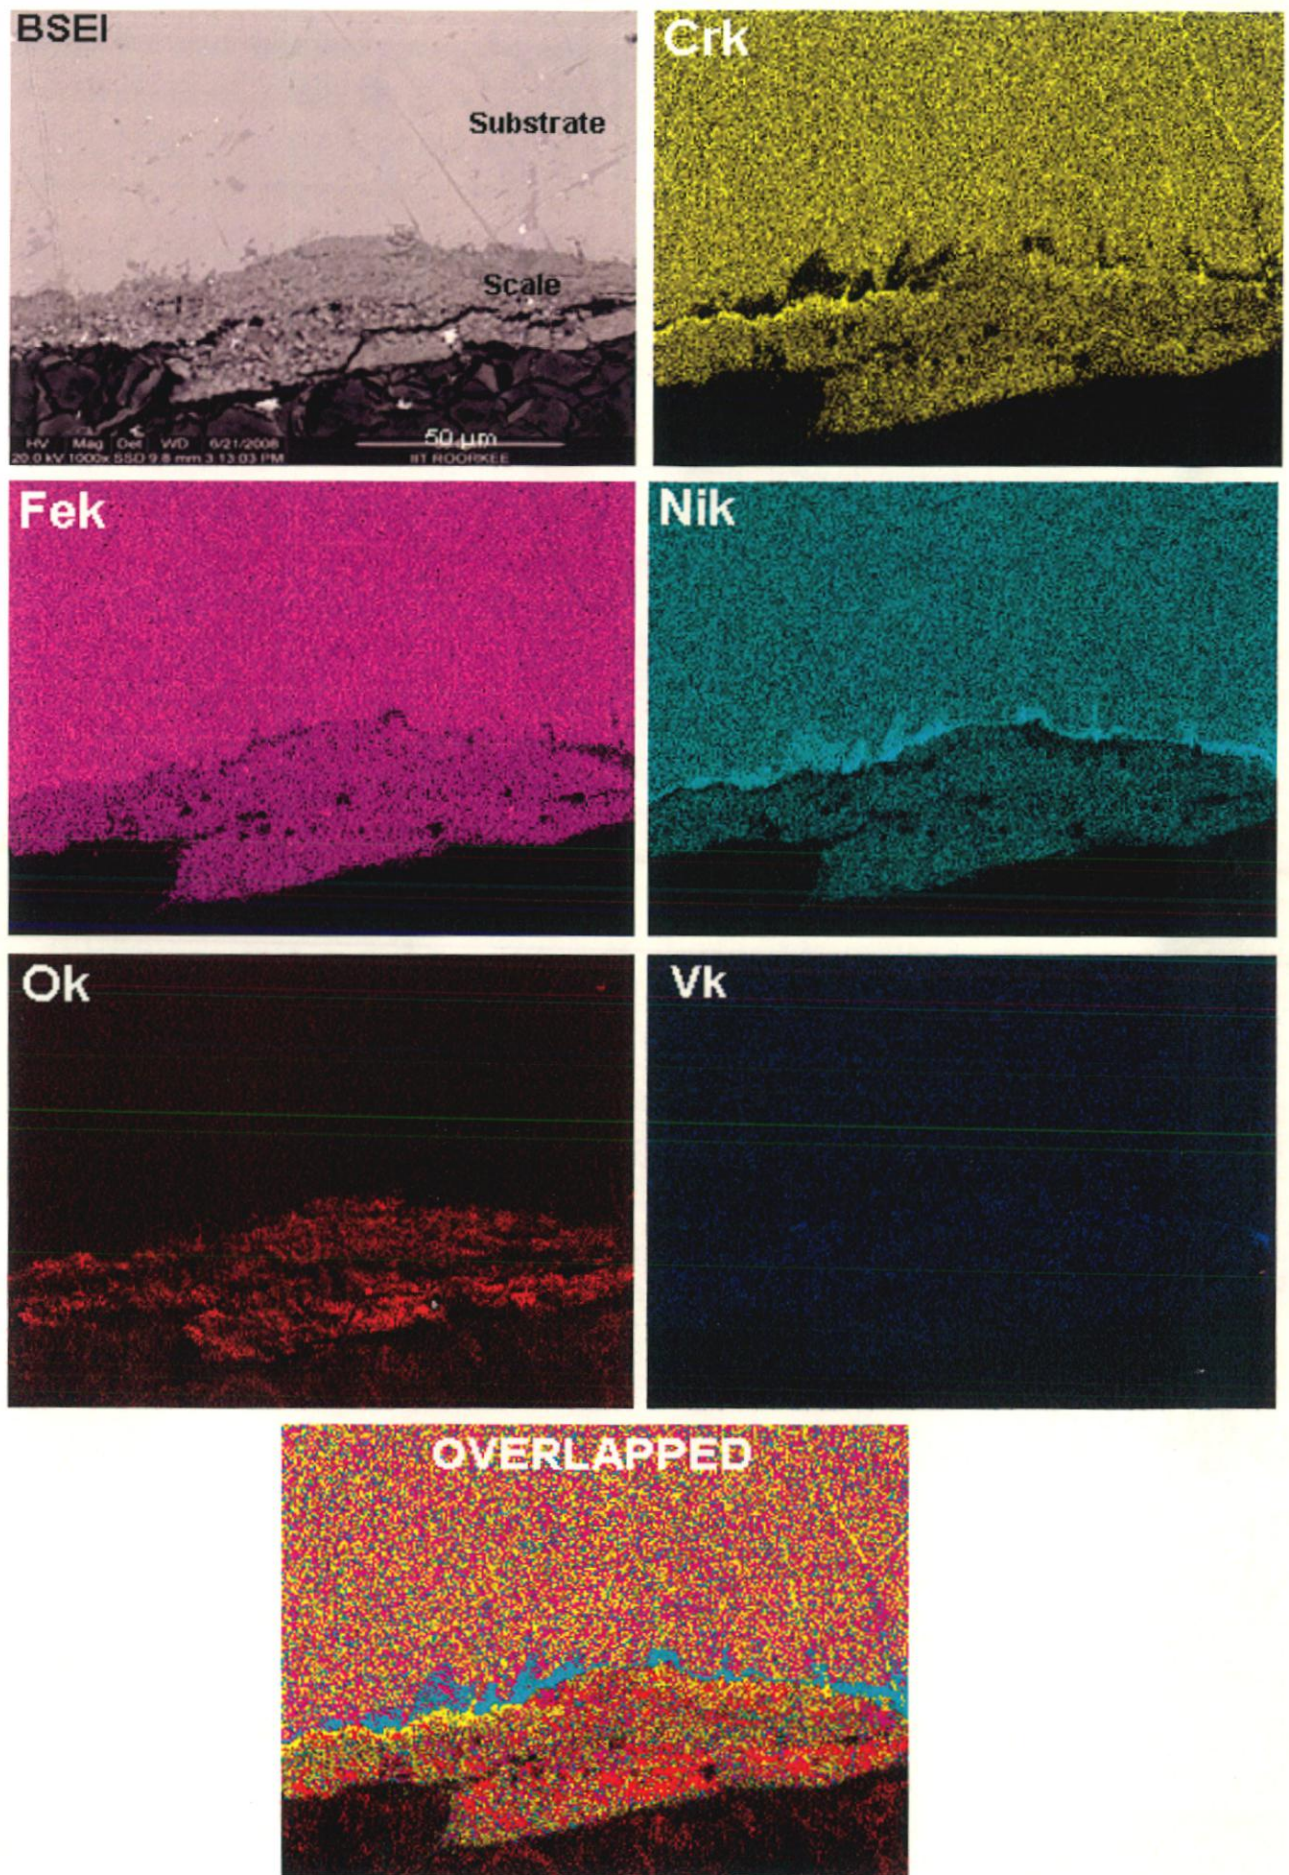
Fig. 6.60: BSEI and X-ray mapping of the cross-section of superalloy superfer 800 subjected to cyclic hot corrosion in $\text{Na}_2\text{SO}_4\text{-60\%V}_2\text{O}_5$ at 900°C for 50 cycles, 1000 X.

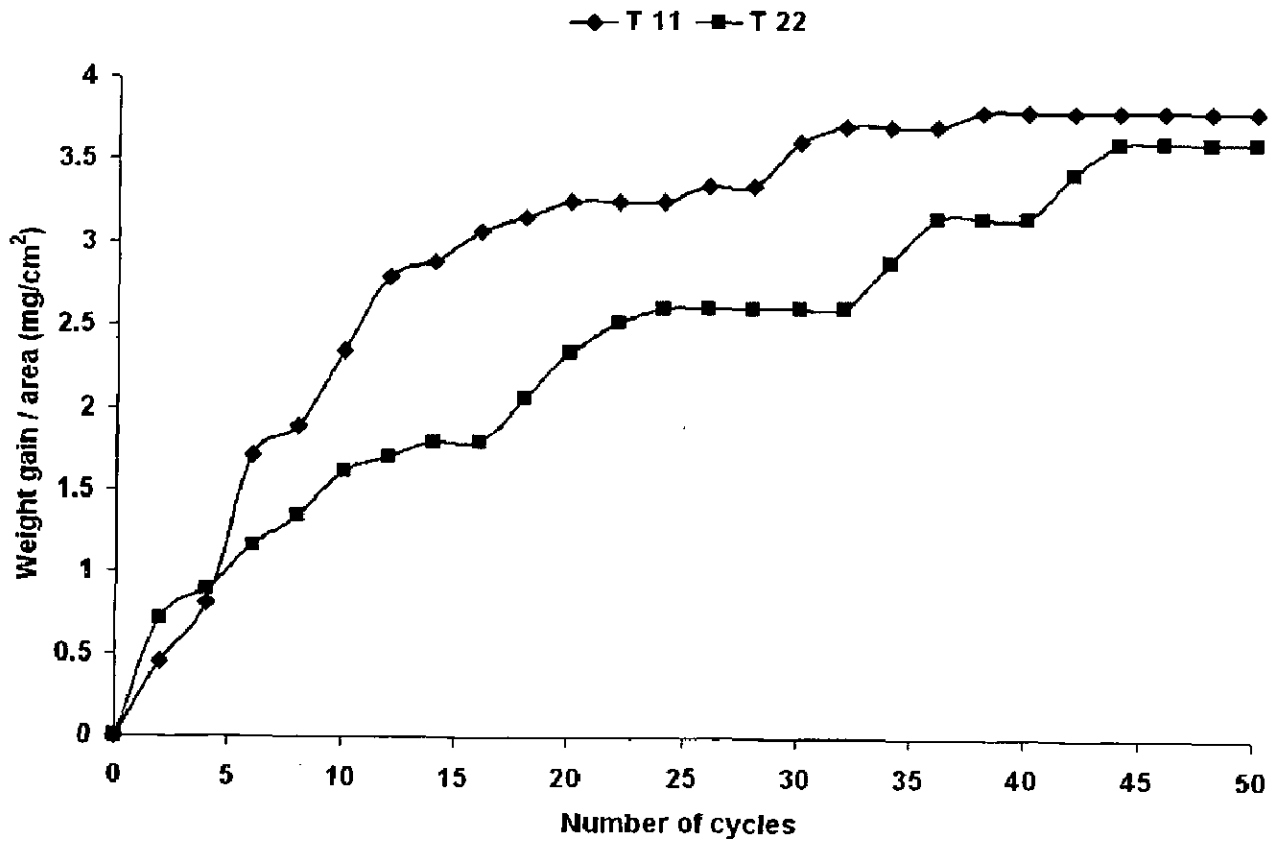
Fig. 6.62: Weight gain plot for Al_2O_3 - 3 wt% TiO_2 coated boiler steels T11 and T22 subjected to cyclic hot corrosion in Na_2SO_4 -60% V_2O_5 at 900°C for 50 cycles.

Weight gain per unit area expressed in mg/cm^2 is plotted as a function of time expressed in number of cycles for molten salt exposed Al_2O_3 - 3 wt% TiO_2 coated T11, T22 boiler steels is shown in Fig. 6.62 and for superalloys Superni 600, superni 718 and

Superfer 800 superalloys is shown in Fig. 6.64. The total weight gain at the end of 50 cycles for coated boiler steels T11 and T22 is 3.787 and 3.594, mg/cm² respectively. Weight gain square (mg²/cm⁴) plotted as a function of time (number of cycles) or boiler steels is shown in Fig.6.63. There is scatter in data, if the scatter in the measurements is not considered, the values of parabolic rate constant (K_p) for coated boiler steels T11 and T22 are calculated as 8.19×10^{-11} and 7.57×10^{-11} g² cm⁻⁴ s⁻¹ respectively.
