STUDY OF DETONATION GUN COATED ALLOYS FOR RESISTANCE TO EROSION AND CORROSION

A THESIS

METALLURGICAL AND MATERIALS ENGINEERING

This thesis investigates the erosion and corrosion performance of Al_2O_3 -3 wt % TiO_2 thermal spray coatings deposited by detonation gun technique. As-sprayed coatings were characterized by using the combined techniques of optical microscopy, microhardness testing, X-ray diffractometry (XRD) and scanning electron microscopy/energy-dispersive analysis (SEM/EDX). The corrosion performance was evaluated in oxidising and molten salt environment and also in actual working conditions of boiler. The erosion performance was evaluated at room temperature conditions as well as under high temperature conditions, high erodent velocity, and actual boiler conditions. The corrosion behavior and morphological development were investigated by weight change kinetics, metallographs, depths of attack, metal thickness losses, and XRD analyses.

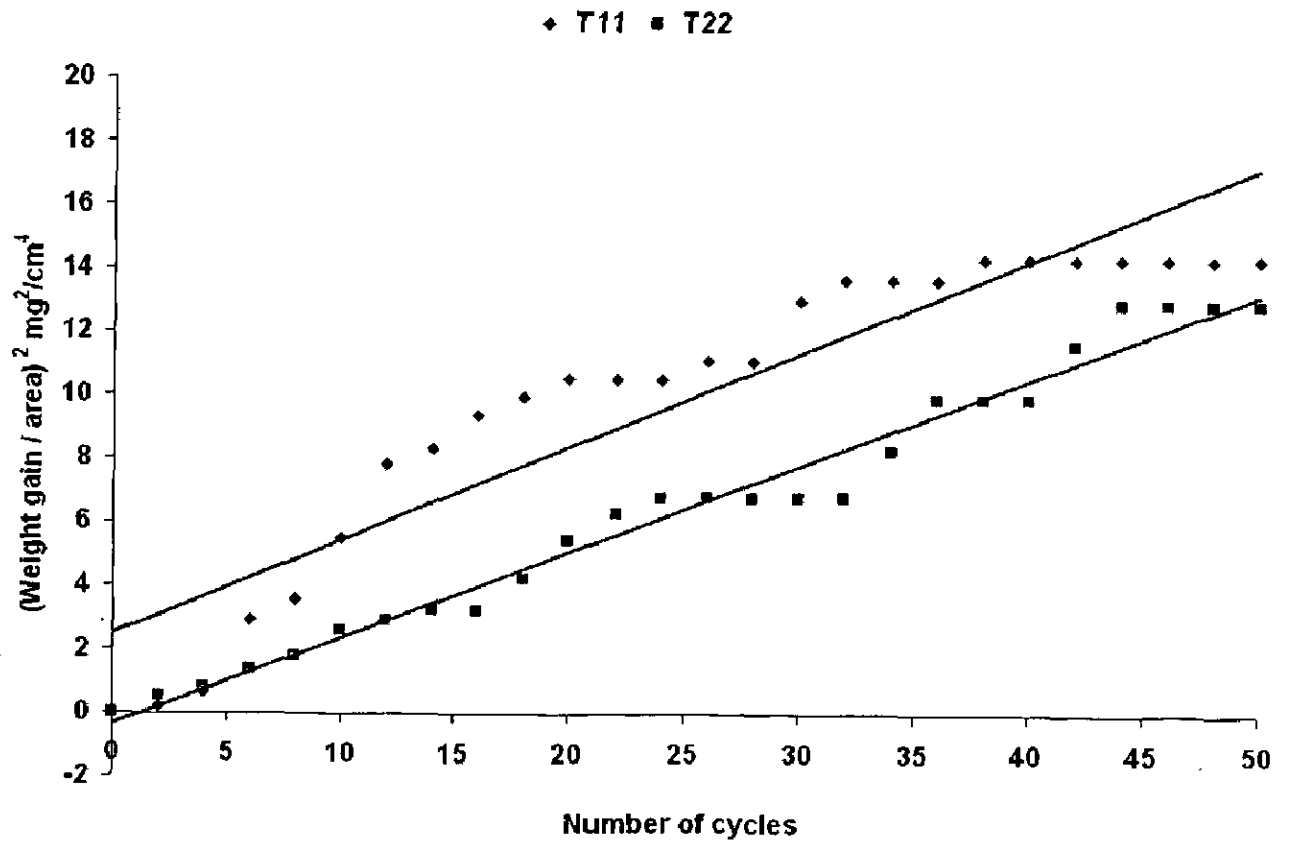
Fig.6.63: Weight gain square (mg^2/cm^4) plot for Al_2O_3 - 3 wt% TiO_2 coated boiler steels T11 and T22 subjected to cyclic hot corrosion in Na_2SO_4 -60% V_2O_5 at 900°C for 50 cycles.

Superfer 800 superalloys is shown in Fig. 6.64. The total weight gain at the end of 50 cycles for coated boiler steels T11 and T22 is 3.787 and 3.594, mg/cm² respectively. Weight gain square (mg²/cm⁴) plotted as a function of time (number of cycles) or boiler steels is shown in Fig.6.63. There is scatter in data, if the scatter in the measurements is not considered, the values of parabolic rate constant (K_p) for coated boiler steels T11 and T22 are calculated as 8.19×10^{-11} and 7.57×10^{-11} g² cm⁻⁴ s⁻¹ respectively.

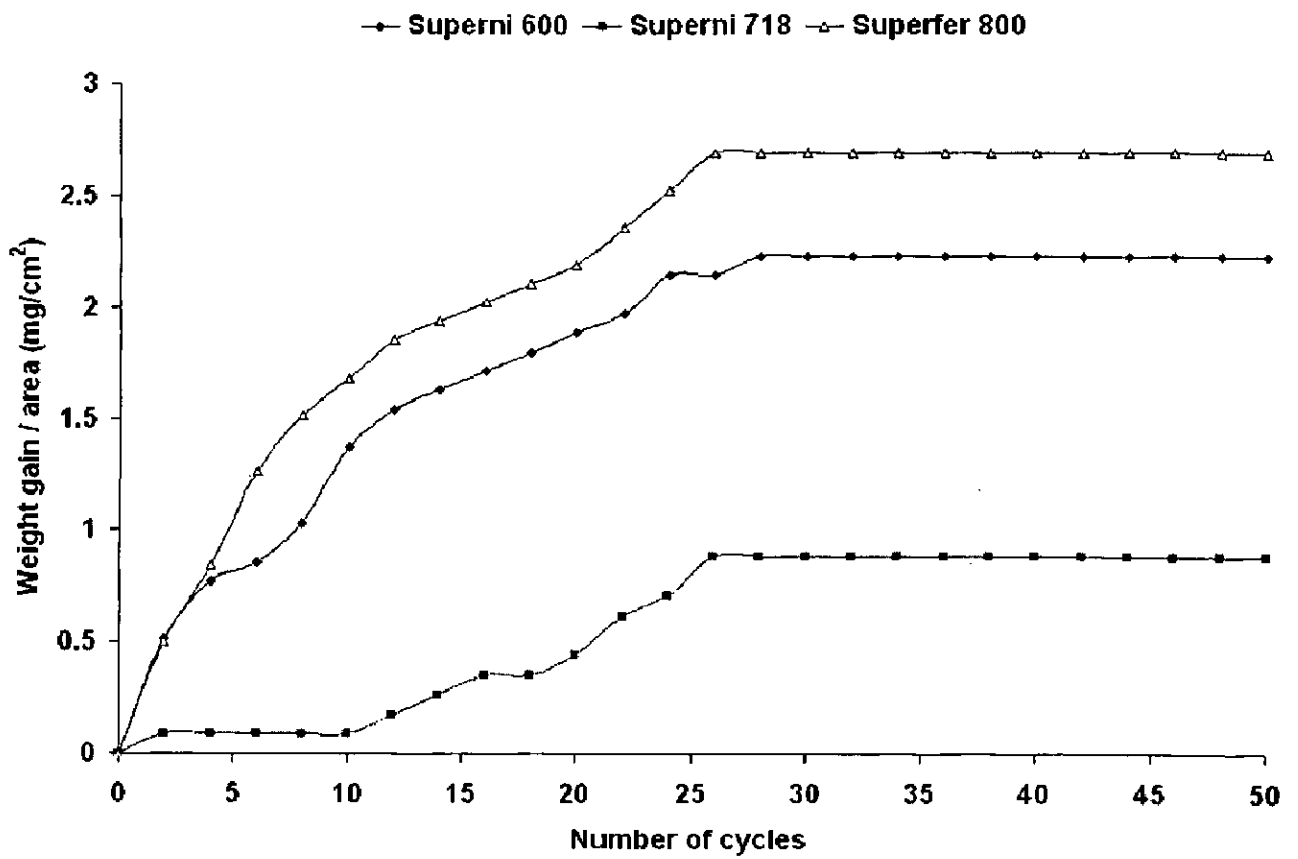
Fig. 6.64: Weight gain plot for Al_2O_3 - 3 wt% TiO_2 coated superalloys Superni 600, Superni 718, Superfer 800 subjected to cyclic hot corrosion in Na_2SO_4 -60% V_2O_5 at 900°C for 50 cycles.

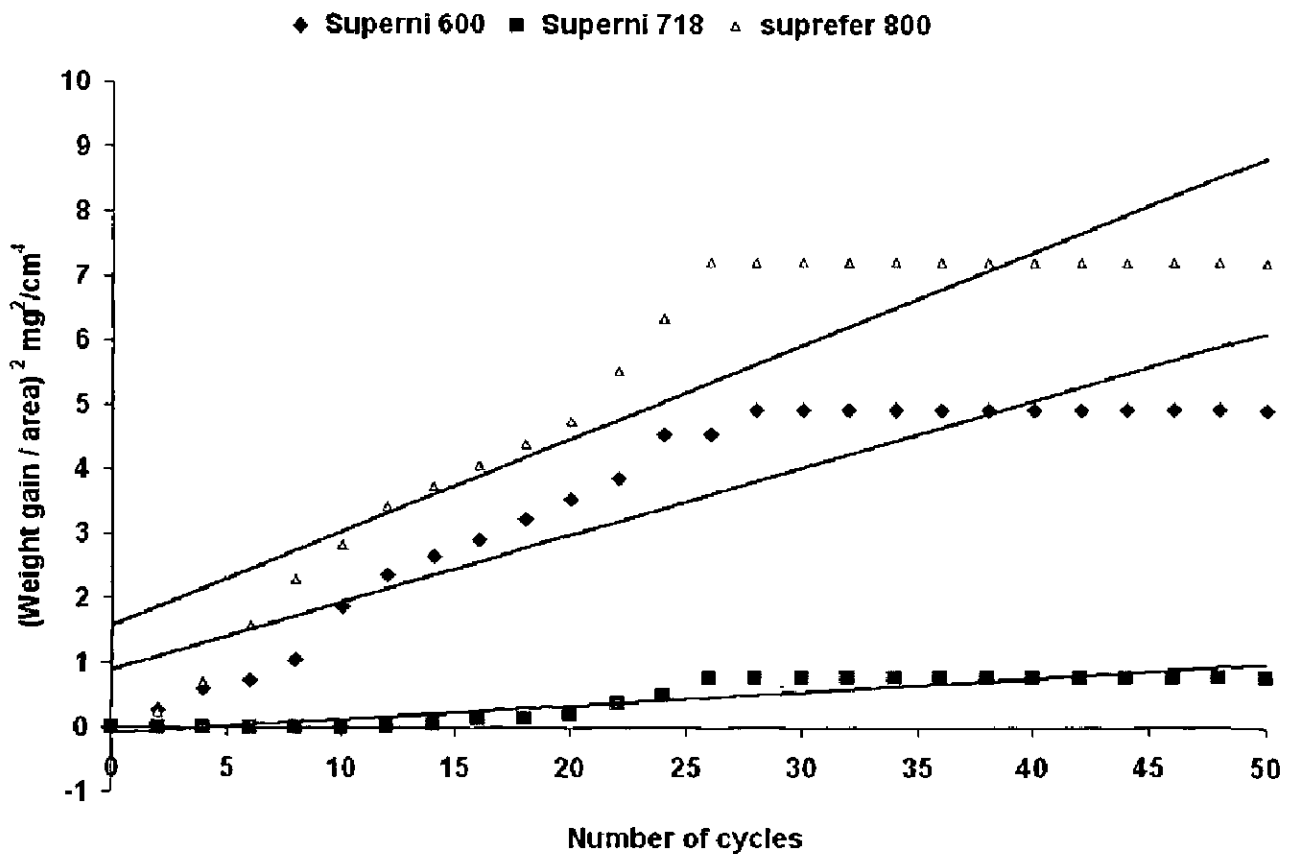
Fig.6.65: Weight gain square (mg^2/cm^4) plot for Al_2O_3 - 3 wt% TiO_2 coated superalloys Superni 600, Superni 718, Superfer 800 subjected to cyclic hot corrosion in Na_2SO_4 -60% V_2O_5 at 900°C for 50 cycles.

In Fig. 6.65, the (weight gain/unit area)² versus number of cycles for all the coated superalloys are plotted to determine the conformance with the parabolic rate law. The curve for Superni 718 is parabolic. While in case of superni 600 and superfer 800, scatter in the data can be observed in the plots and the data can not be approximated by a parabolic relationship. If the scatter in the measurements is not considered, the values of parabolic rate constant (K_p) for the superalloys Superni 600, 718 and Superfer 800 are calculated as 2.91×10^{-11} , 5.91×10^{-12} and 4.03×10^{-11} g² cm⁻⁴ s⁻¹ respectively.

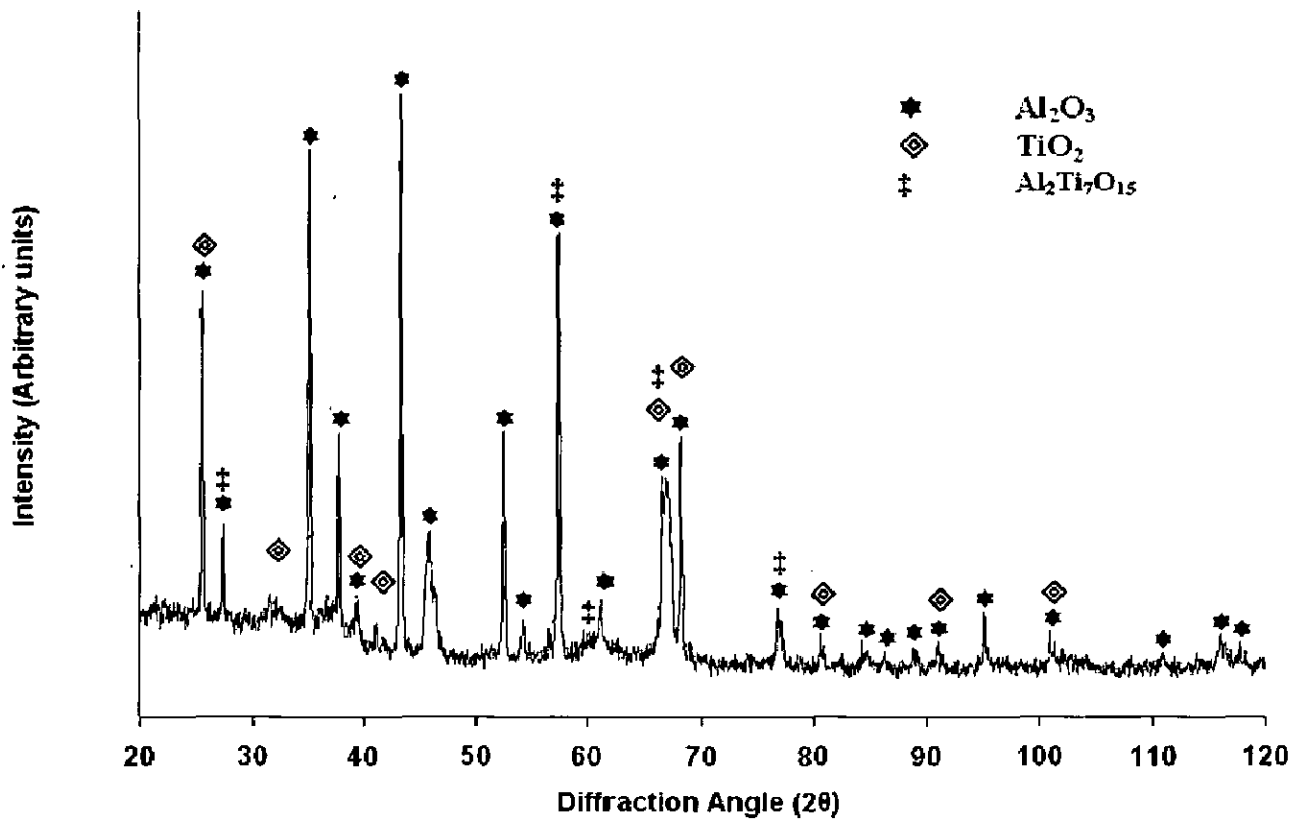
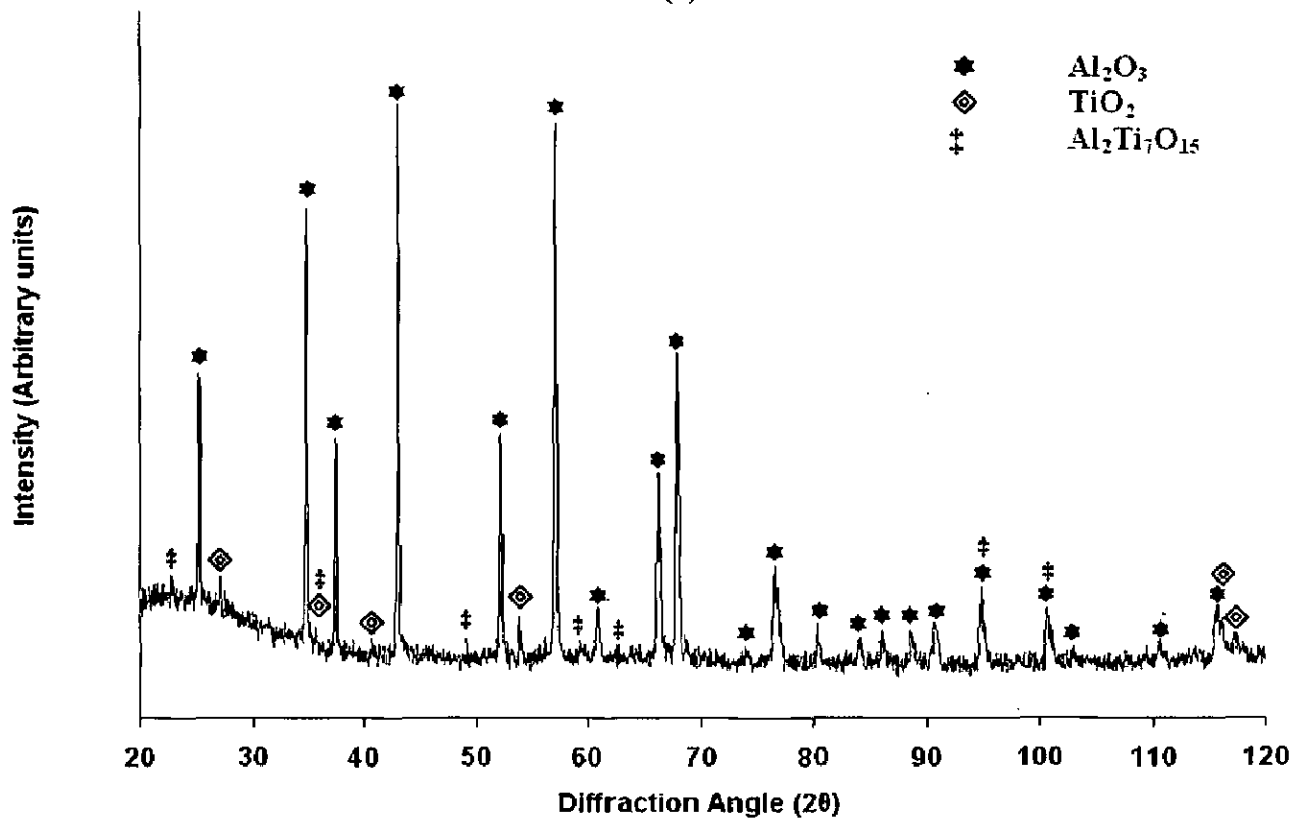
Fig. 6.66: X-ray diffraction profiles for Al_2O_3 -3 wt% TiO_2 coated boiler steels subjected to cyclic hot corrosion in Na_2SO_4 -60% V_2O_5 at 900°C for 50 cycles.
 (a) T11 (b) T22

X-ray diffraction profiles for Al₂O₃-3 wt% TiO₂ coated boiler steels subjected to cyclic hot corrosion in Na₂SO₄-60%V₂O₅ at 900°C for 50 cycles are shown in Fig. 6.66. Both coated boiler steels T11 and T22 have Al₂O₃ and TiO₂ as the main constituent with minor peak of Al₂TiO₇O₁₅. The X-ray diffractograms for the coated superalloys after exposure to molten salt at 900°C for 50 cycles is shown in Figs. 6.67 and 6.68. Major peaks of Al₂O₃ and TiO₂ along with minor peaks of Al₂TiO₅ were observed in all the coated superalloys under study.

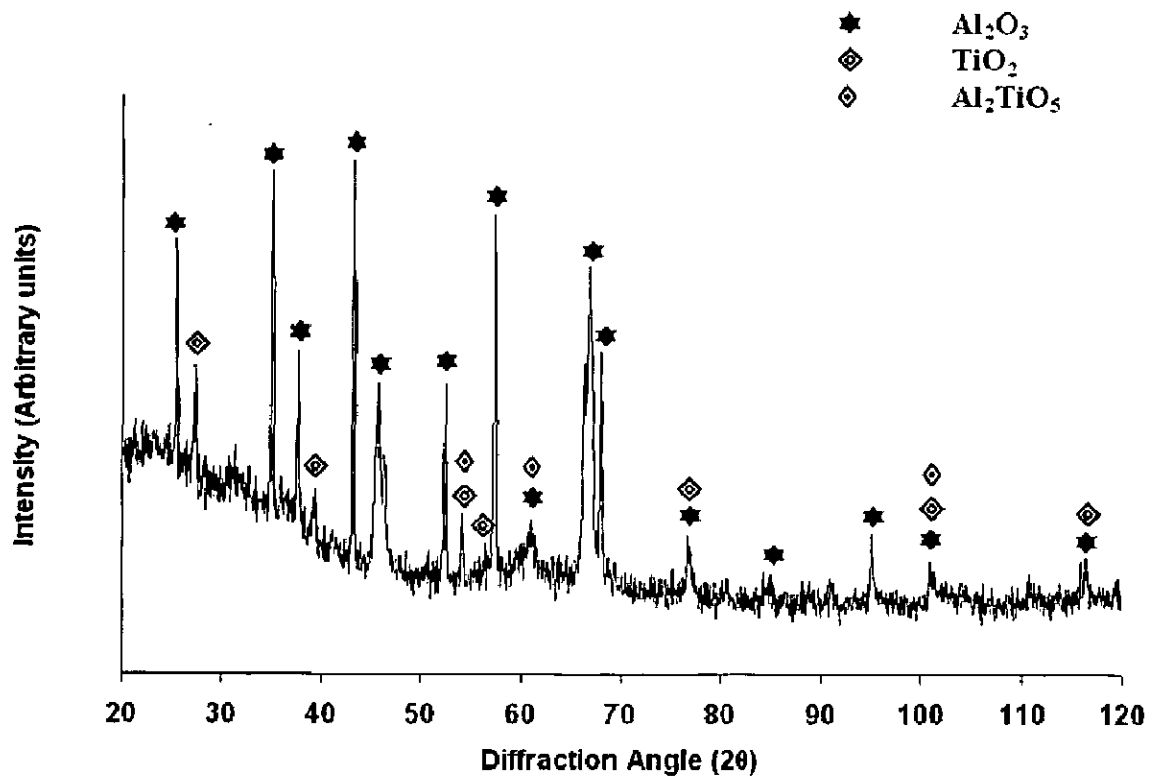
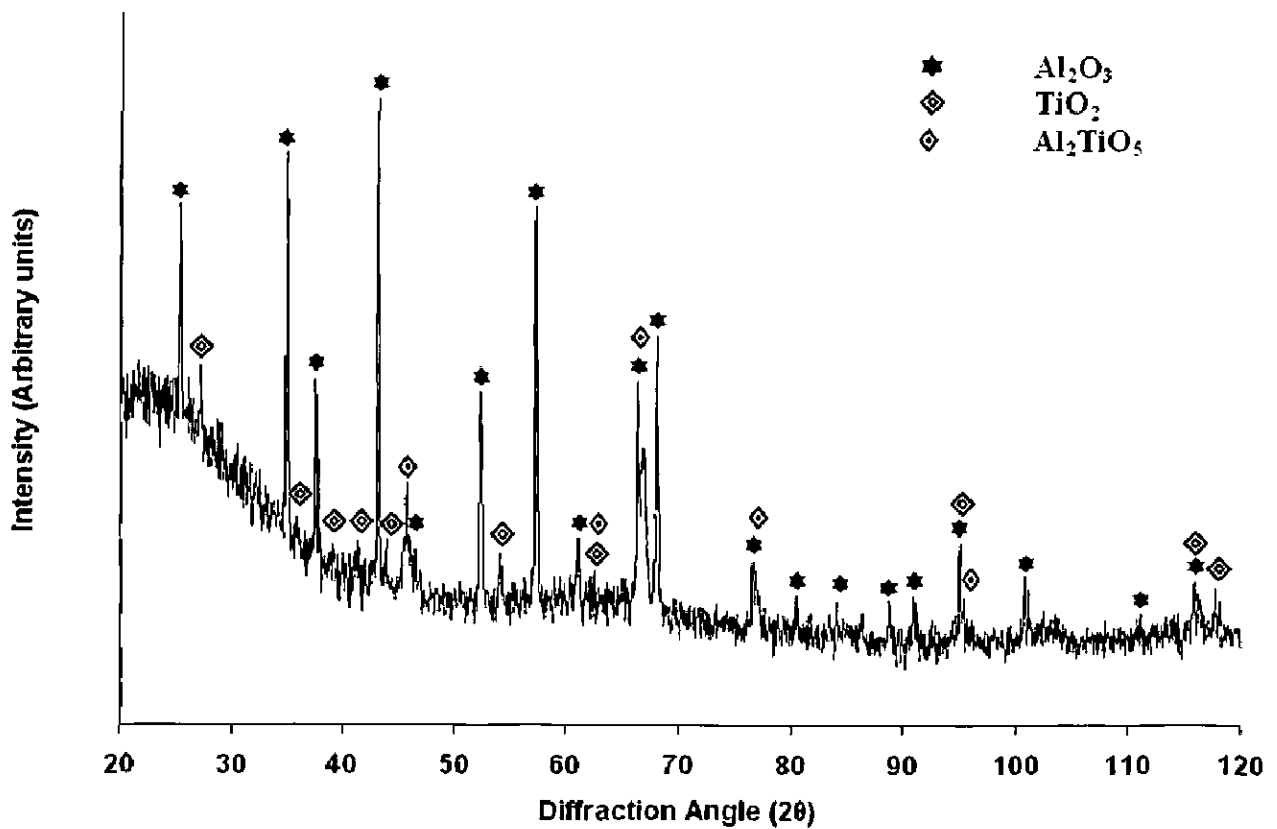
Fig. 6.67: X-ray diffraction profiles for Al_2O_3 -3 wt% TiO_2 coated superalloys subjected to cyclic hot corrosion in Na_2SO_4 -60% V_2O_5 at 900°C for 50 cycles.

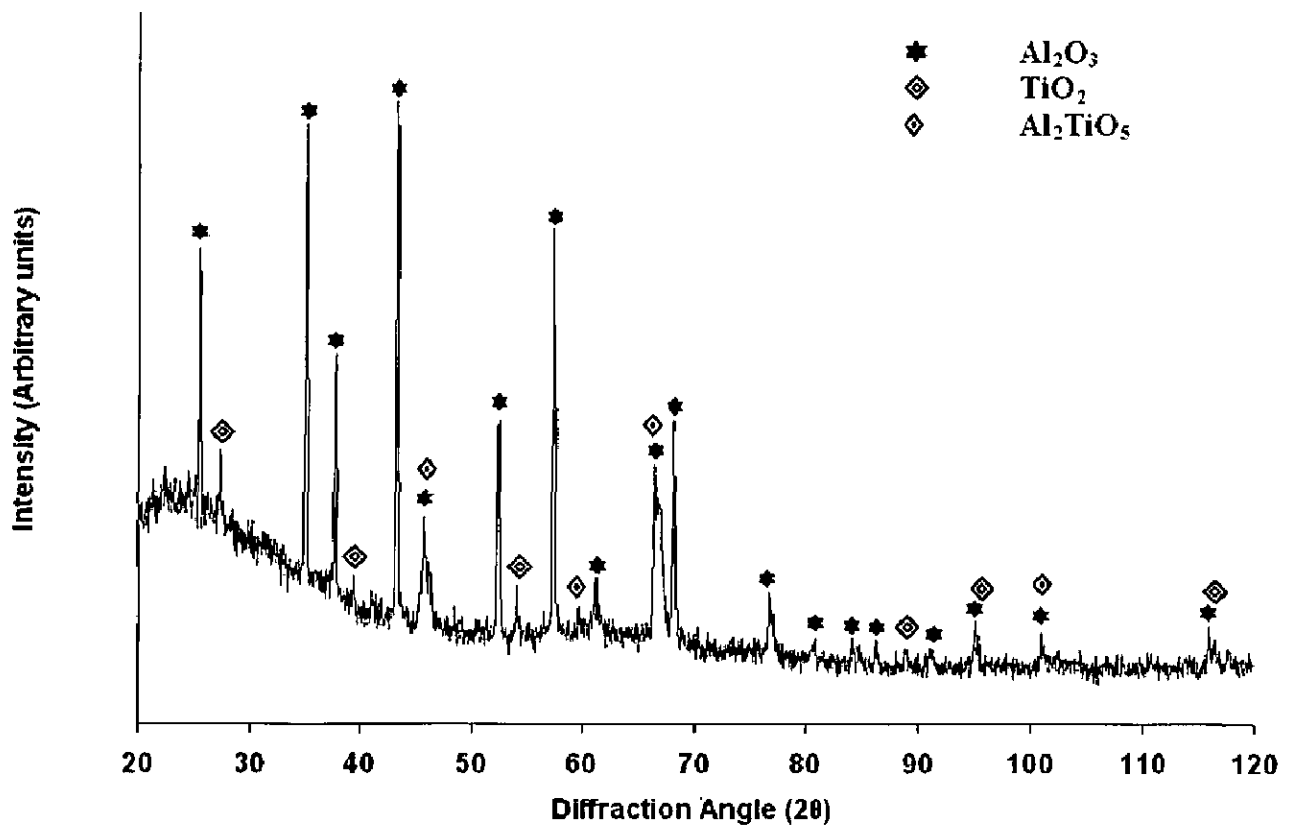
Fig. 6.68: X-ray diffraction profiles for Al₂O₃-3 wt% TiO₂ coated superalloy Superfer 800 subjected to cyclic hot corrosion in Na₂SO₄-60% V₂O₅ at 900°C for 50 cycles.

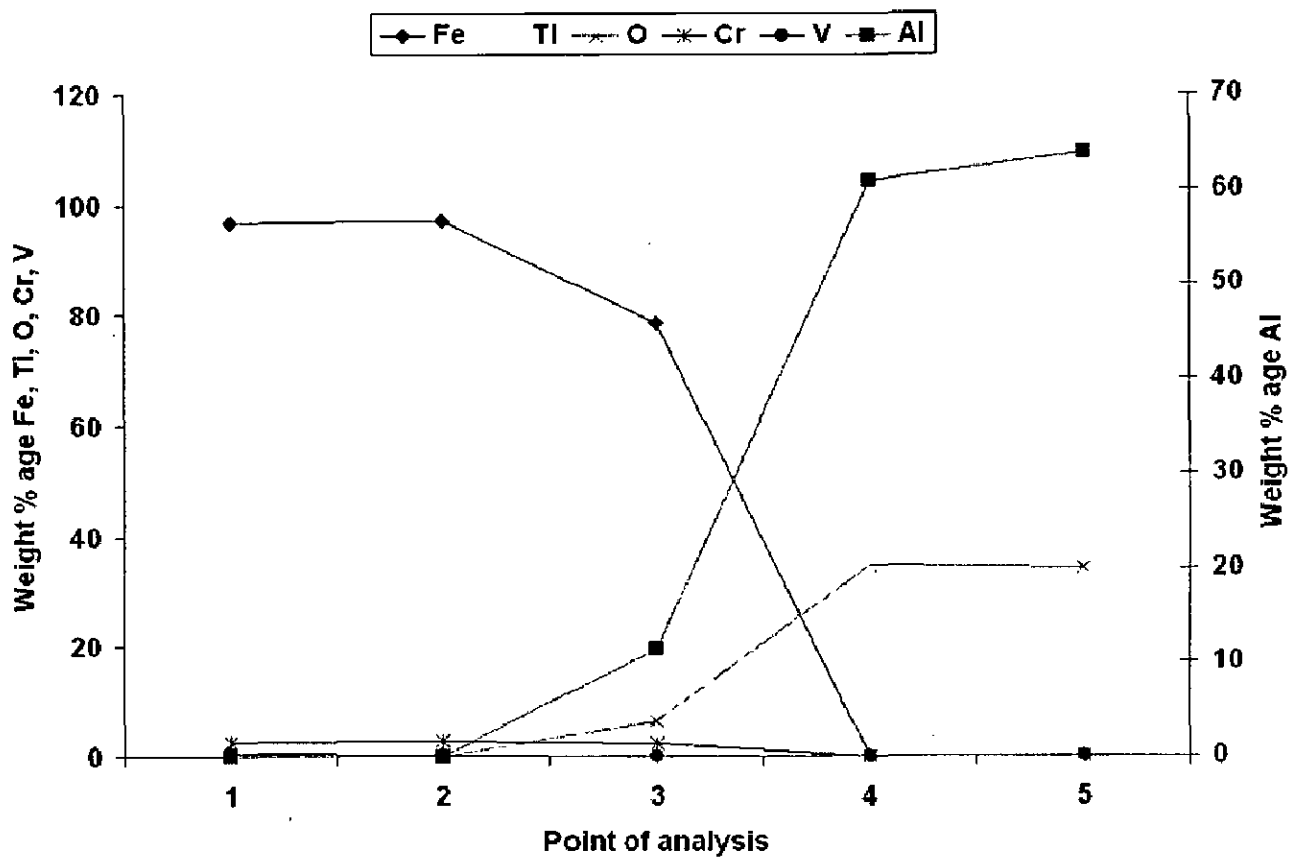
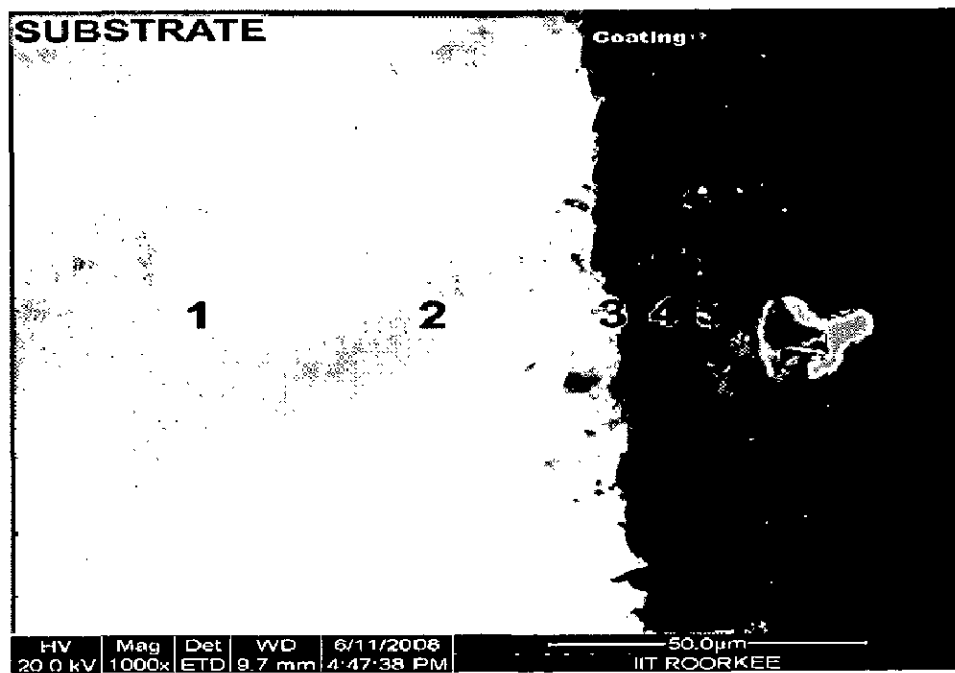
Fig.6.71: Cross sectional morphology and elemental composition variation across the cross-section of $\text{Al}_2\text{O}_3\text{-3wt\%TiO}_2$ coated boiler steel T11 exposed to $\text{Na}_2\text{SO}_4\text{-60\%V}_2\text{O}_5$ at 900°C for 50 cycles, 1000 X.

The BSE image and the EDX analysis across the cross section on Al_2O_3 -3 wt% TiO_2 coated alloys after exposure to Na_2SO_4 -60% V_2O_5 environment at 900°C for 50 cycles is shown in Fig.6.71 to Fig. 6.75. The results of the cross-section analysis of T11 and T22 boiler steels after molten salt exposure are plotted and shown in Fig. 6.71 and 6.72 along with micrographs. By viewing the cross sectional micrograph and the corresponding EDX analysis of coated T11, it is quite clear that coating is firm and intact and there is no deterioration of coating and hence coating has protected the surface very well. There is no penetration of oxygen in the substrate during the entire exposure of the coated specimen. As we approach from substrate to coating, at point 3, 4 and point 5 there is no indication of presence of elements other than present in the coating and same is in case of T22.

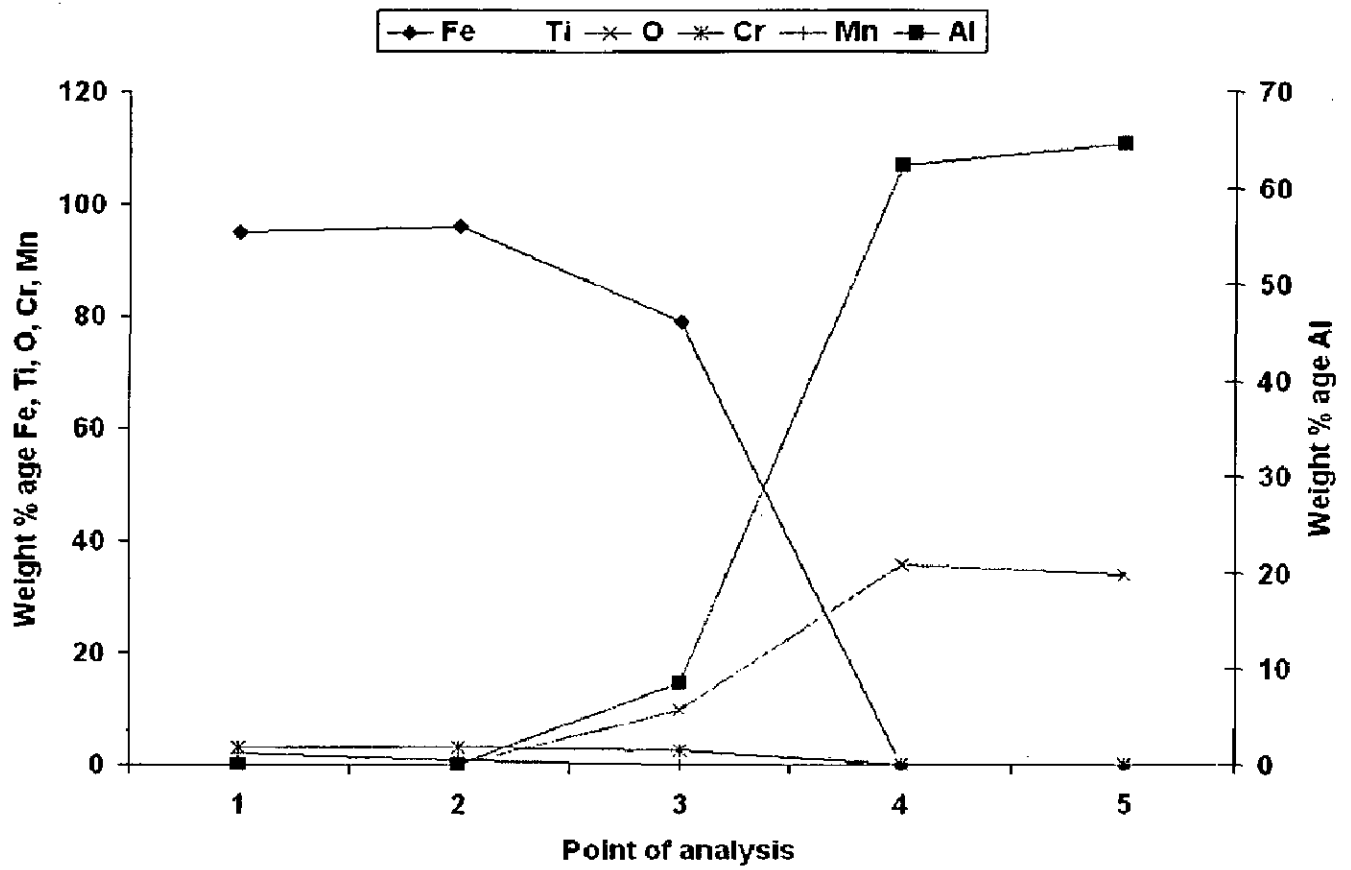
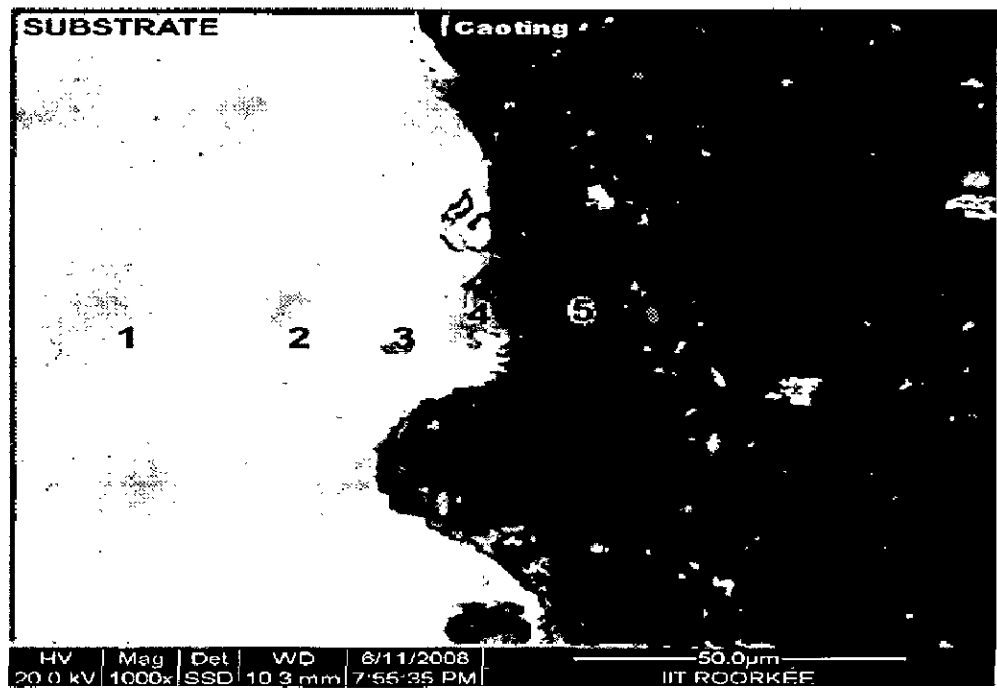
Fig.6.72: Cross sectional morphology and elemental composition variation across the cross-section of $\text{Al}_2\text{O}_3\text{-3wt\%TiO}_2$ Coated boiler steel T22 exposed to $\text{Na}_2\text{SO}_4\text{-60\%V}_2\text{O}_5$ at 900°C for 50 cycles, 1000 X.

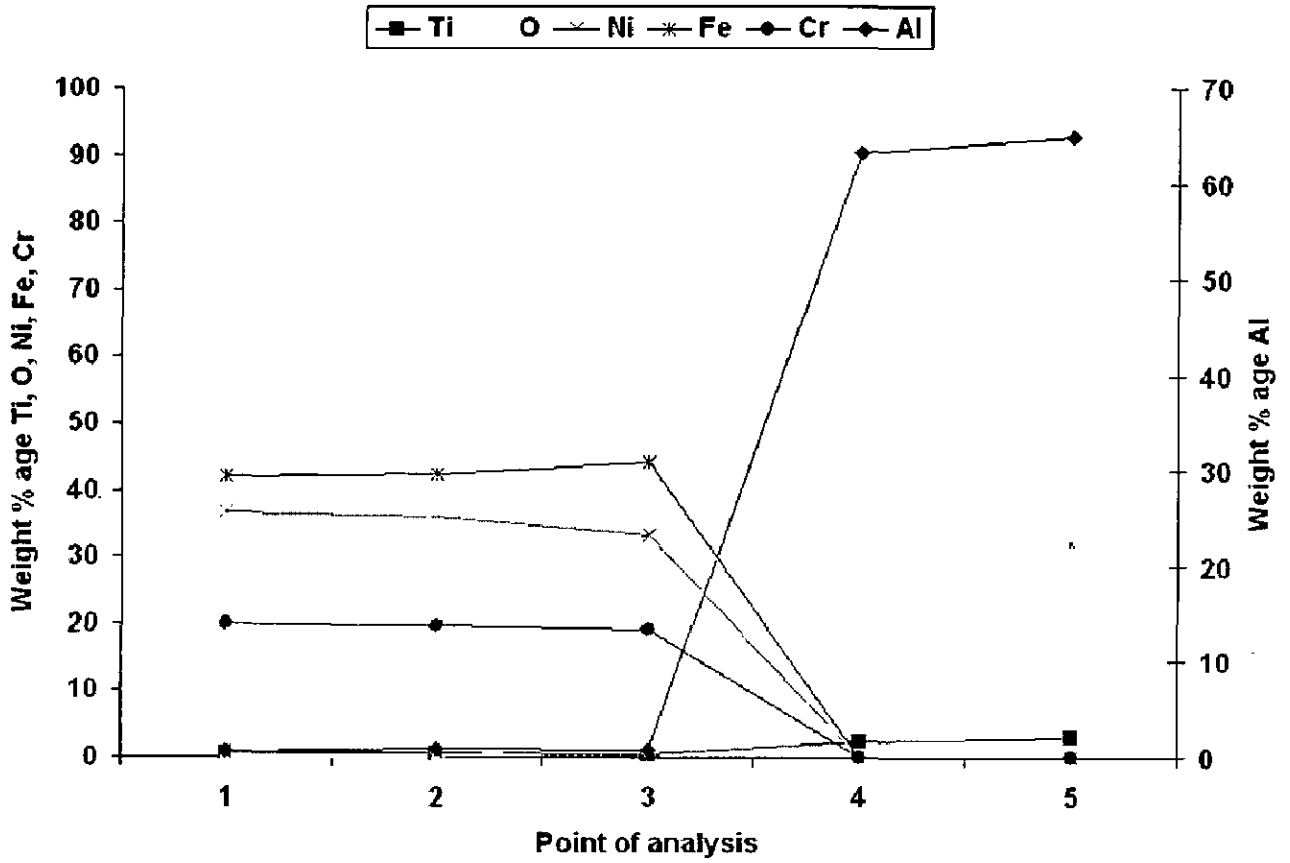
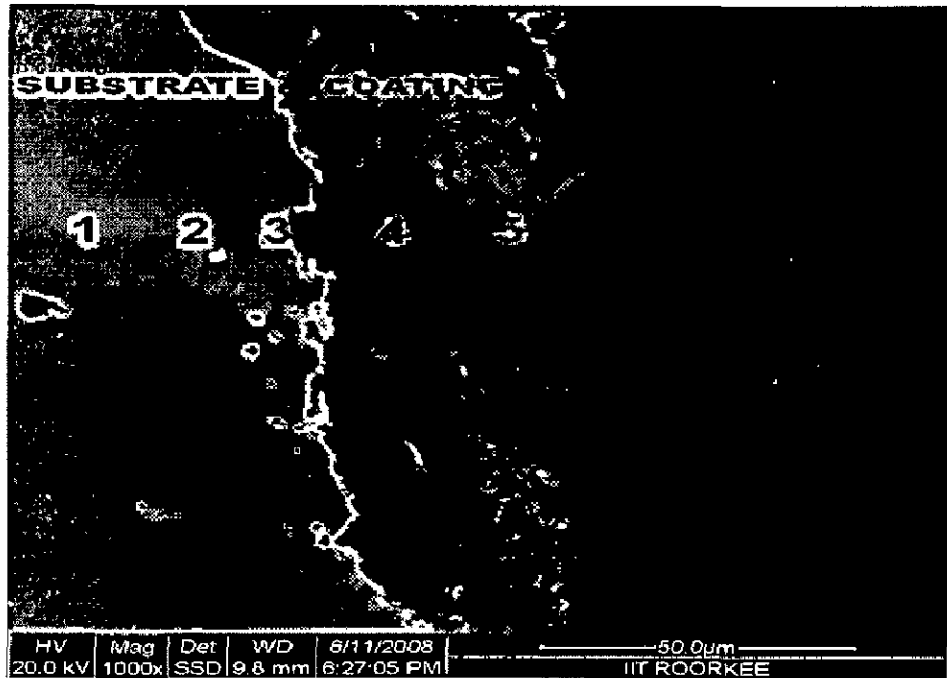
Fig.6.74: Cross sectional morphology and elemental composition variation across the cross-section of $\text{Al}_2\text{O}_3\text{-3wt\%TiO}_2$ Coated superalloy Superni 600 exposed to $\text{Na}_2\text{SO}_4\text{-60\%V}_2\text{O}_5$ at 900°C for 50 cycles, 1000 X.

composition across the cross-section of superalloy Superni 600 subjected to cyclic oxidation in air at 900°C after 50 cycles has been depicted in Fig. 6.73. The plots of elemental composition variation show that the scale mainly consists of aluminum and Titanium along with oxygen. There is no penetration of oxygen into the substrate through the coating. In superni 718, (Fig. 6.74) coating is intact and adherent and there is no oxidation of substrate beneath the coating. In superfer 800, Fig. 6.75, the coating has major portion of aluminium oxide

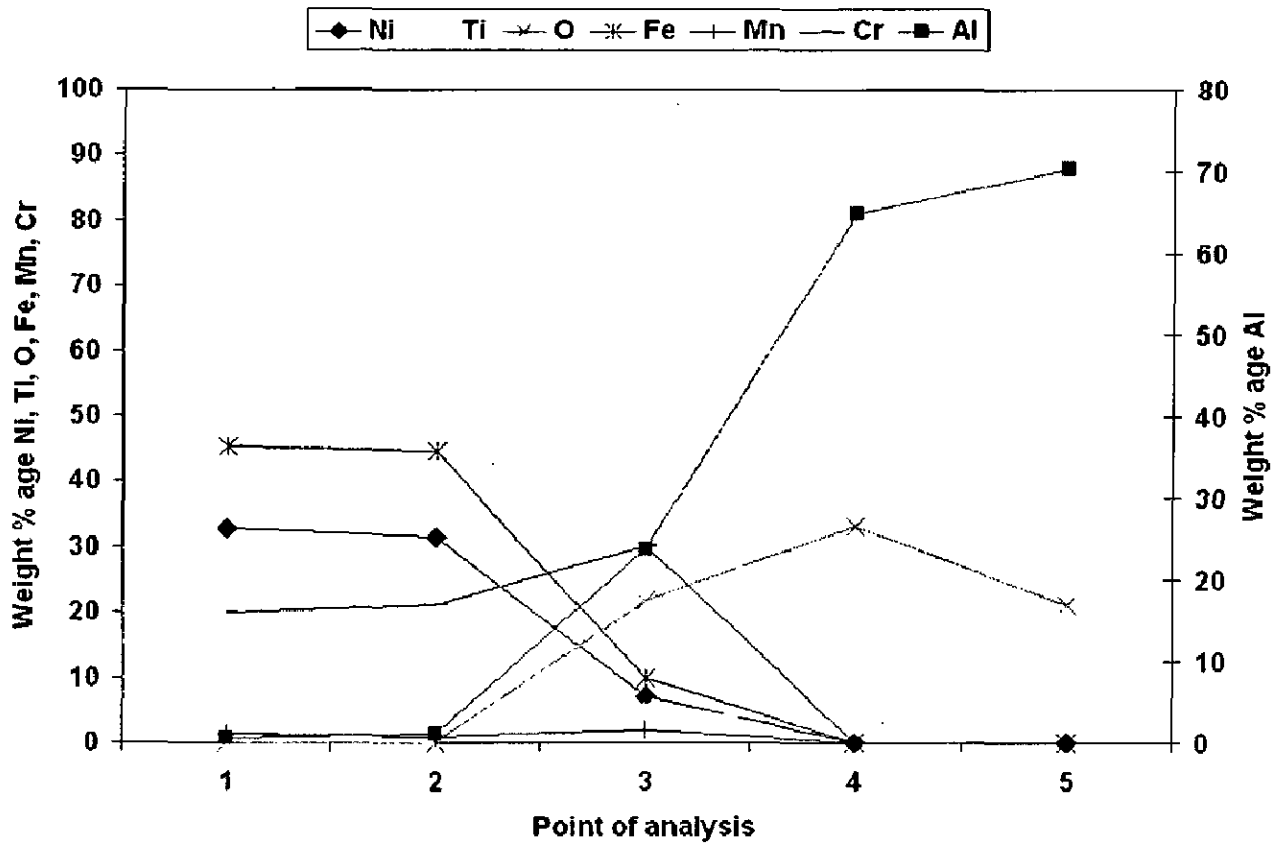
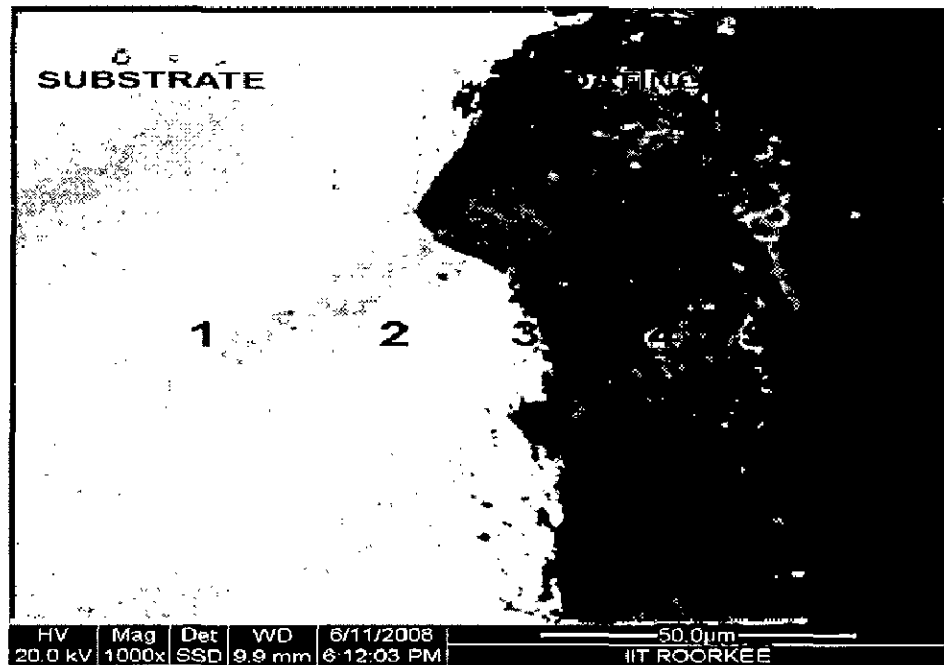
Fig.6.75: Cross sectional morphology and elemental composition variation across the cross-section of $\text{Al}_2\text{O}_3\text{-3wt\%TiO}_2$ coated superalloy Superfer 800 exposed to $\text{Na}_2\text{SO}_4\text{-60\%V}_2\text{O}_5$ at 900°C for 50 cycles, 1000 X.

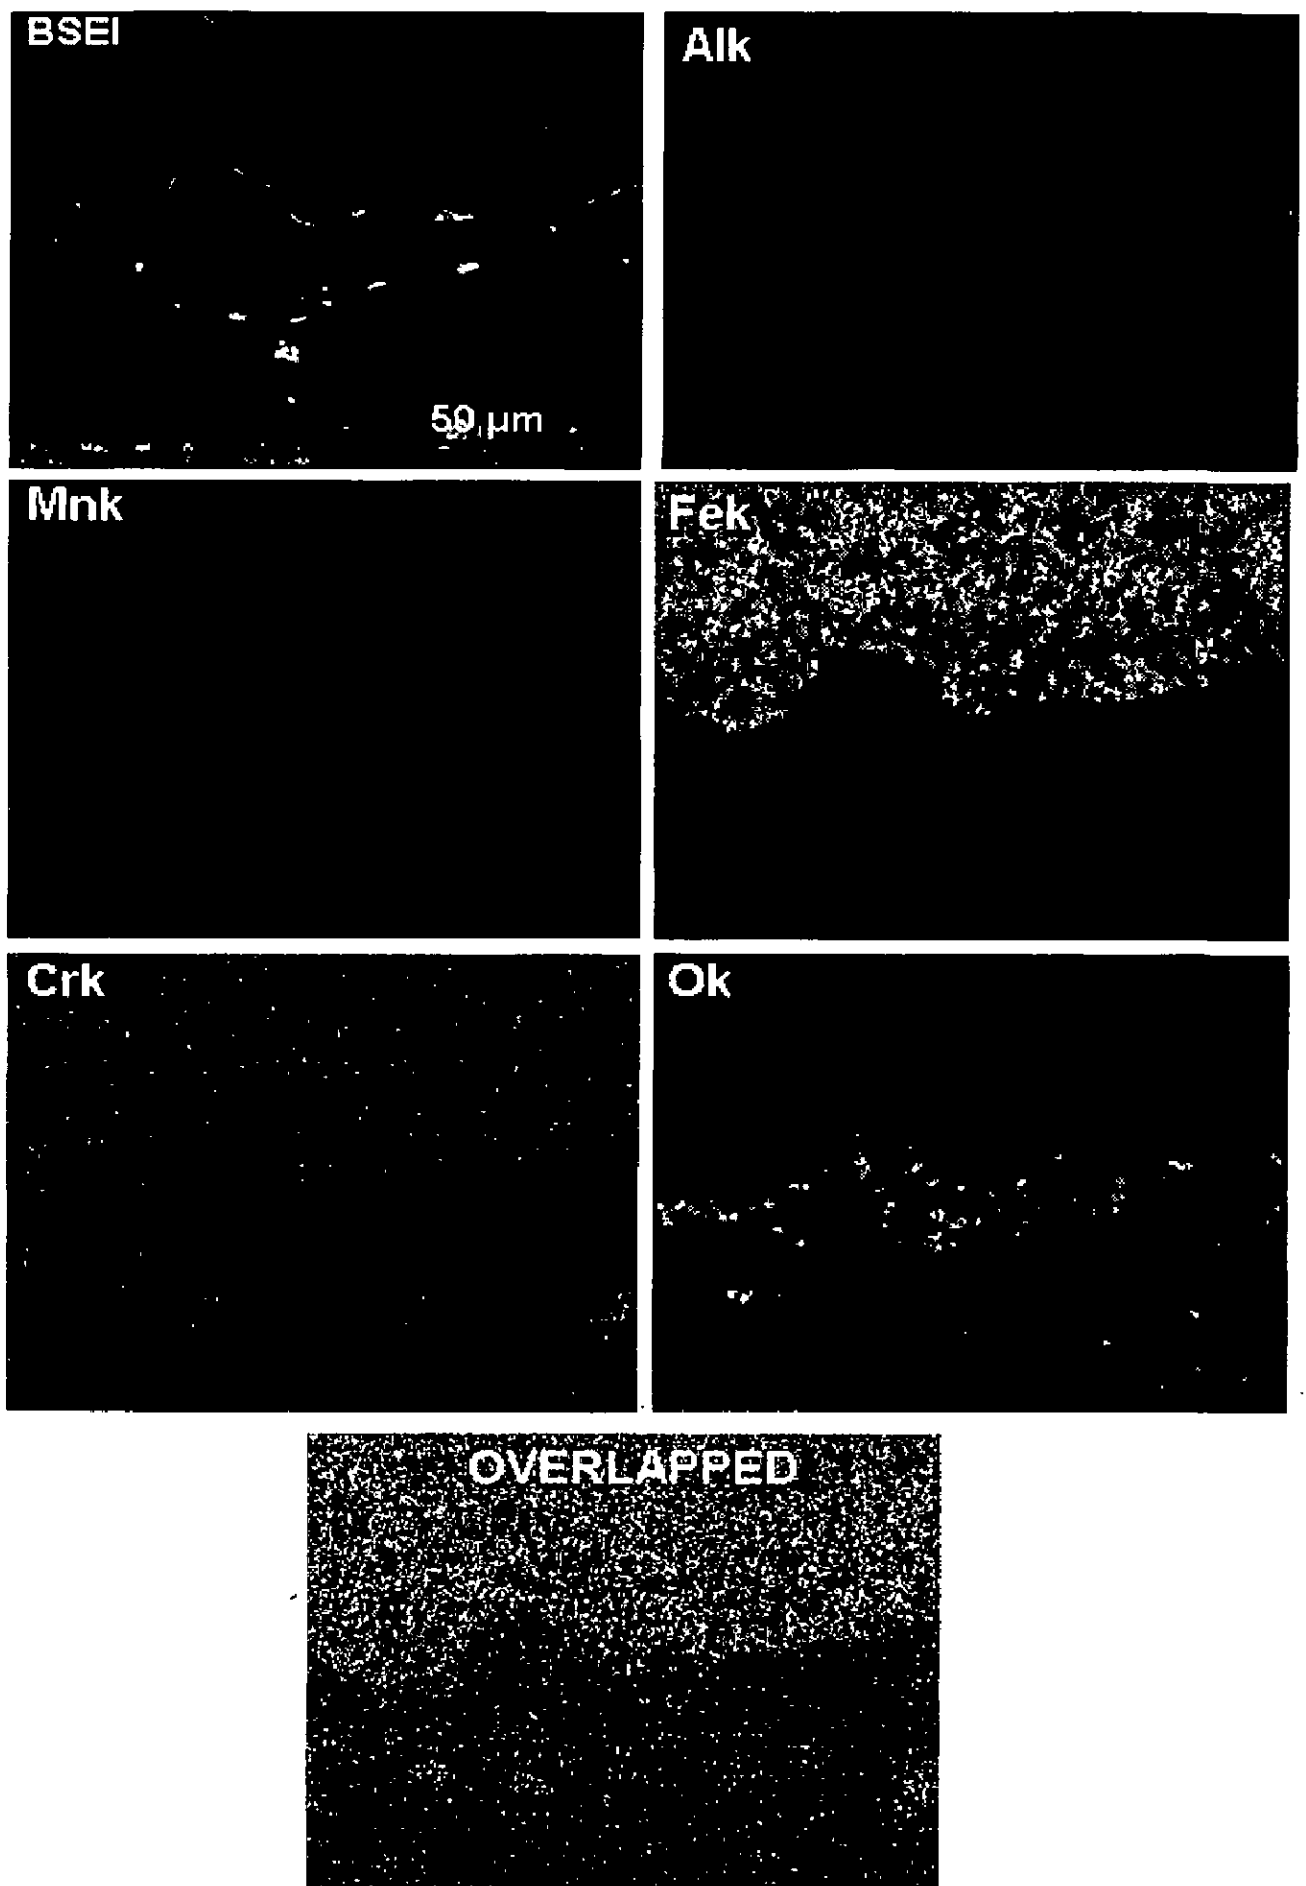
Fig. 6.77: BSEI and X-ray mapping of the cross-section of Al_2O_3 -3 wt% TiO_2 coated boiler steel T22 subjected to cyclic hot corrosion in Na_2SO_4 -60% V_2O_5 at 900°C for 50 cycles, 1000 X.

Back Scattered Electron Image of cross-section of Al_2O_3 -3 wt% TiO_2 coated substrate alloys (T11, T22, superni 600, superni 718 and Superfer 800) exposed to molten salt at 900°C and corresponding X-ray mapping after oxidation in air at 900°C after 50 cycles is shown in Fig. 6.76 to 6.80 respectively. In all the Al_2O_3 -3 wt% TiO_2 coated alloys coating has acted as a barrier and thus have prevented oxidation of substrate by inhibiting the penetration of oxygen. There is no spalling of coating throughout the testing. In boiler steels T11 and T22 (Fig.6.76 and 6.77), main constituent is aluminium oxide and there is no inward penetration of any element into the substrate but in maps of boiler steel T22 , iron is visible at the interface of epoxy and coating which could have been impinged into the epoxy during polishing of the specimen. In coated superni 600, Fe_2O_3 is visible at the right edge of the coating adjoining to epoxy depicted in Fig. 6.78. In case of coated superni 718, (Fig. 6.79) major phase of coating Al_2O_3 and TiO_2 band is visible in the coating and there is no penetration of oxygen into the substrate through the coating. Fig. 6.80 shows the mapping for coated superfer 800, in which coating is intact and there is no inward penetration of oxygen or any other element.

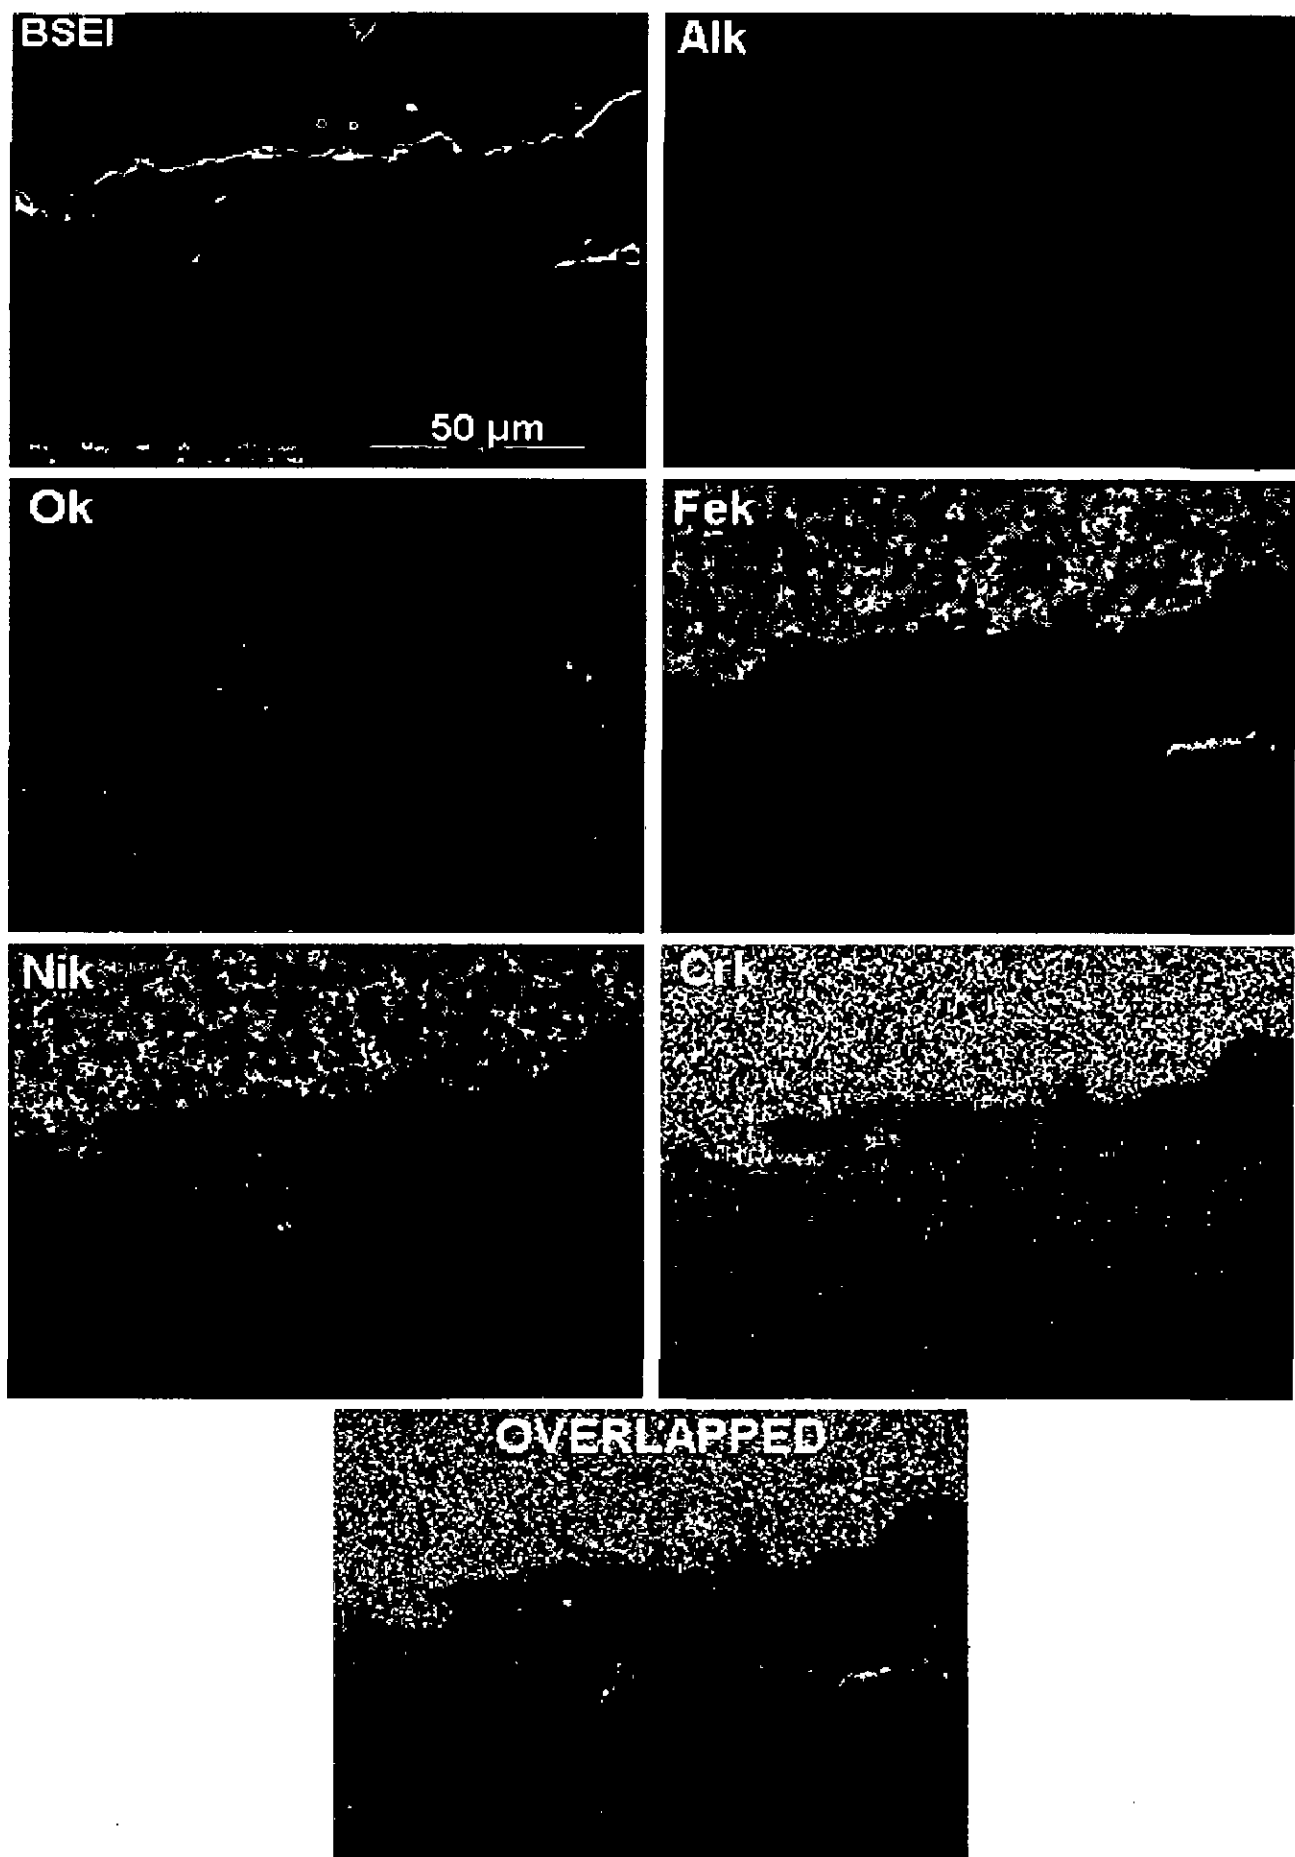
Fig. 6.78: BSEI and X-ray mapping of the cross-section of $\text{Al}_2\text{O}_3\text{-3 wt\%TiO}_2$ coated superalloy Superni 600 subjected to cyclic hot corrosion in $\text{Na}_2\text{SO}_4\text{-60\%V}_2\text{O}_5$ at 900°C for 50 cycles, 1000 X.
