STUDY OF DETONATION GUN COATED ALLOYS FOR RESISTANCE TO EROSION AND CORROSION

A THESIS

METALLURGICAL AND MATERIALS ENGINEERING

This thesis investigates the erosion and corrosion performance of Al_2O_3 -3 wt % TiO_2 thermal spray coatings deposited by detonation gun technique. As-sprayed coatings were characterized by using the combined techniques of optical microscopy, microhardness testing, X-ray diffractometry (XRD) and scanning electron microscopy/energy-dispersive analysis (SEM/EDX). The corrosion performance was evaluated in oxidising and molten salt environment and also in actual working conditions of boiler. The erosion performance was evaluated at room temperature conditions as well as under high temperature conditions, high erodent velocity, and actual boiler conditions. The corrosion behavior and morphological development were investigated by weight change kinetics, metallographs, depths of attack, metal thickness losses, and XRD analyses.

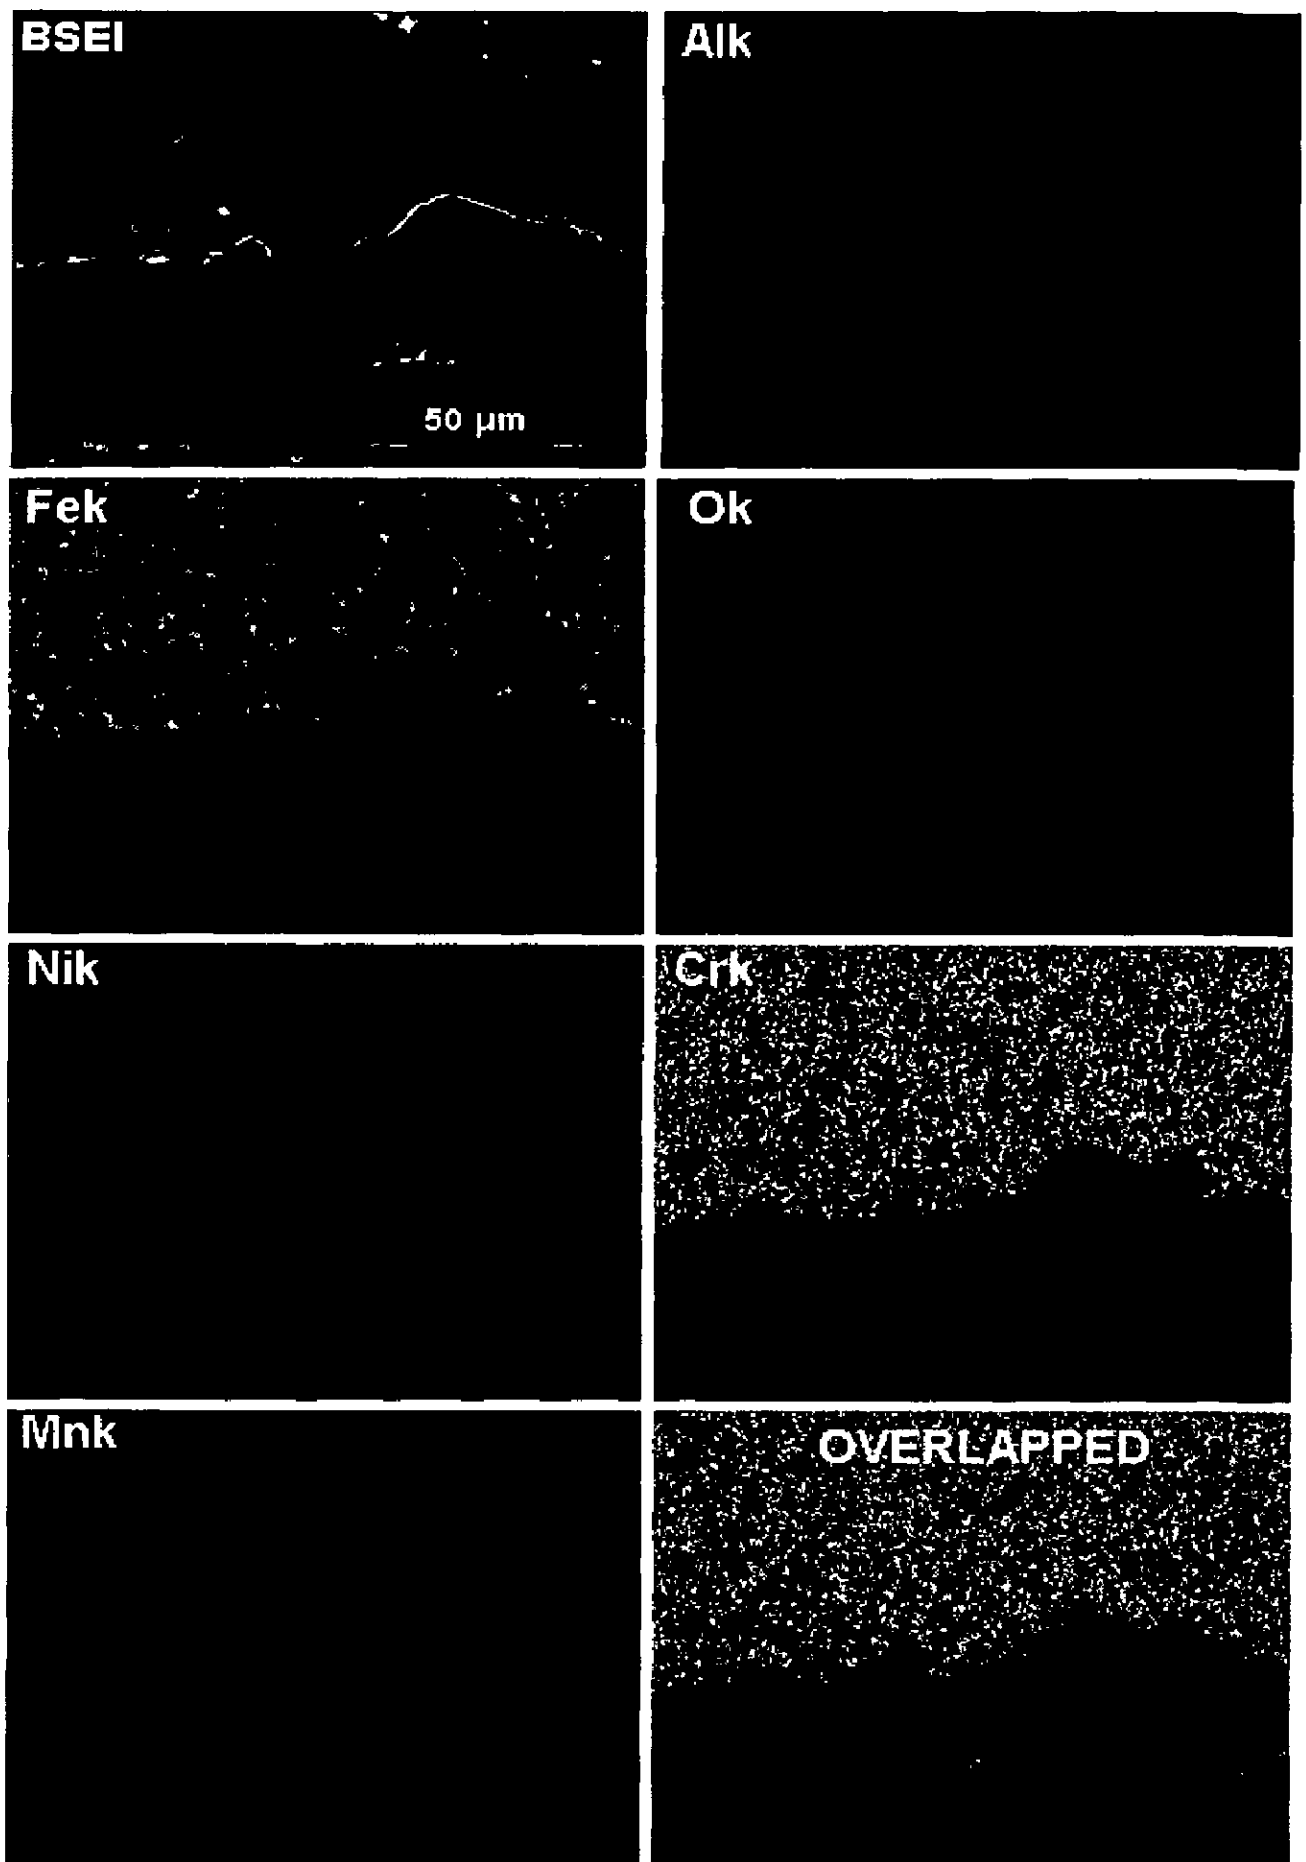
Fig.6.80: BSEI and X-ray mapping of the cross-section of Al_2O_3 -3 wt% TiO_2 coated superalloy Superfer 800 subjected to cyclic hot corrosion in Na_2SO_4 -60% V_2O_5 at 900°C for 50 cycles, 1000 X.

Back Scattered Electron Image of cross-section of Al_2O_3 -3 wt% TiO_2 coated substrate alloys (T11, T22, superni 600, superni 718 and Superfer 800) exposed to molten salt at 900°C and corresponding X-ray mapping after oxidation in air at 900°C after 50 cycles is shown in Fig. 6.76 to 6.80 respectively. In all the Al_2O_3 -3 wt% TiO_2 coated alloys coating has acted as a barrier and thus have prevented oxidation of substrate by inhibiting the penetration of oxygen. There is no spalling of coating throughout the testing. In boiler steels T11 and T22 (Fig.6.76 and 6.77), main constituent is aluminium oxide and there is no inward penetration of any element into the substrate but in maps of boiler steel T22 , iron is visible at the interface of epoxy and coating which could have been impinged into the epoxy during polishing of the specimen. In coated superni 600, Fe_2O_3 is visible at the right edge of the coating adjoining to epoxy depicted in Fig. 6.78. In case of coated superni 718, (Fig. 6.79) major phase of coating Al_2O_3 and TiO_2 band is visible in the coating and there is no penetration of oxygen into the substrate through the coating. Fig. 6.80 shows the mapping for coated superfer 800, in which coating is intact and there is no inward penetration of oxygen or any other element.

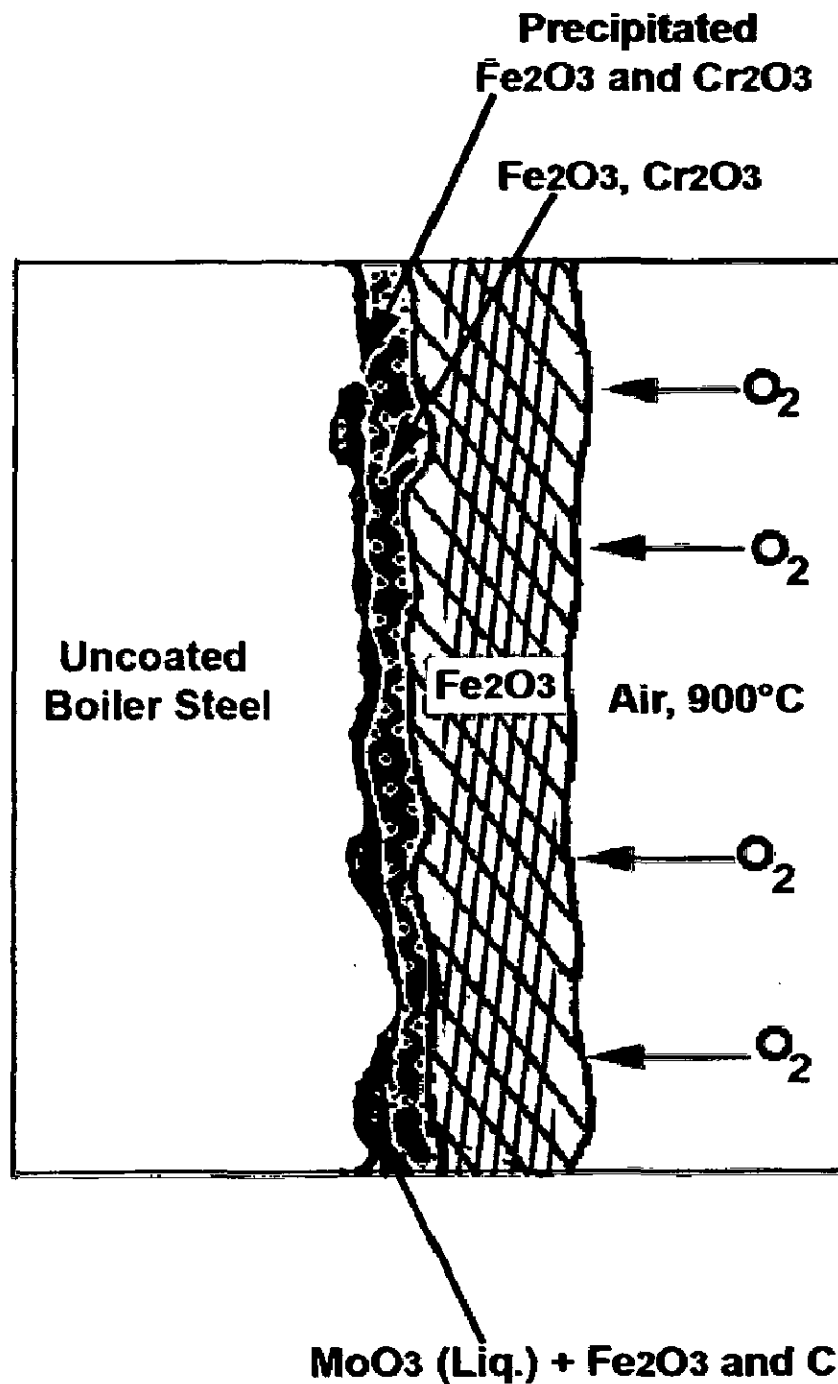
Fig. 6.81: Schematic diagram showing probable mode of oxidation attack on T22 boiler steel exposed to air at 900°C for 50 cycles.

molybdenum or even to molybdenum. Simultaneously MoO_3 may exert dissolving action on other oxides, such as Fe_2O_3 and Cr_2O_3 and this fluxing may further get accelerated by the enthalpy of formation of Fe_2O_3 and Cr_2O_3 which tends to increase in the temperature at the alloy-scale interface. The mode of oxidation attack can be explained schematically as shown in Fig. 6.81 which is similar to one reported by Chatterjee et al (2001).

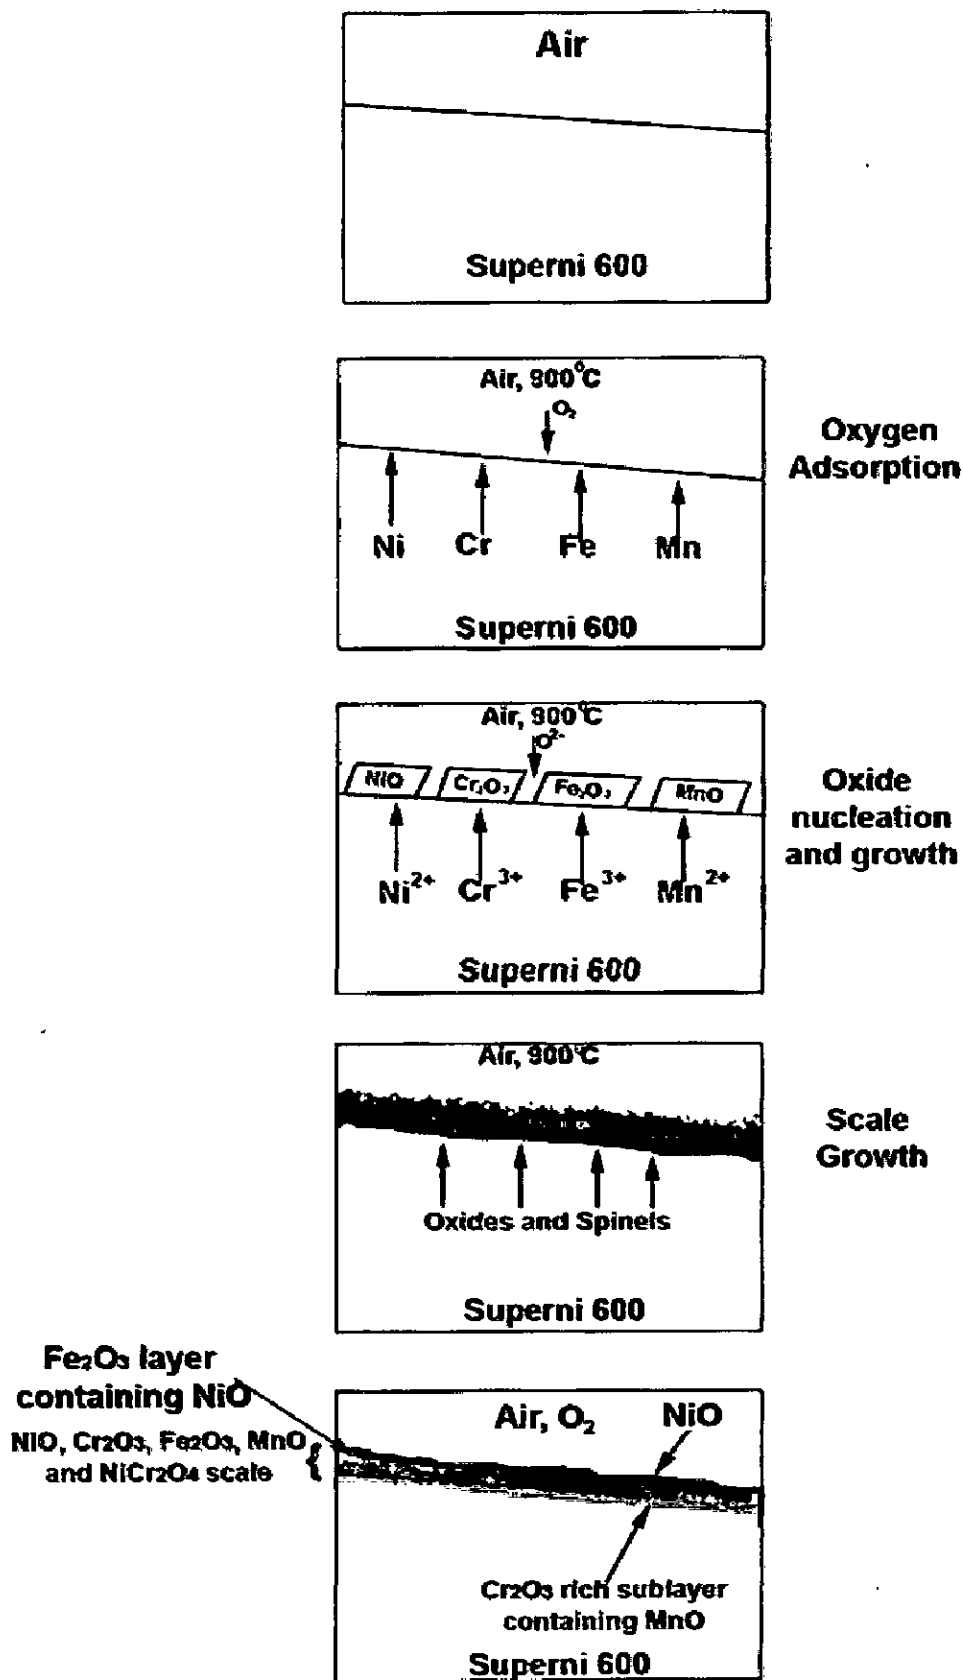
Fig. 6.82: Schematic diagram showing probable mode of oxidation attack on Ni based superalloys exposed to air at 900°C for 50 cycles.

The probable mode of oxidation attack on Ni based superalloys is shown schematically in Fig.6.82 which is similar to mechanism suggested by Stott (1998) in his study on oxidation of alloys at elevated temperature which can be taken as a representative case for the Ni based superalloys under study. As suggested by Stott (1998), in oxidation initiation stage i.e. when the alloy surface adsorb the oxygen molecules, small impinging nuclei of all the thermodynamically stable oxides such as those of Ni, Cr, Fe and Mn develop on the surface of the alloy. These nuclei then coalesce rapidly to give a transient layer of various oxides in a very short time as the temperature of study becomes high. As Ni percentage is highest in the superalloy Superni 600, the amount of nickel oxide in this layer will be the highest, whereas chromium oxide will be the second dominating phase, followed by oxides of Fe and Mn. Oxides like NiCr_2O_4 may also form by reaction of oxides of Ni and Cr in the transient layer. This transient layer continues to grow with NiO at the top of the scale along with iron oxide, while the thermodynamically favored chromia attempt to establish a complete layer at the base of this transient layer along with MnO. Once a continuous layer Cr_2O_3 is formed at the alloy/scale interface, the rate of oxidation is then controlled by transport of reactants across this layer, which is much slower process than across the initially formed NiO-rich layer. While in case of iron based superalloy i.e Superfer 800, mainly iron oxide phase is formed. The probable mode of oxidation attack for Superfer 800 is shown schematically in Fig. 6.83. In starting stage, oxygen is adsorbed by the surface resulting in formation of iron oxide and other oxides of the constituent elements. As Fe percentage is highest in the superalloy Superfer 800, the amount of iron oxide in this layer will be the highest, oxides like NiCr_2O_4 may also form by reaction of oxides of Ni and Cr in the transient layer. This transient layer continues to grow with iron oxide at the top as well as internal oxidation is also there. Cr_2O_3 formed is not continuous and thus can not prevent internal oxidation.

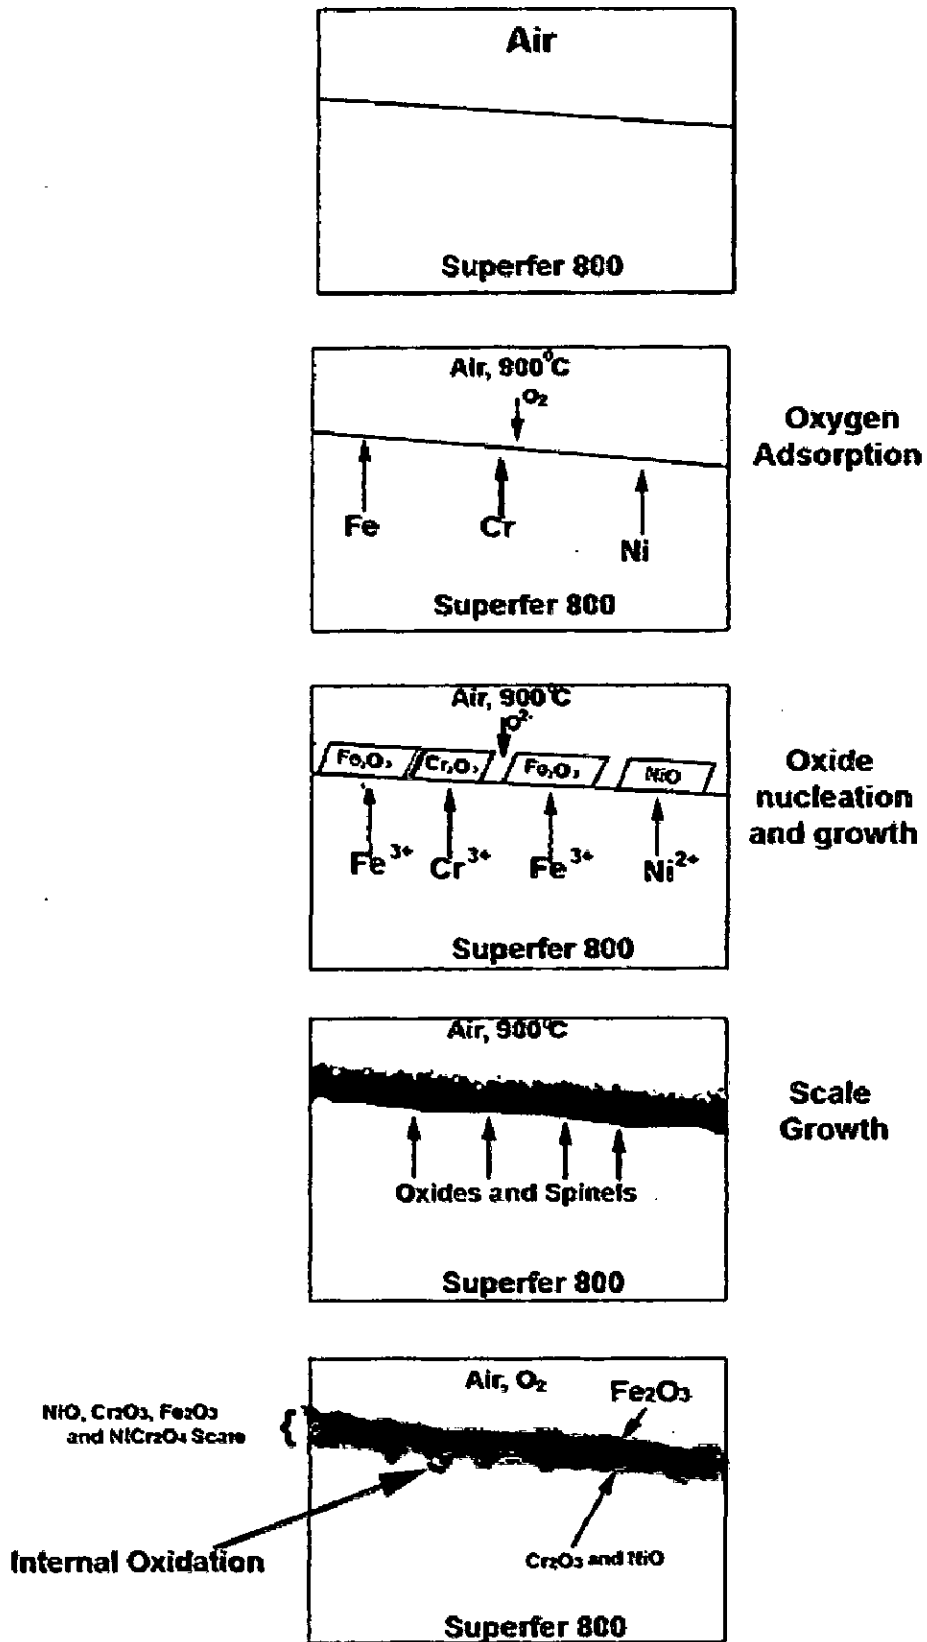
Fig. 6.83: Schematic diagram showing probable mode of oxidation attack on Fe- based superalloy Superfer 800 exposed to air at 900°C for 50 cycles.

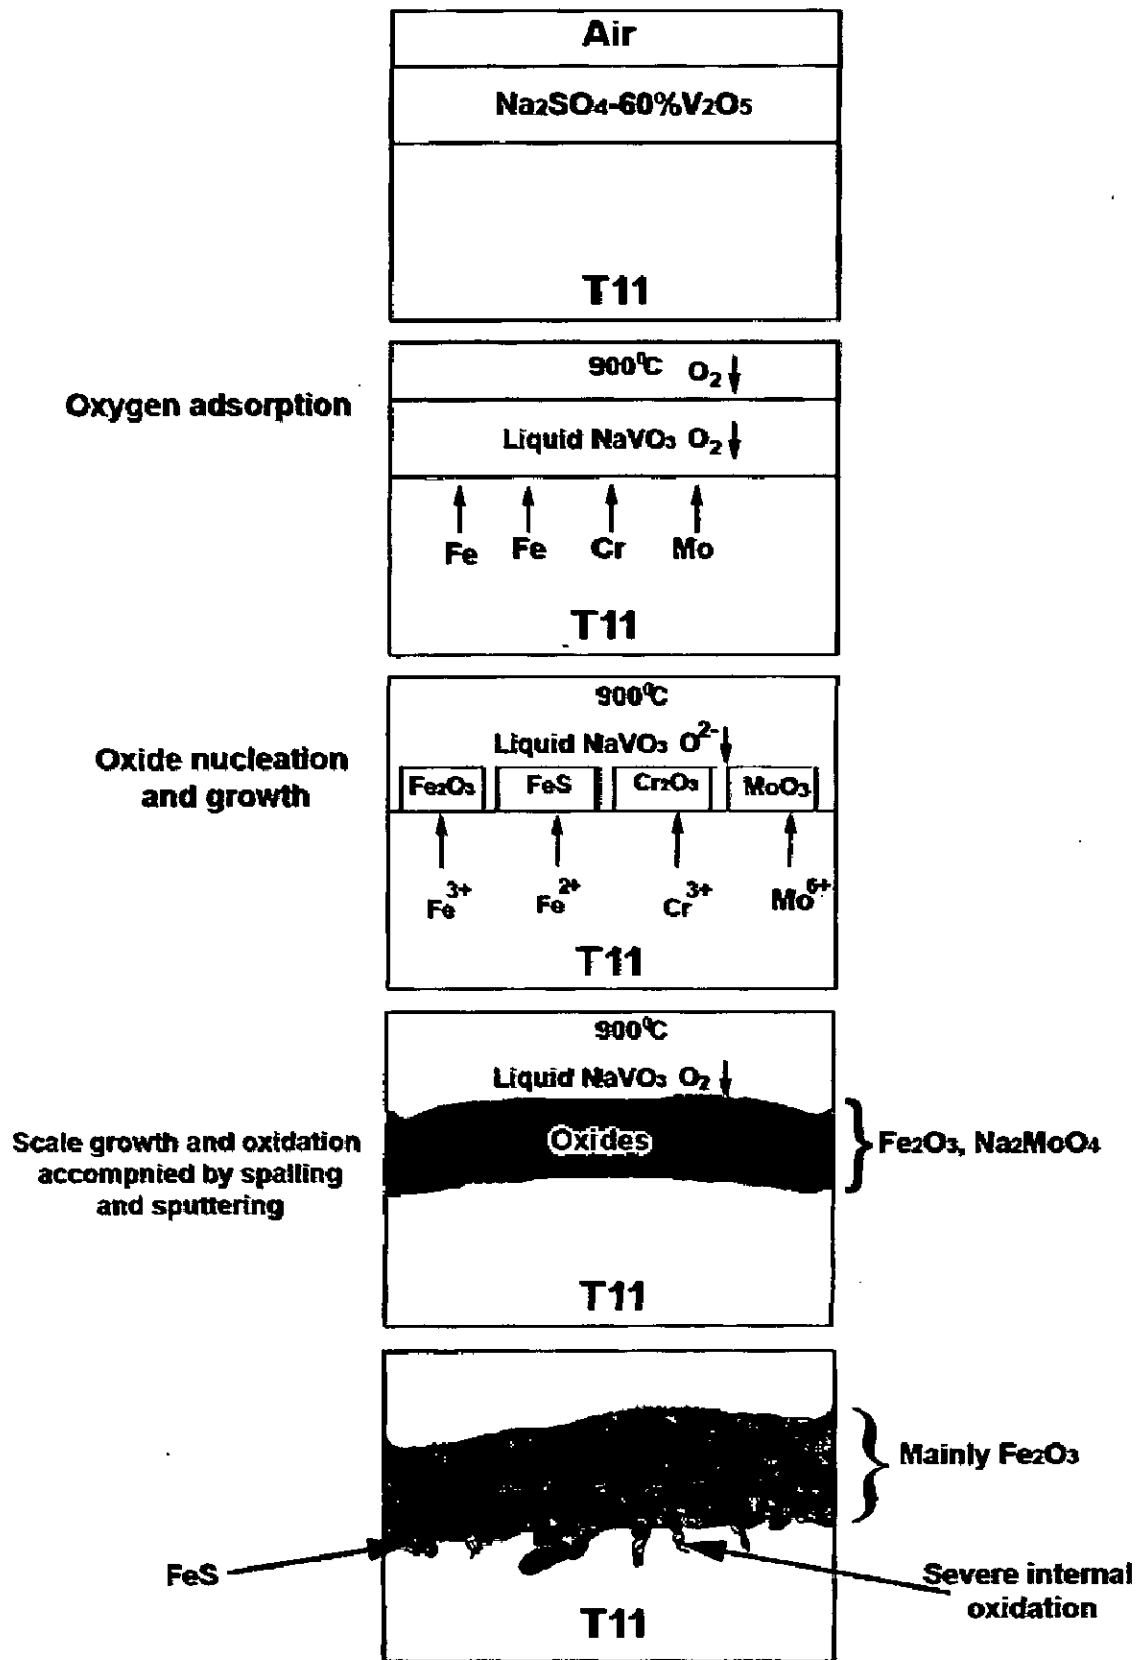
Fig. 6.84: Schematic diagram showing probable mode of hot corrosion attack on Boiler steel T11 exposed to $\text{Na}_2\text{SO}_4\text{-60\%V}_2\text{O}_5$ environment at 900°C for 50 cycles.

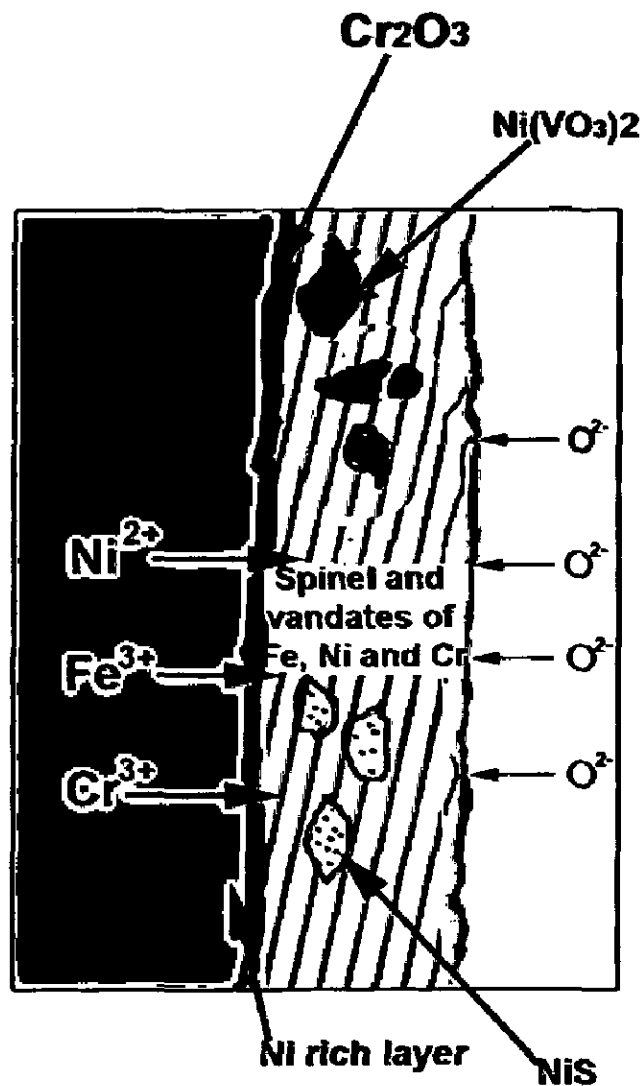
Fig. 6.85: Schematic diagram showing probable mode of hot corrosion attack on Ni based superalloy exposed to Na_2SO_4 -60% V_2O_5 environment at 900°C for 50 cycles.

Fig. 6.85 shows the schematic representation of possible hot corrosion mode of attack in Na_2SO_4 -60% V_2O_5 environment on Ni based superalloys. The surface XRD has indicated

the formation of NiO, Fe₂O₃, Cr₂O₃, FeV₂O₄ and Ni (VO₃)₂ phases. The presence of spinel NiCr₂O₄ has been revealed in Superni 600 superalloy. Through cracks internal penetration has occurred. There is thick scale formation with visible severe internal attack as revealed by X-ray mapping (Fig. 6.58) of the cross-section of superalloy Superni 600 subjected to cyclic hot corrosion in Na₂SO₄-60%V₂O₅ at 900°C for 50 cycles. As oxygen is present throughout the scale, it can be inferred that there is formation of iron oxide, nickel oxide and chromium oxide throughout the scale. Cr₂O₃ formed is providing protection for further oxidation. Vanadium enriched band is present in the scale. Ni has diffused from the substrate and is concentrated along the substrate scale boundary and preventing further corrosion.

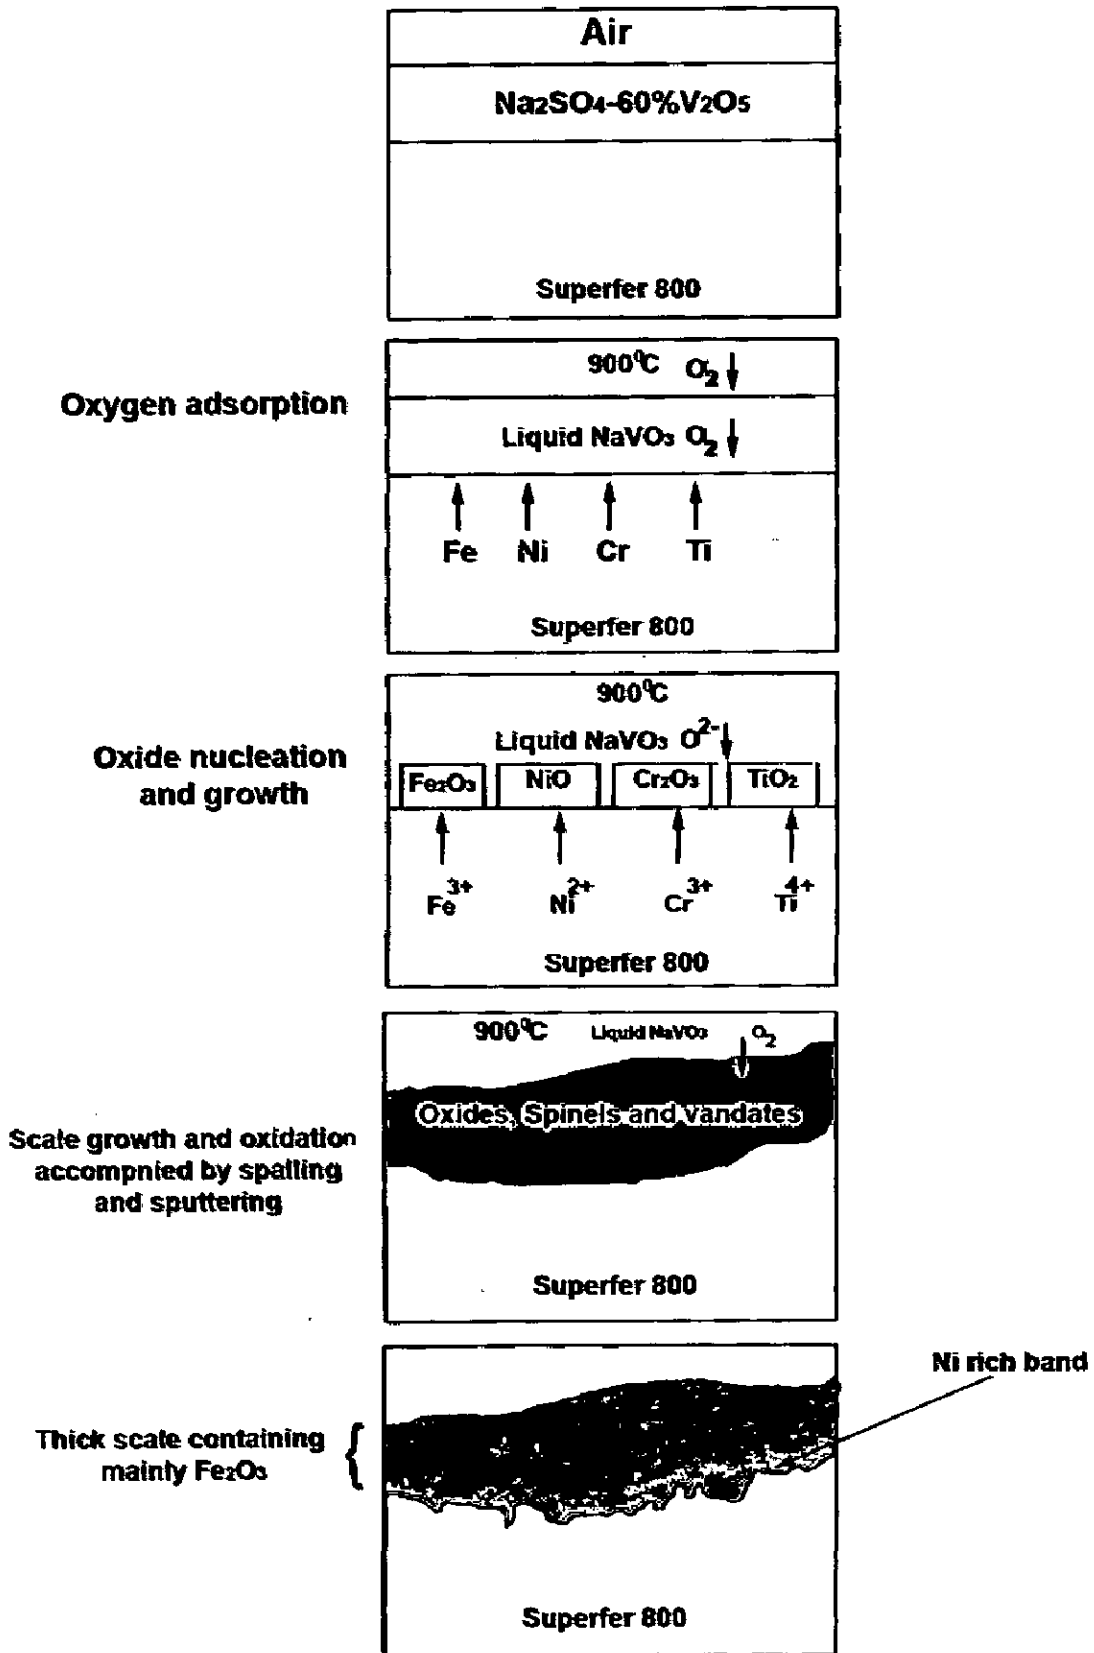
Fig. 6.86: Schematic diagram showing probable mode of hot corrosion attack on Superfer 800 superalloy exposed to Na₂SO₄-60%V₂O₅ environment at 900°C for 50 cycles.

In case of hot corroded Superfer 800 phases identified are Fe₂O₃, NiO, NiCr₂O₄, and FeV₂O₄. Formation of iron vanadate has been revealed in case of Superfer 800. Scale formed is porous and fragile with higher percentage of Fe₂O₃ and some amount of Chromium oxide and Ni oxide. Nickel concentration has increased in the substrate along substrate scale interface in the shape of thin band which has prevented the further oxidation as Cr has migrated to form the Cr₂O₃ scale. Cr has come from substrate to form irregular Cr₂O₃ band leaving a Ni rich band in the substrate which is clearly visible in the overlapped map as shown in Fig. 6.60. The schematic representation of possible hot corrosion mode of attack in Na₂SO₄-60%V₂O₅ environment on Superfer 800 superalloy is shown in Fig. 6.86.

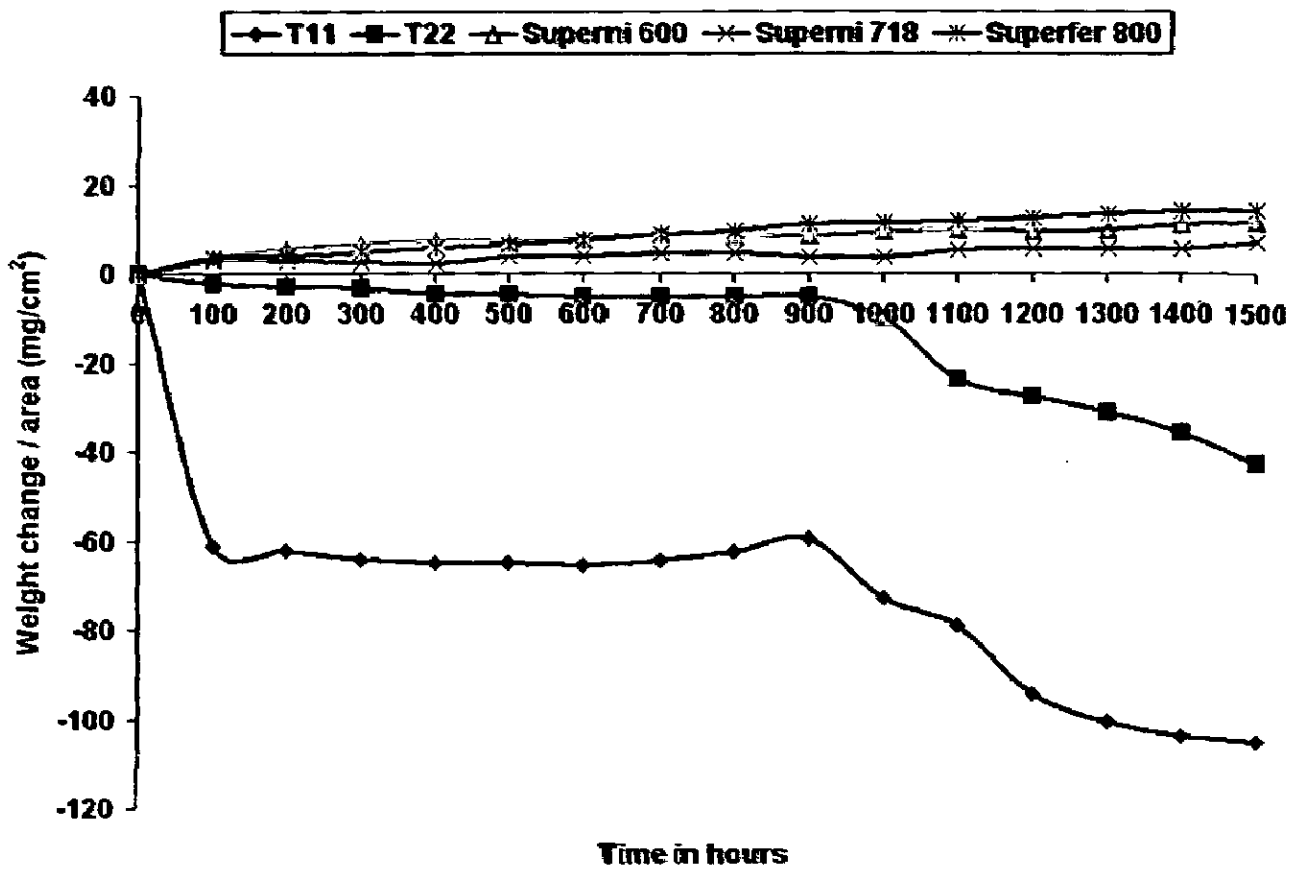
Fig. 7.2: Weight change plot for uncoated alloys exposed to superheater of the coal fired boiler for 1500 hours at 700°C.

Assessment of the weight change was carried out after exposure at 700°C in boiler conditions on uncoated substrate alloys. The weight change consists of weight gain owing to the formation of the oxide scale and weight loss due to solid particle erosion and the suspected spalling and fluxing of the oxide scale. The net weight change of the substrate alloys in the given environment represents the combined effect of erosion and corrosion. Weight change per unit area expressed in mg/cm^2 has been plotted as a function of time expressed in hours for substrate alloys as shown in Fig.7.2. Due to severe spalling and cracking boiler steels have shown decrease in weight. Initially the weight loss is very fast due to cracking and peeling off of surface scale, then it remained almost constant for few cycles and then again weight loss was steep. While all the superalloys have shown increase in weight. The extent of erosion-corrosion has been measured in terms of metal layer lost due to scaling after 1500 hours exposure. The thickness of metal lost is 2.0782 mm and 1.7117 mm in T11 and T22 steels respectively while in case of superalloys, thickness loss is 0.2178, 0.2301 and 0.2588 mm for Superni 600, superni 718 and Superfer 800 respectively as indicated in Fig.7.3. The weight gain of the samples owes to the formation of oxide scale and deposition of fly ash and weight loss is due to continuous erosion due to fly ash and other erosive particles in the blast. Throughout the study, boiler steels suffered a weight loss. The corresponding degradation rates expressed in mils per year (mpy) and are found to be 478.13, 393.81, 50.11, 52.94 and 59.54 for T11, T 22, Superni 600, Superni 718 and Superfer 800 respectively.

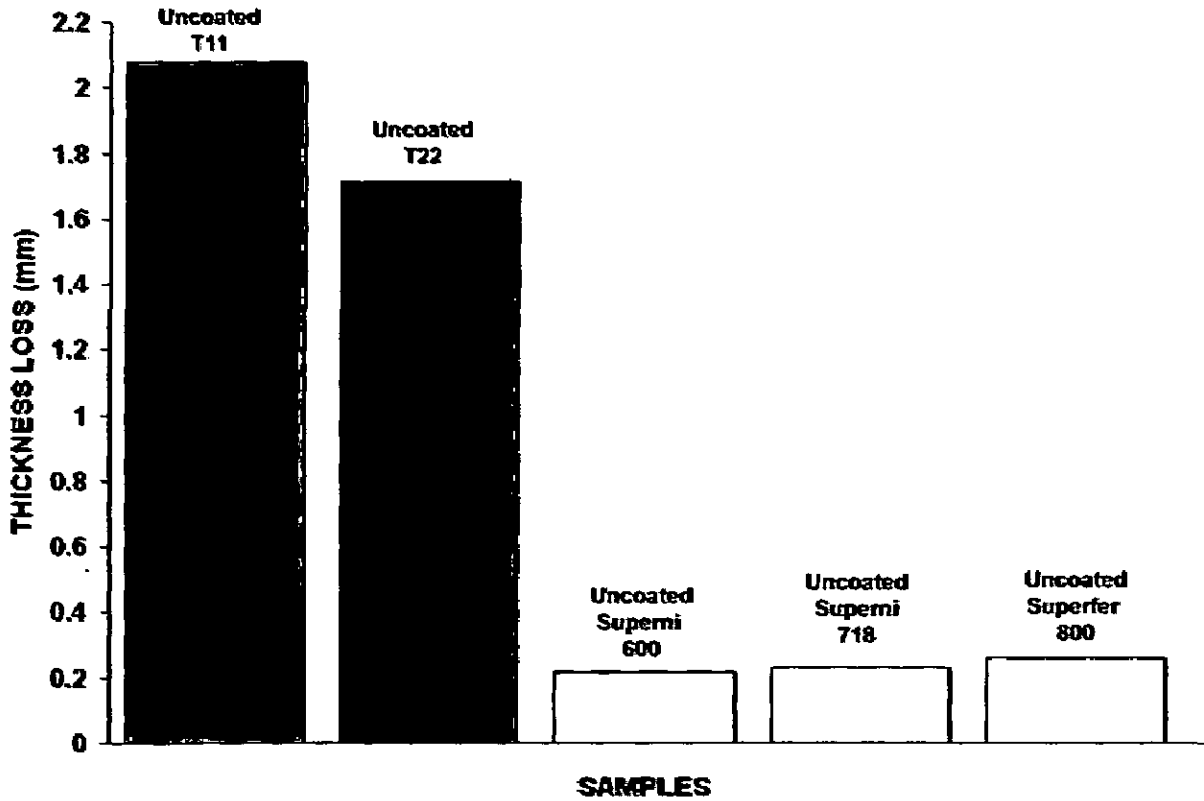
Fig. 7.3: Bar chart indicating the thickness lost in mm by the uncoated alloys after 1500 hours exposure to the coal fired boiler at 700°C.

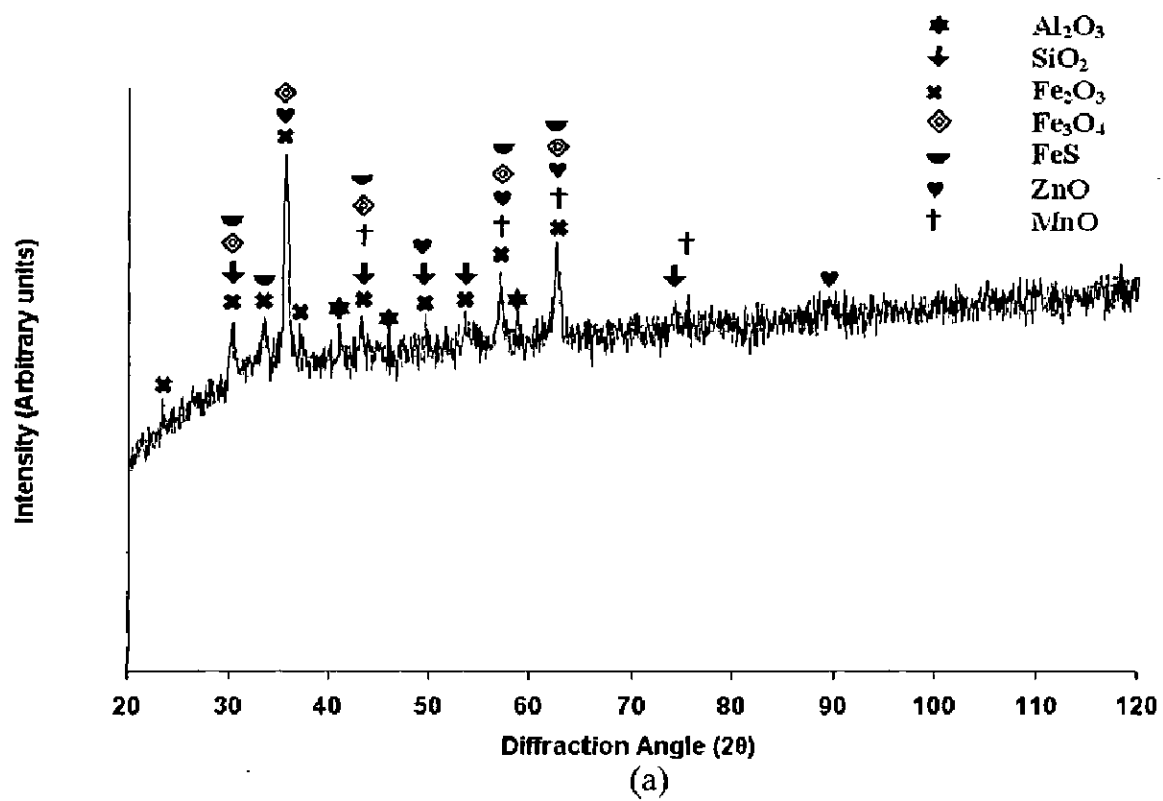
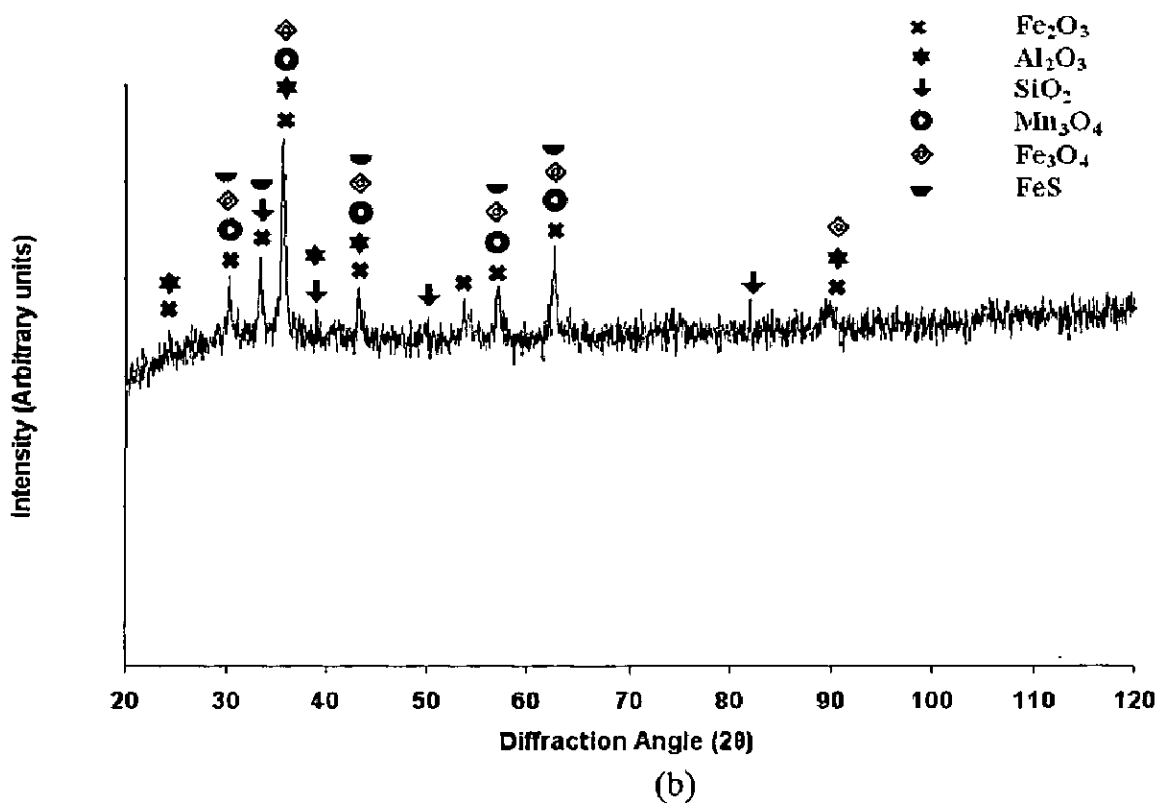
Fig. 7.4: X-ray diffraction profiles for boiler steels exposed to superheater of the coal fired boiler for 1500 hours at 700°C.
 (a) T11 (b) T22

The X-ray diffractograms for T11, T22, Superni 600, Superni 718 and Superfer 800 substrate alloys after exposure to actual boiler environment for 1500 hours are shown in Fig. 7.4-7.6 respectively. In the boiler environment, T11 and T22 steels have indicated Fe_2O_3 and Fe_3O_4 as the main constituent. FeS was also detected and minor peaks of Al_2O_3 , SiO_2 , ZnO and MnO which is indicative of deposition of fly ash on the surface of exposed steel as shown in Fig. 7.4. In case of superalloys shown in Fig. 7.5 and Fig. 7.6, Ni is main constituent in the scale with peaks of Fe_2O_3 , NiO, Al_2O_3 , SiO_2 and NiFe. In case of Superfer 800, Cr_2O_3 phase is also observed.

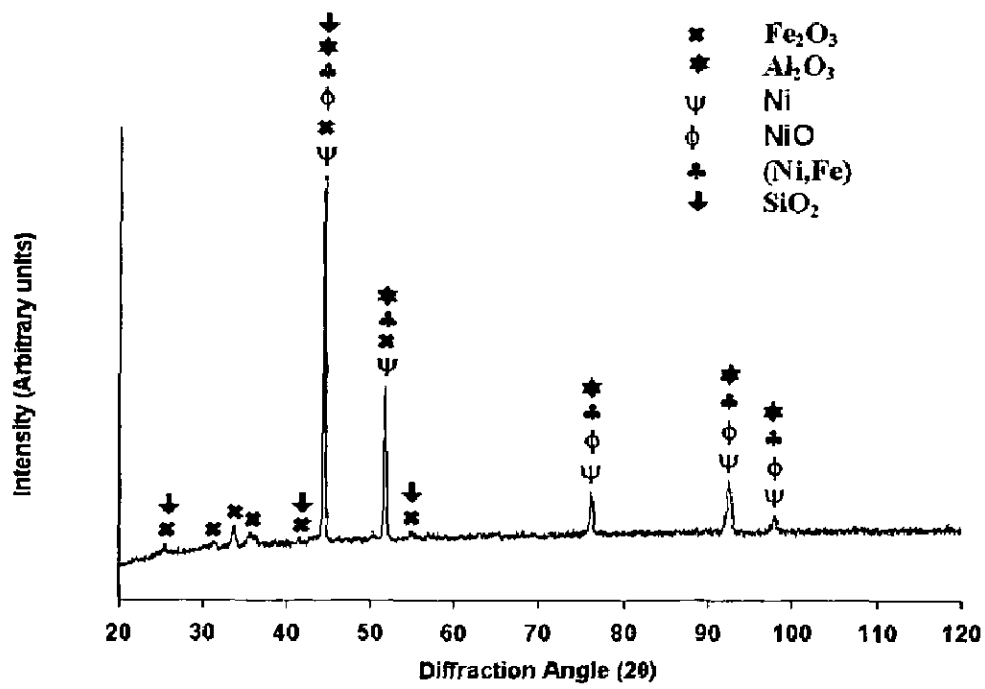
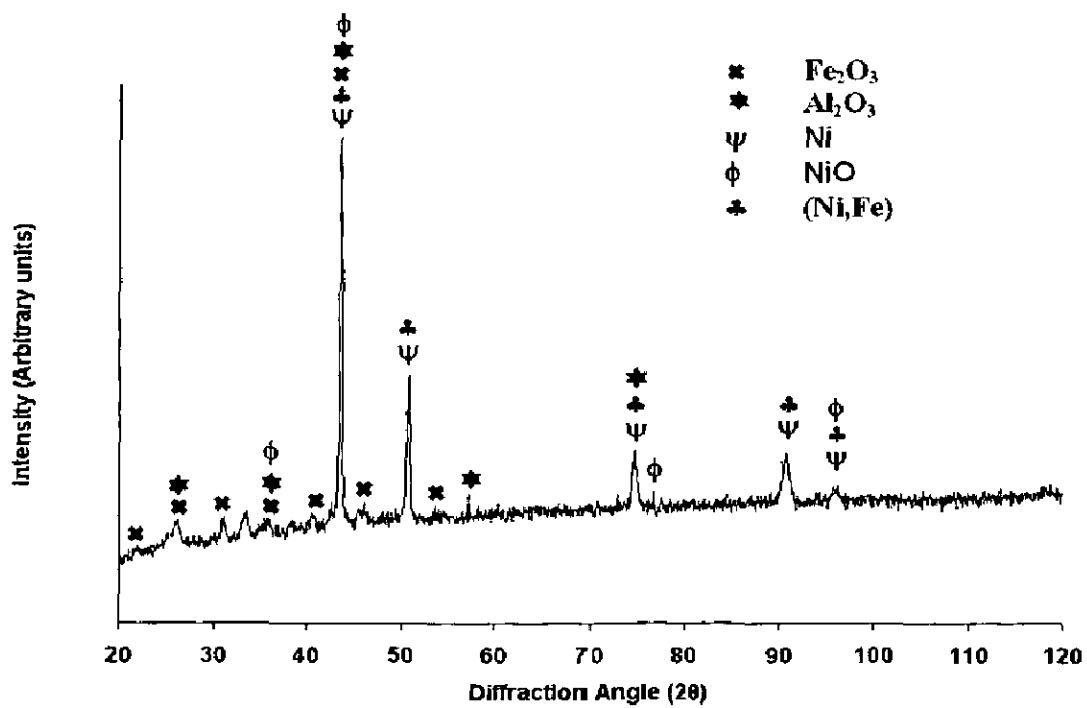
Fig. 7.5: X-ray diffraction profiles for superalloys exposed to superheater of the coal fired boiler for 1500 hours at 700°C.
 (a) Superni 600 (b) Superni 718

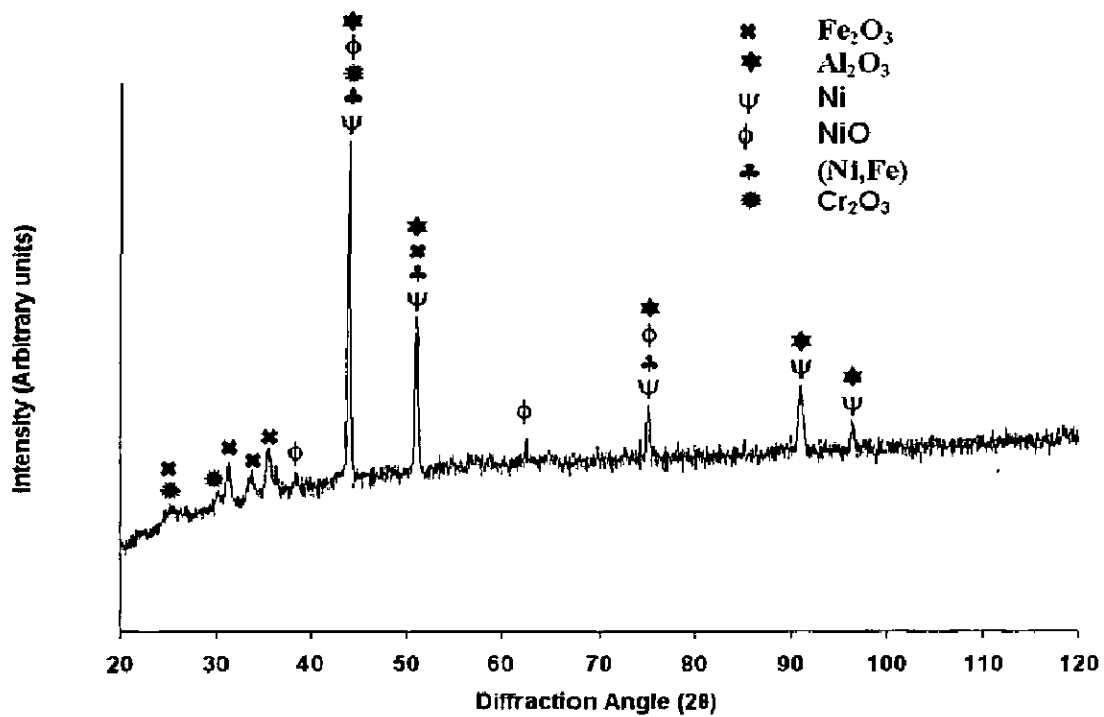
Fig. 7.6: X-ray diffraction profiles for superalloy Superfer 800 exposed to superheater of the coal fired boiler for 1500 hours at 700°C.

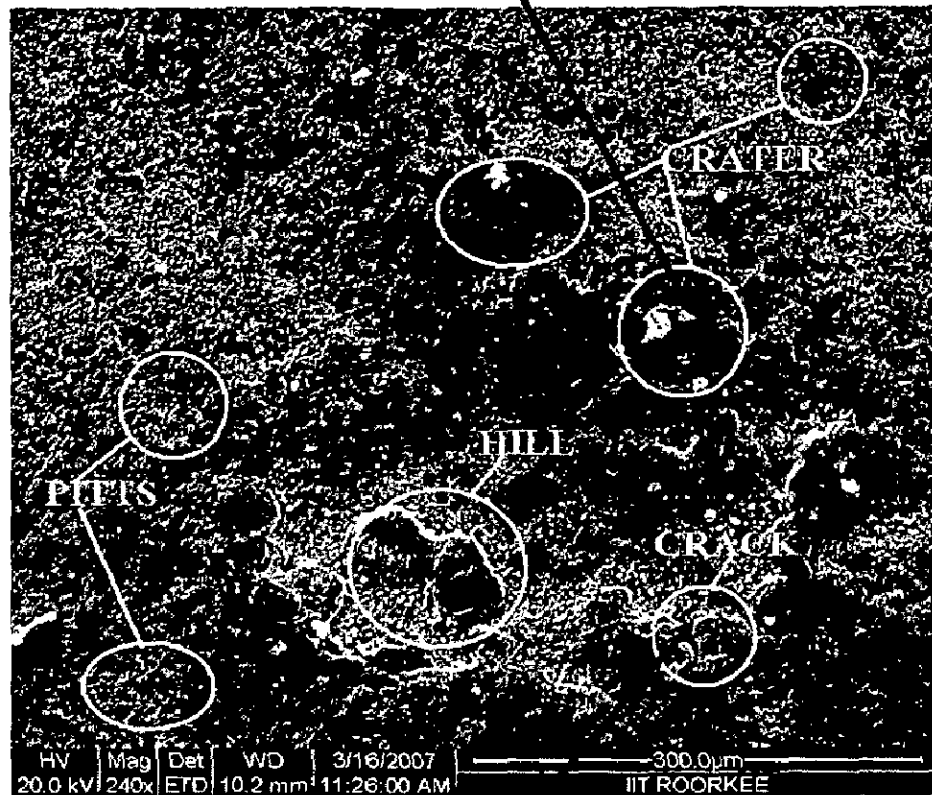
Element	Wt %
O	31.48
Al	08.50
Si	09.28
Ca	00.58
Mg	00.09
Ti	00.98
Fe	47.14
Zn	01.95

Fig. 7.8: Surface scale morphology and EDX analysis for boiler steel T22 exposed to superheater of the coal fired boiler for 1500 hours at 700°C.

SEM/EDX analysis was used for the detection of presence of corrosion products and corrosion-inhibiting species and their concentrations. Scale development and the effect of boiler conditions on the exposed surface was studied. The surface scale morphology and the EDX analysis for substrate alloys exposed to superheater region of coal fired boiler after 1500 hrs is shown in Fig.7.7-7.11. From SEM/EDX analysis of boiler steels T11 and T22 it has been revealed that the main constituent of scale are Fe, Al, Si and O as shown in Fig. 7.7 and 7.8. The oxide scale formed was porous and less adherent consisting mainly of iron oxide. On thin bands of the matrix phase, large bulbous oxides formed, protruding well above the surface. The micrograph indicates massive scale along with presence of embedded ash at some points and nodules are also present. There is a presence of pits and cracks in scale and also hills and craters are formed which is a clear indication of combined effect of erosion and corrosion caused by combined action of flue gases along with impact of fly ash. Rapid growth of iron oxide in the matrix region of the boiler steels led to much thicker scale formation. The EDX analysis of surface scale revealed the presence of Si, Al, Fe, Na, Ca, Mg along with O which are the constituents of fly ash. Some ash particles can be seen embedded in the scale as white colour nodules. In case of boiler steels steel exposed to boiler conditions micrographs indicates a continuous granular scale consisting mainly of Fe, Si and Al along with O. The appearance of scale in case of boiler steels is highly bulky, porous with a continuous network of cracks along the scale.
