STUDY OF DETONATION GUN COATED ALLOYS FOR RESISTANCE TO EROSION AND CORROSION

A THESIS

METALLURGICAL AND MATERIALS ENGINEERING

This thesis investigates the erosion and corrosion performance of Al_2O_3 -3 wt % TiO_2 thermal spray coatings deposited by detonation gun technique. As-sprayed coatings were characterized by using the combined techniques of optical microscopy, microhardness testing, X-ray diffractometry (XRD) and scanning electron microscopy/energy-dispersive analysis (SEM/EDX). The corrosion performance was evaluated in oxidising and molten salt environment and also in actual working conditions of boiler. The erosion performance was evaluated at room temperature conditions as well as under high temperature conditions, high erodent velocity, and actual boiler conditions. The corrosion behavior and morphological development were investigated by weight change kinetics, metallographs, depths of attack, metal thickness losses, and XRD analyses.

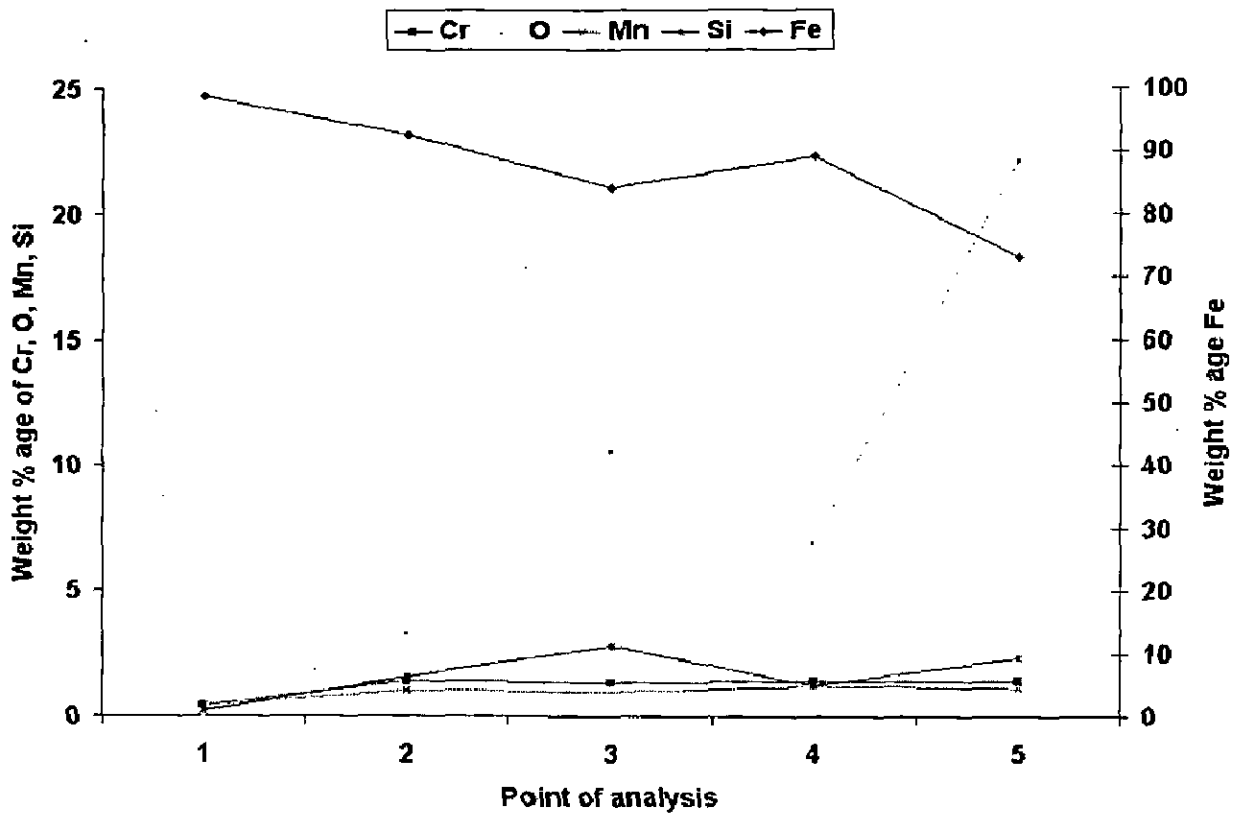
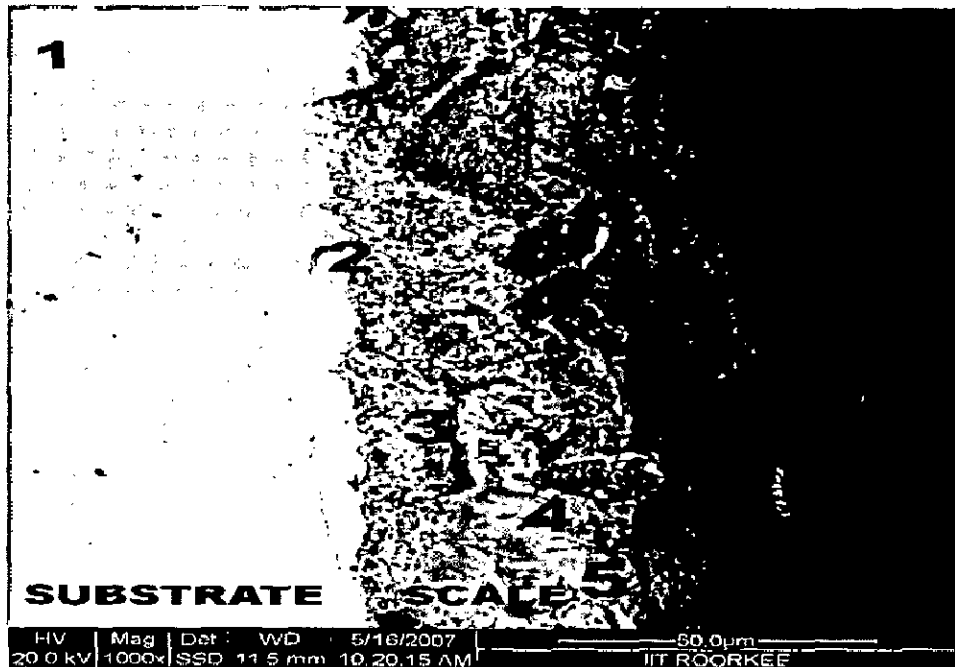
Fig. 7.12: Oxide scale morphology and elemental composition variation across the cross-section of T11 boiler steel exposed to superheater of the coal fired boiler for 1500 hours at 700°C

The BSE image and the EDX analysis across the cross section of uncoated alloys are shown in Fig.7.12 to Fig.7.16. In case of boiler steels, (Fig. 7.12 and 7.13) the scale was quite fragile and porous and was continuously peeled off from the surface.

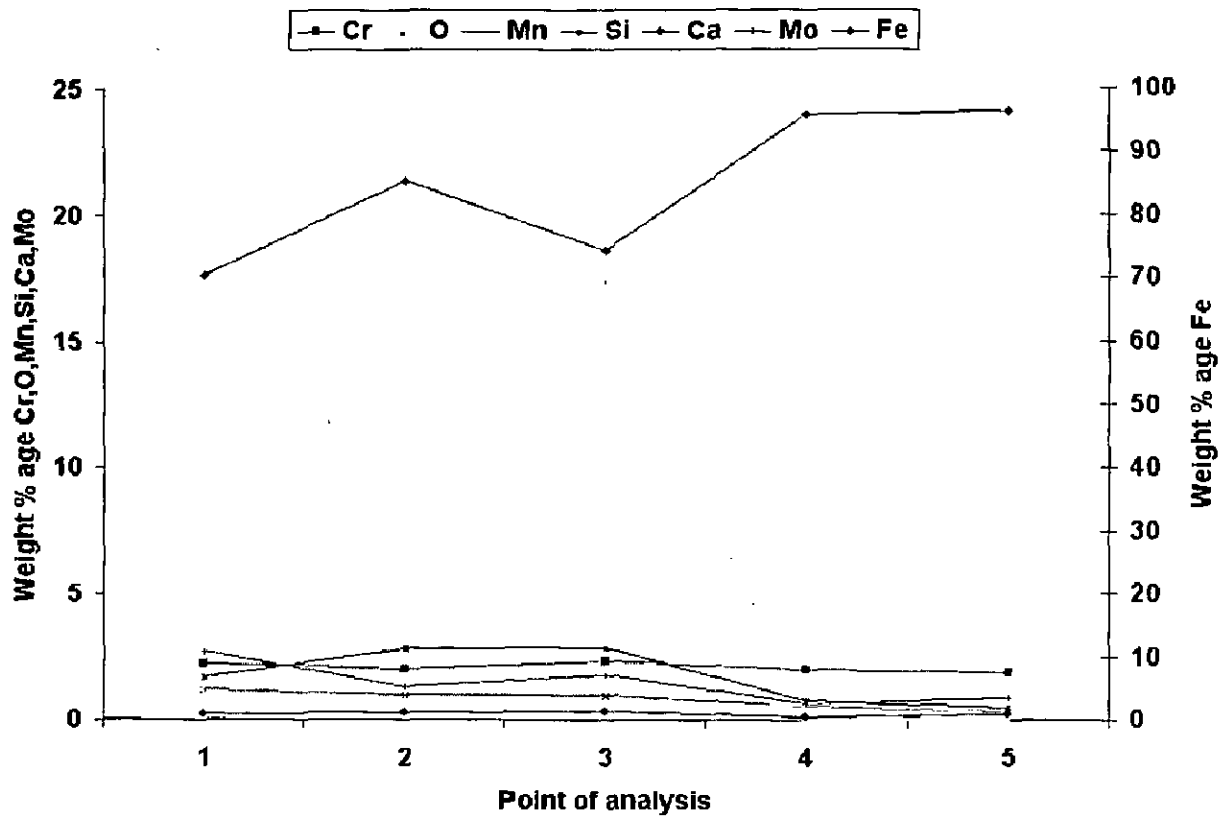
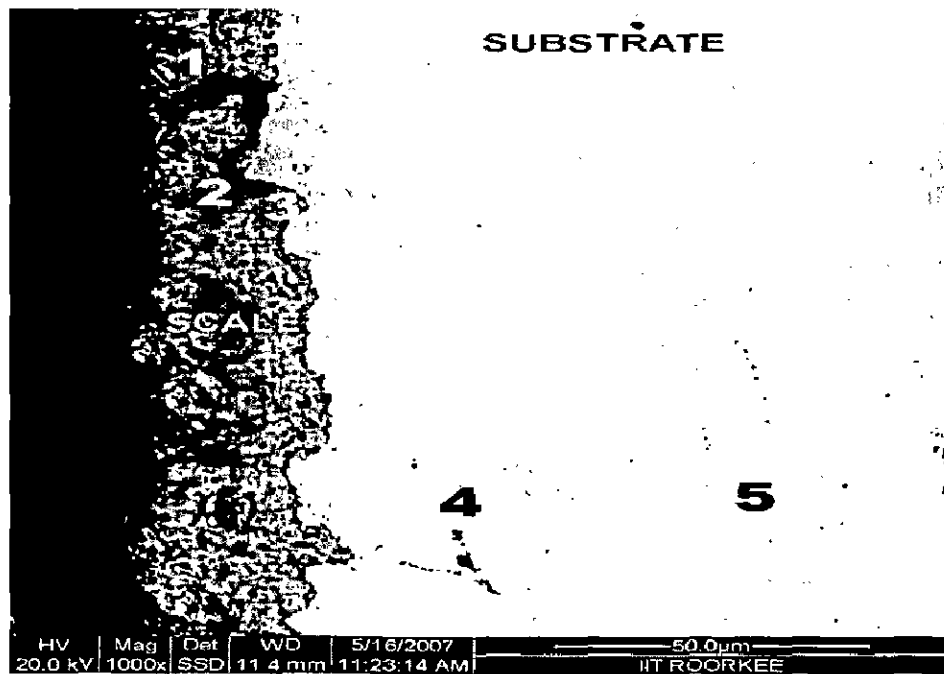
Fig. 7.13: Oxide scale morphology and elemental composition variation across the cross-section of T22 boiler steel exposed to superheater of the coal fired boiler for 1500 hours at 700°C.

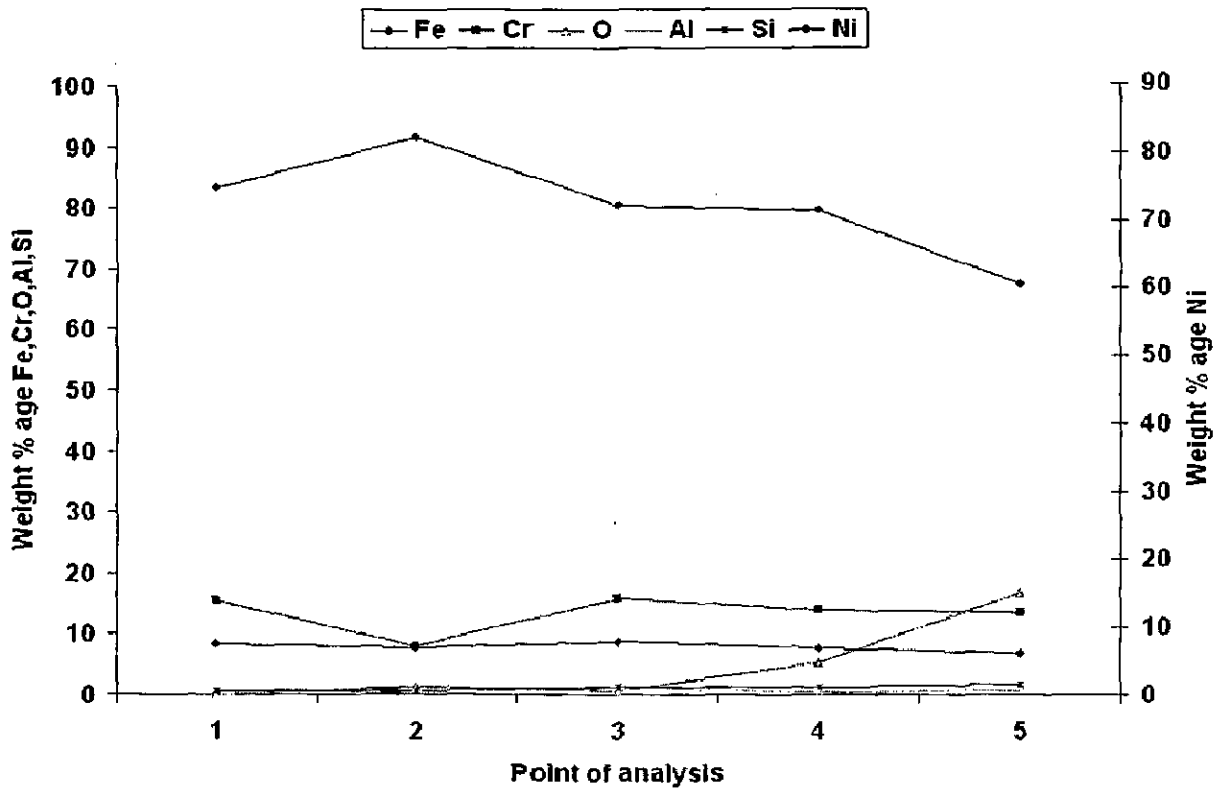
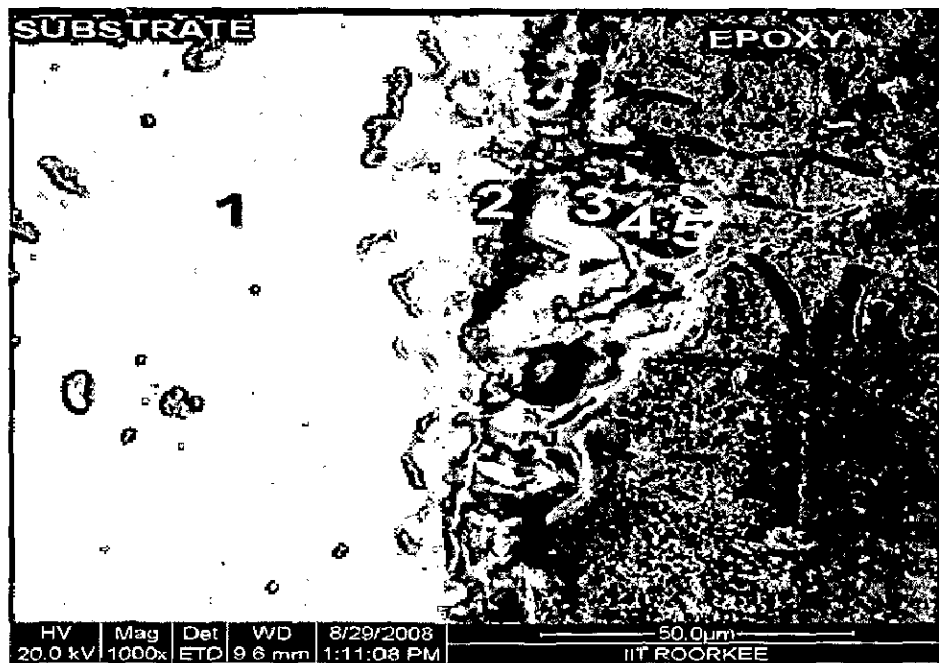
Fig. 7.14: Oxide scale morphology and elemental composition variation across the cross-section of Superni 600 superalloy exposed to superheater of the coal fired boiler for 1500 hours at 700°C.

The cross sectional morphology and the corresponding EDX analysis (Fig. 7.14 to Fig. 7.16) for Superni 600, Superni 718 and Superfer 800 superalloys after 1500 hrs exposure to actual environment of coal fired boiler has revealed that the scale mainly consisted of Ni and Fe along with oxygen. Oxygen along with chromium is present throughout the scale in all the superalloys. Also minor percentage of Al and Si is present throughout the scale in all superalloys.

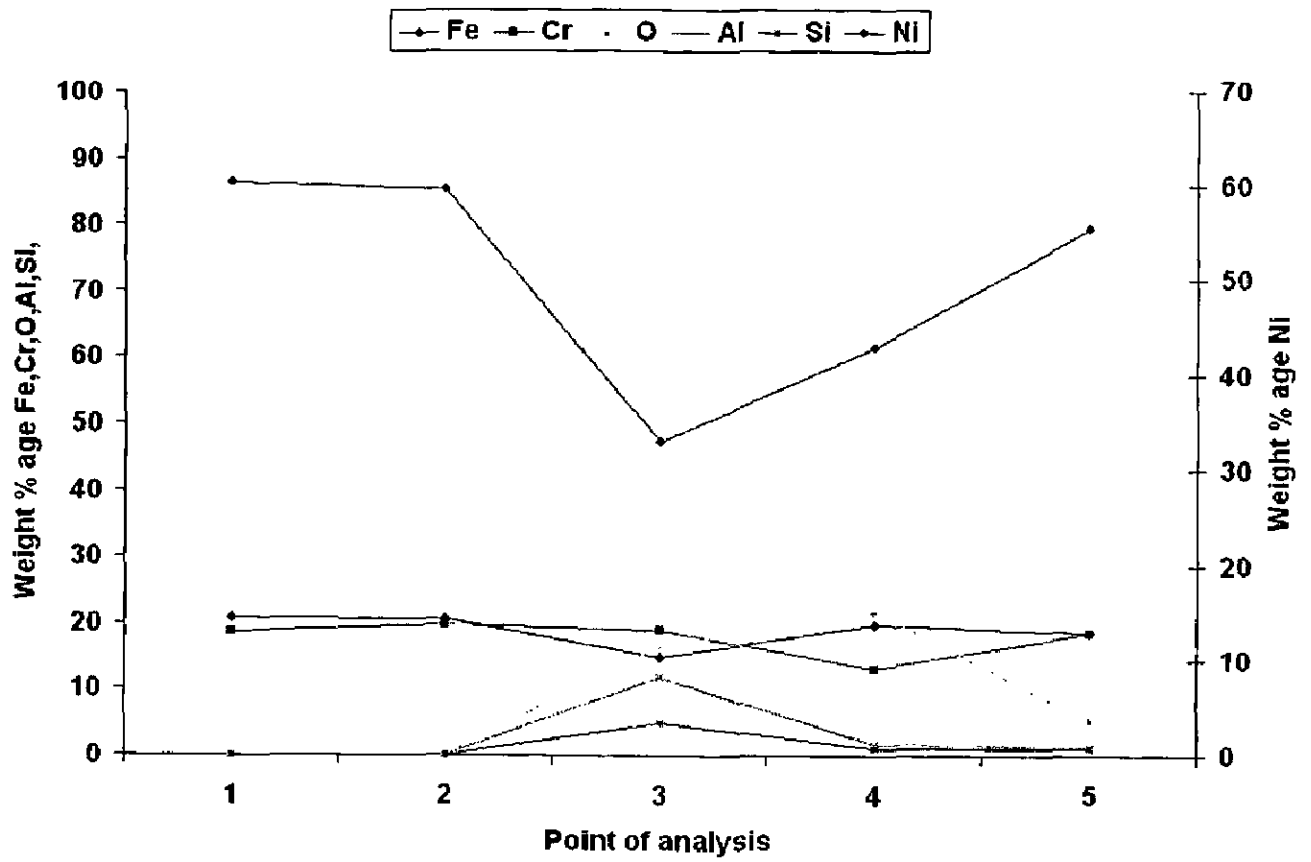
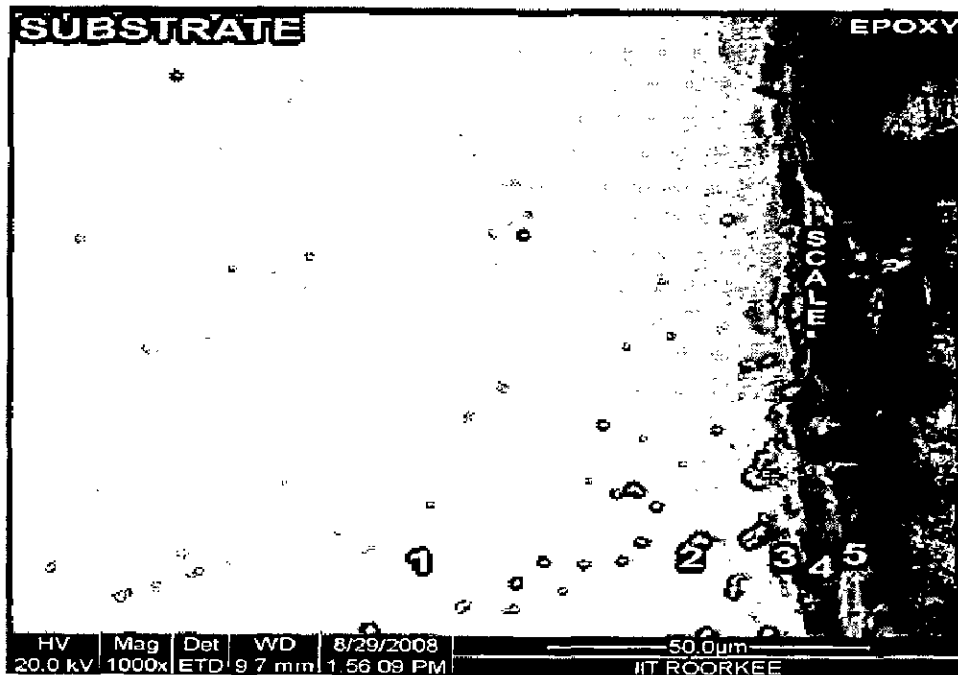
Fig. 7.15: Oxide scale morphology and elemental composition variation across the cross-section of Superni 718 superalloy exposed to superheater of the coal fired boiler for 1500 hours at 700°C

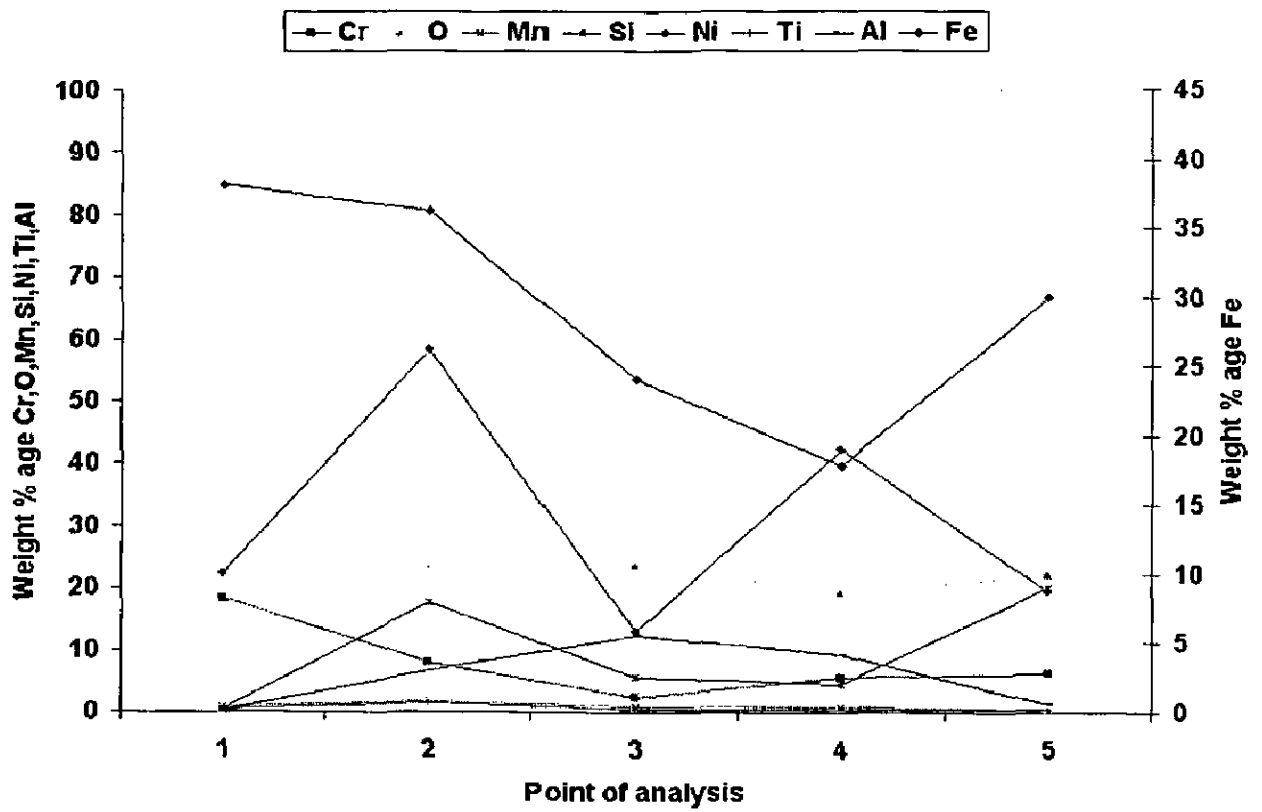
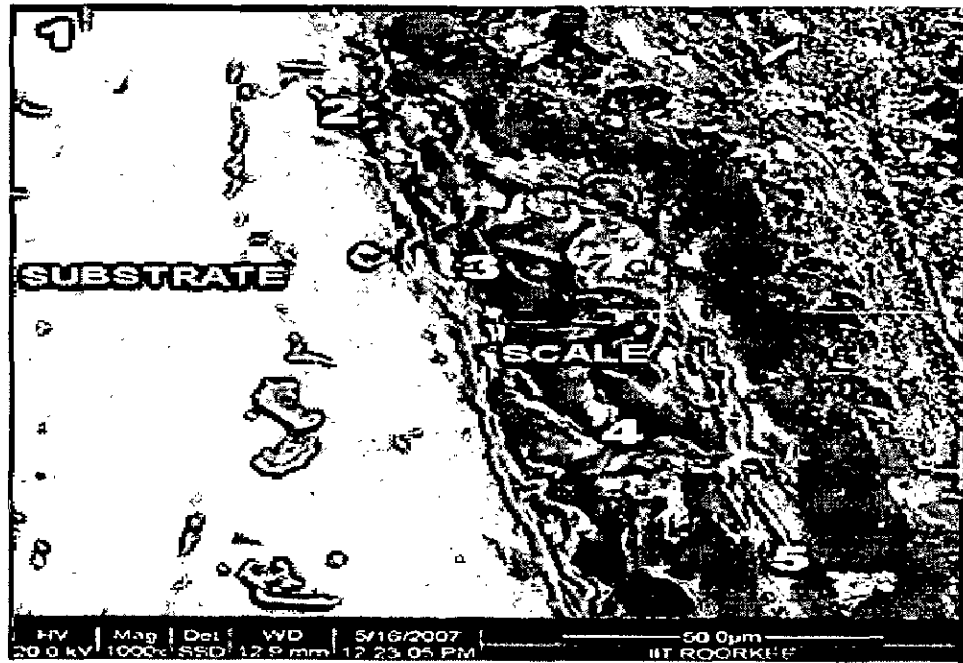
Fig. 7.16: Oxide scale morphology and elemental composition variation across the cross-section of Superfer 800 superalloy exposed to superheater of the coal fired boiler for 1500 hours at 700°C.

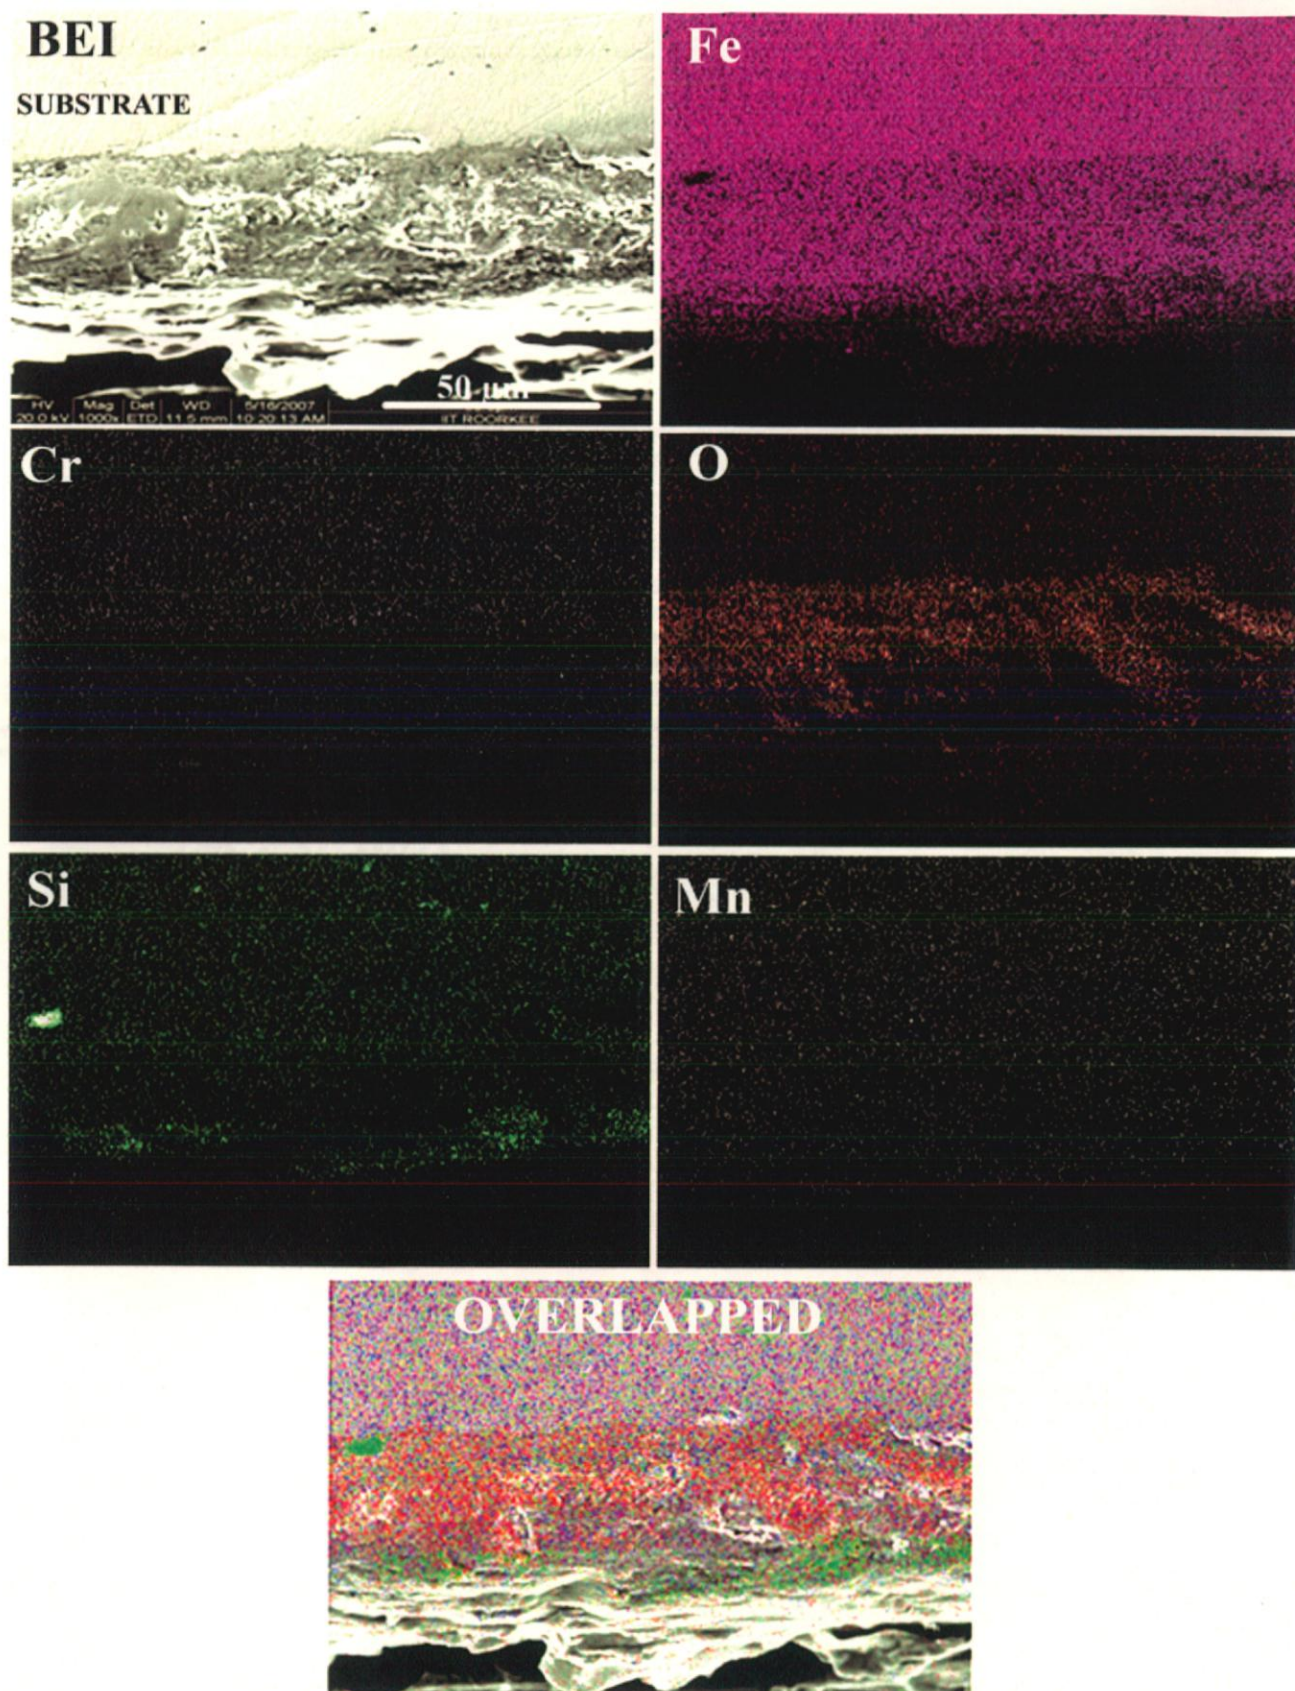
Fig. 7.17: Back scattered electron image and the corresponding x-ray mappings of cross section of uncoated T11 steel after 1500 hours exposure in boiler.

Back Scattered Electron Image of cross-section of uncoated substrate alloys (T11, T22, Superni 600, Superni 718 and Superfer 800) and corresponding X-ray mapping after 1500 hours exposure to boiler environment is shown in Fig.7.17 to 7.21 respectively. There is presence of ash particles indicated by presence of Al and Si with oxygen on the top surface of the scale. In boiler steels, mainly iron oxide is formed. At the top of scale Si is spread throughout the scale indicating ash embedment. Continuous spalling of scale was observed during the cyclic exposure. In case of boiler steel T11 (Fig.7.17), iron oxide remained the main constituent of the scale with presence of minor concentration of Mn, Cr and Si. In elemental maps, a thick Silica particle could be seen embedded in the scale and silica is also observed in the top of the scale. In boiler steel T22, (Fig. 7.18) main constituent is iron oxide with presence of minor concentration of Cr and Si. There is very thin Cr rich band just above the substrate scale interface.

The XRD and EDX analysis has shown the presence of ash deposits on the surface of the specimens. The interaction of ash with the oxide scales is further supported by X-ray mapping analysis (Figs. 7.17, 7.18, 7.19, 7.20 and 7.21). The corrosion scale formed on the boiler steels was made up only of iron oxide as revealed by XRD. Some fly ash particles were also found embedded into the iron oxide layer. Cross section examination by SEM of the tested samples for 1500 hours showed that the corrosion scale was only made of iron oxide. Backscatter electron image of the corrosion scale showed presence of oxygen throughout the scale. From the surface morphologies, it can also be seen that the layer of the corrosion scale is generally porous. Porous and non adherent scale with tendency to severe spalling and cracking has been observed for the boiler steels used in present investigation. Wang (1988) has also observed severe scaling and spalling for 2.25Cr-1Mo steel during 1000 hours cyclic study at 740°C in medium-BTU coal fired boiler. Iron, silicon and aluminium in substantial amount along with oxygen were the detected elements in the surface layer suggesting interaction of ash with oxide layer. Similar observations have been reported by Harb et al. (1990), Sidhu (2003), Sidhu (2006) and Ramesh (2008). The fly ash particles embedded in the outer layer contained silicon, aluminum, oxygen and in some particles there were also small amounts of potassium, magnesium, calcium and manganese. In the study reported by Pan and Riley (2003), it was disclosed that the SA-210 (A36) steel tested at the windows on the second floor of the boiler suffered a high corrosion rate. Further during this study, use of a higher chlorine containing coal resulted in higher SA-213T-22 corrosion in the superheater area.

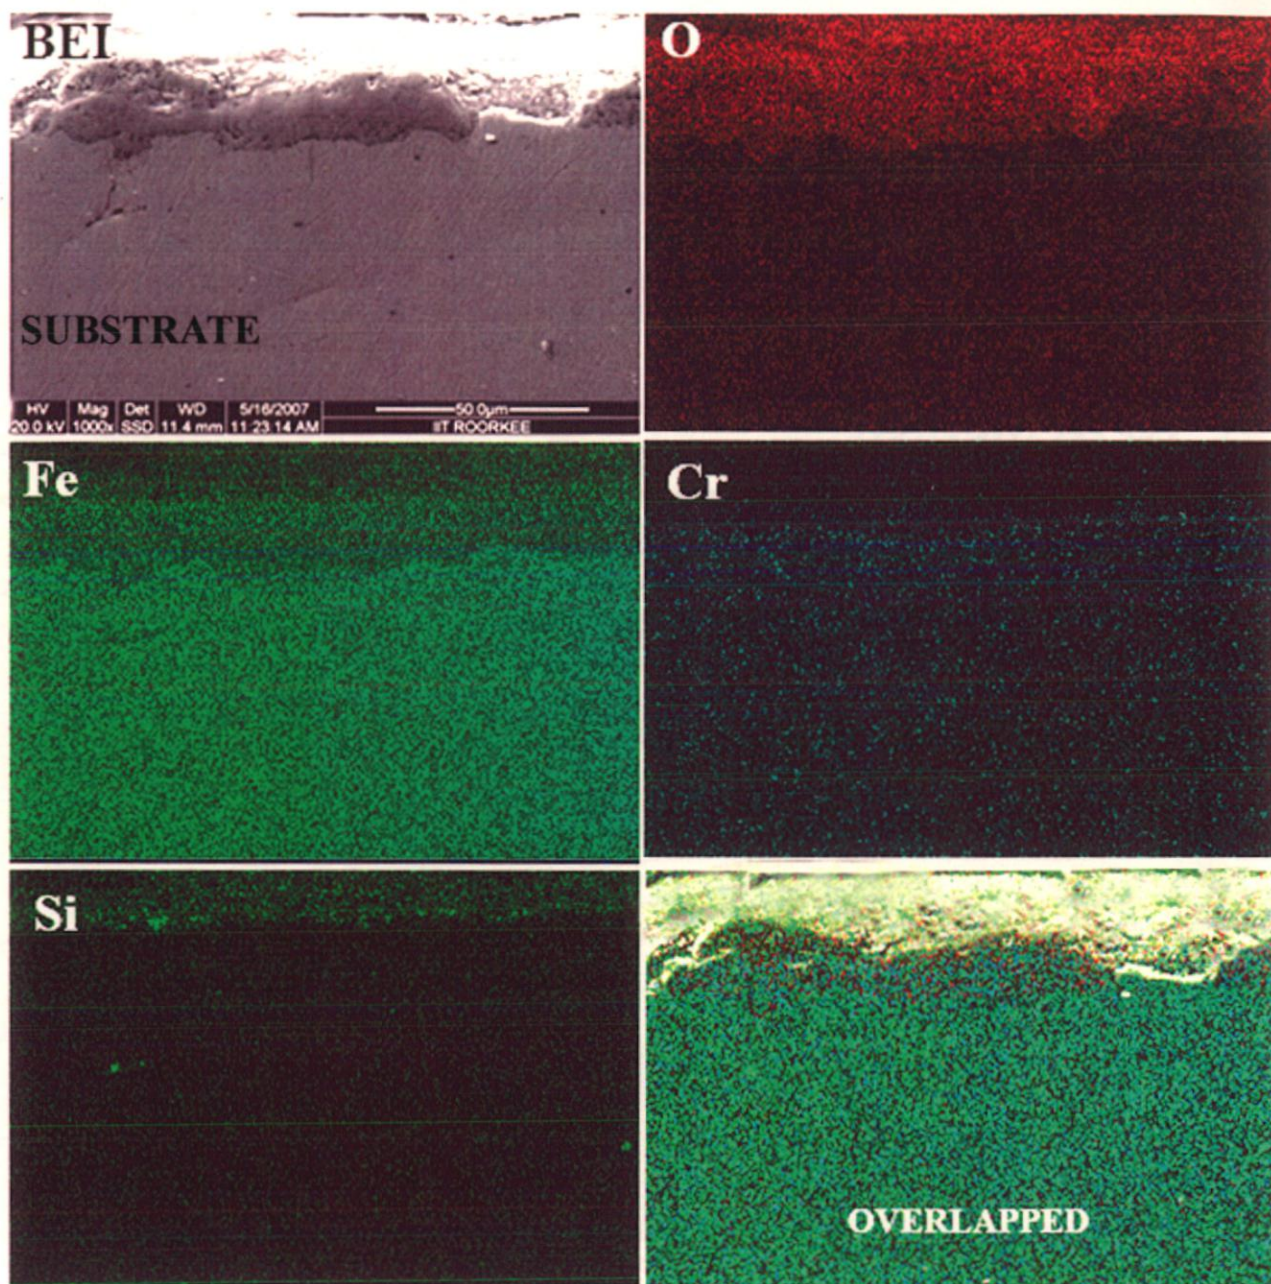
Fig. 7.18: Back scattered electron image and the corresponding x -ray mappings of cross section of uncoated T22 steel after 1500 hours exposure in boiler.

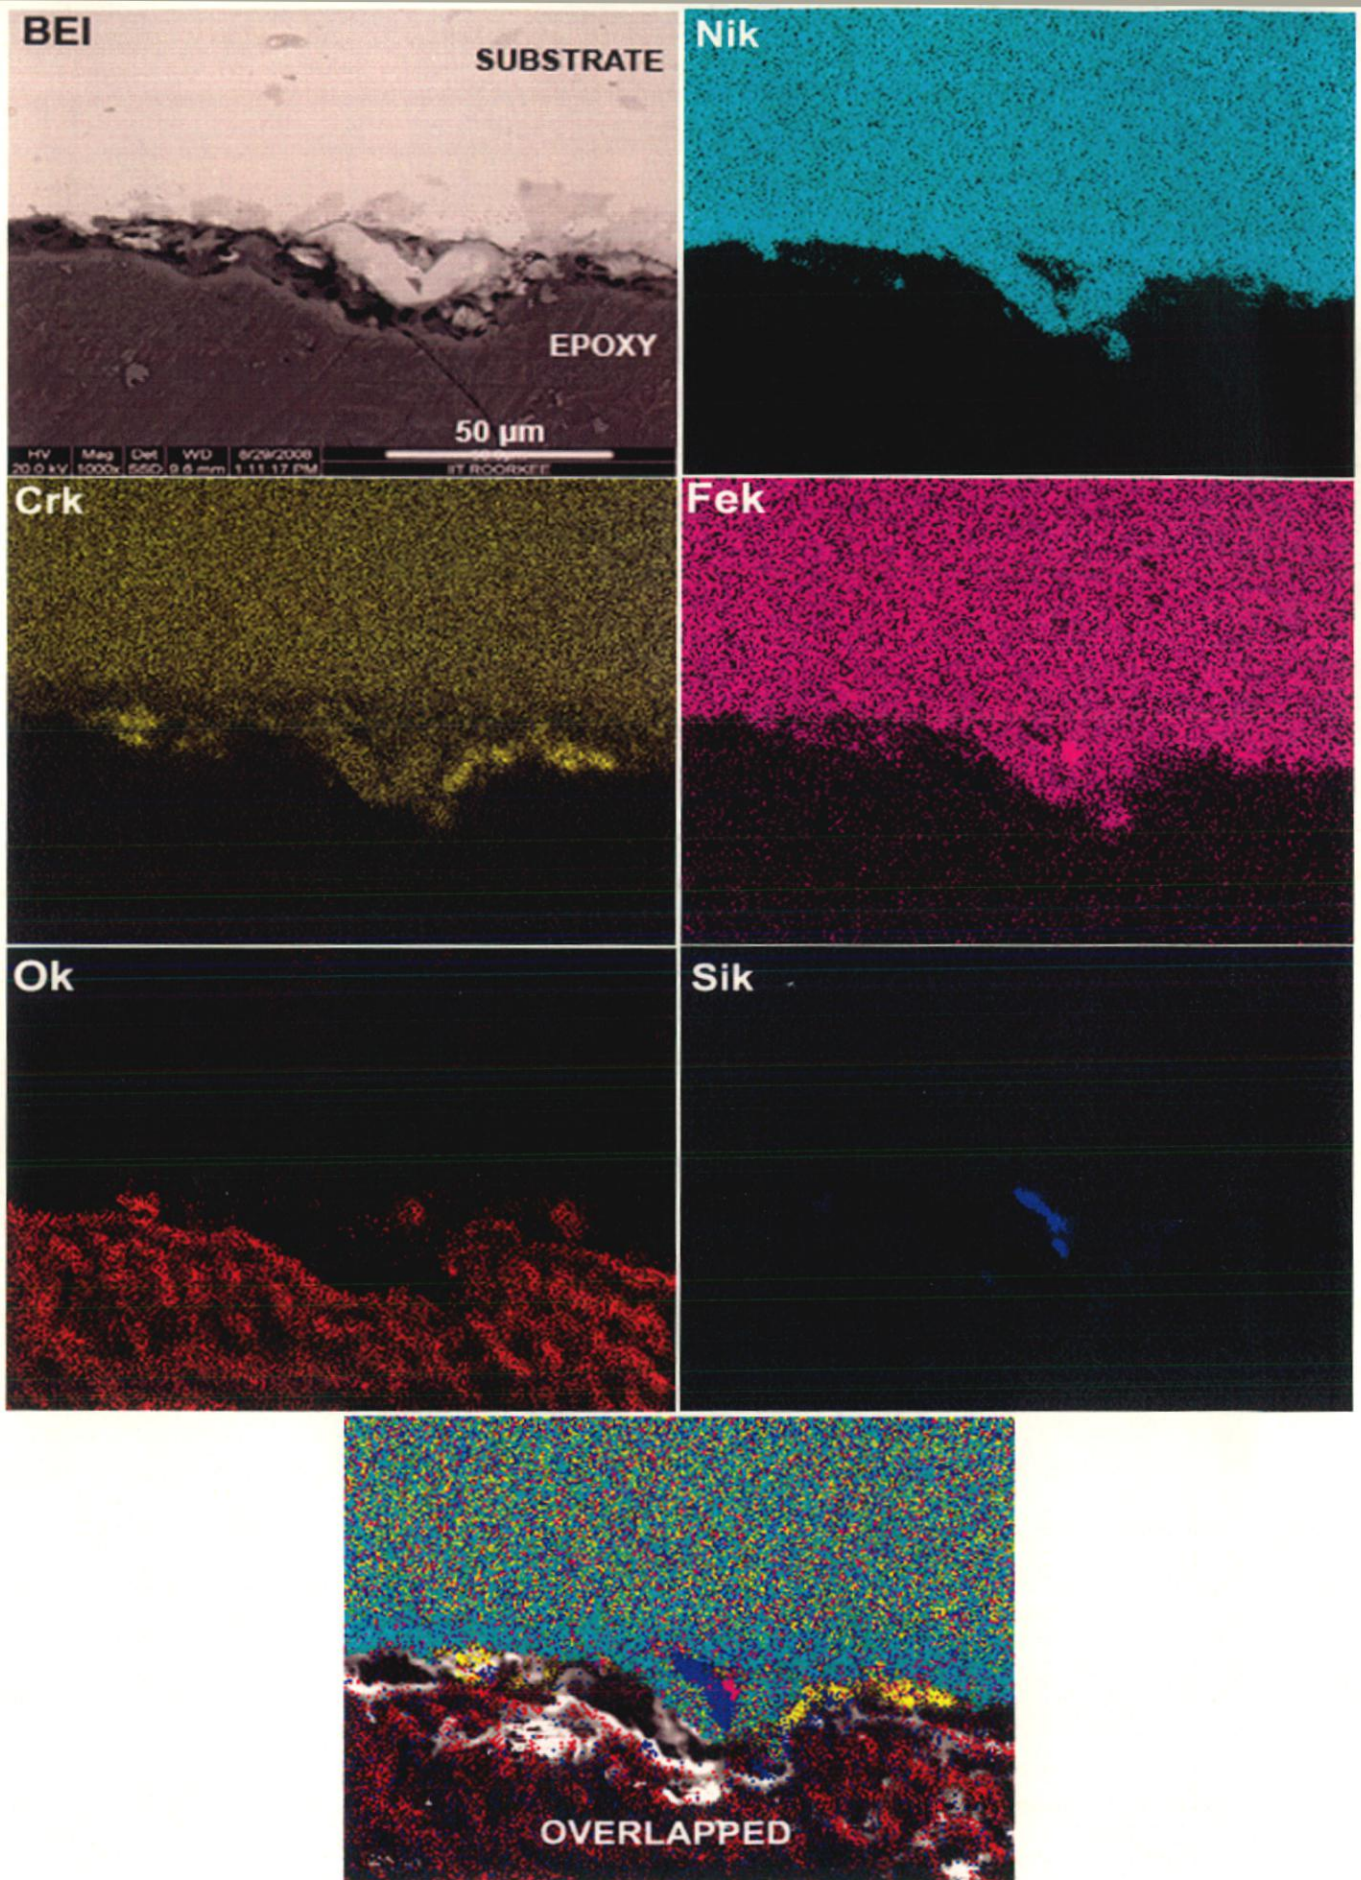
Fig. 7.19: Back scattered electron image and the corresponding x -ray mappings of cross section of uncoated superalloy Superni 600 after 1500 hours exposure in boiler.

While in all the superalloys exposed to boiler environment, a very thin scale was observed. In Superni 600, (Fig. 7.19), there is thin Ni rich band in the substrate from which Cr has depleted. This chromium is co existing with oxygen in the outer scale

thereby indicating formation of chromium oxide. There is presence of embedded silica particle which has deformed the metal. In Superni 718, (Fig. 7.20) attack is very minimal and a thin scale was observed. From X-ray mapping, streaks of silica and alumina are indicated on the top of the scale. Also Fe, Ni and Cr are coexisting with oxygen as very thin layers at the top most scale. In Superfer 800, thick scale is formed as shown in (Fig. 7.21). Ni rich layer is present in the substrate at the interface. Also Ni and Cr are coexisting with oxygen at the top of the scale. The scale by itself mainly consists of iron along with oxygen which indicates the formation of Fe_2O_3 . Si, Mg and Al particles can be seen coexisting with oxygen in the elemental maps thereby indicating embedment of ash particles.

In cross sectional analysis, in case of Superni 600, there is thin Ni rich band in the substrate from which Cr has depleted as shown in Fig. 7.19. Also there is presence of embedded silica particle. While in case of Superni 718, (Fig. 7.20) a thin scale was observed on the surface. From X-ray mapping, Fe, Ni and Cr are coexisting with oxygen as very thin layers at the top most scale. Fig 7.44 shows the schematic diagram showing probable erosion corrosion mechanism for the uncoated superalloy Superni 600 exposed to actual boiler environment at 700°C for 1500 hours. As compared to other superalloys, Superfer 800 has shown thick scale (Fig. 7.21) in which Si, Mg and Al particles can be seen coexisting with oxygen in the elemental maps. Ni rich layer is present in the substrate at the interface. Also Ni and Cr are coexisting with oxygen at the top of the scale. The scale by itself mainly consists of iron along with oxygen which indicates the formation of Fe_2O_3 . Probable erosion corrosion mechanism for the uncoated superalloy Superfer 800 exposed to actual boiler environment at 700°C for 1500 hour is shown in Fig. 7.45. In his study Mishra 2006 has also reported the embedment of fly ash particles on the top layer of the exposed surface.

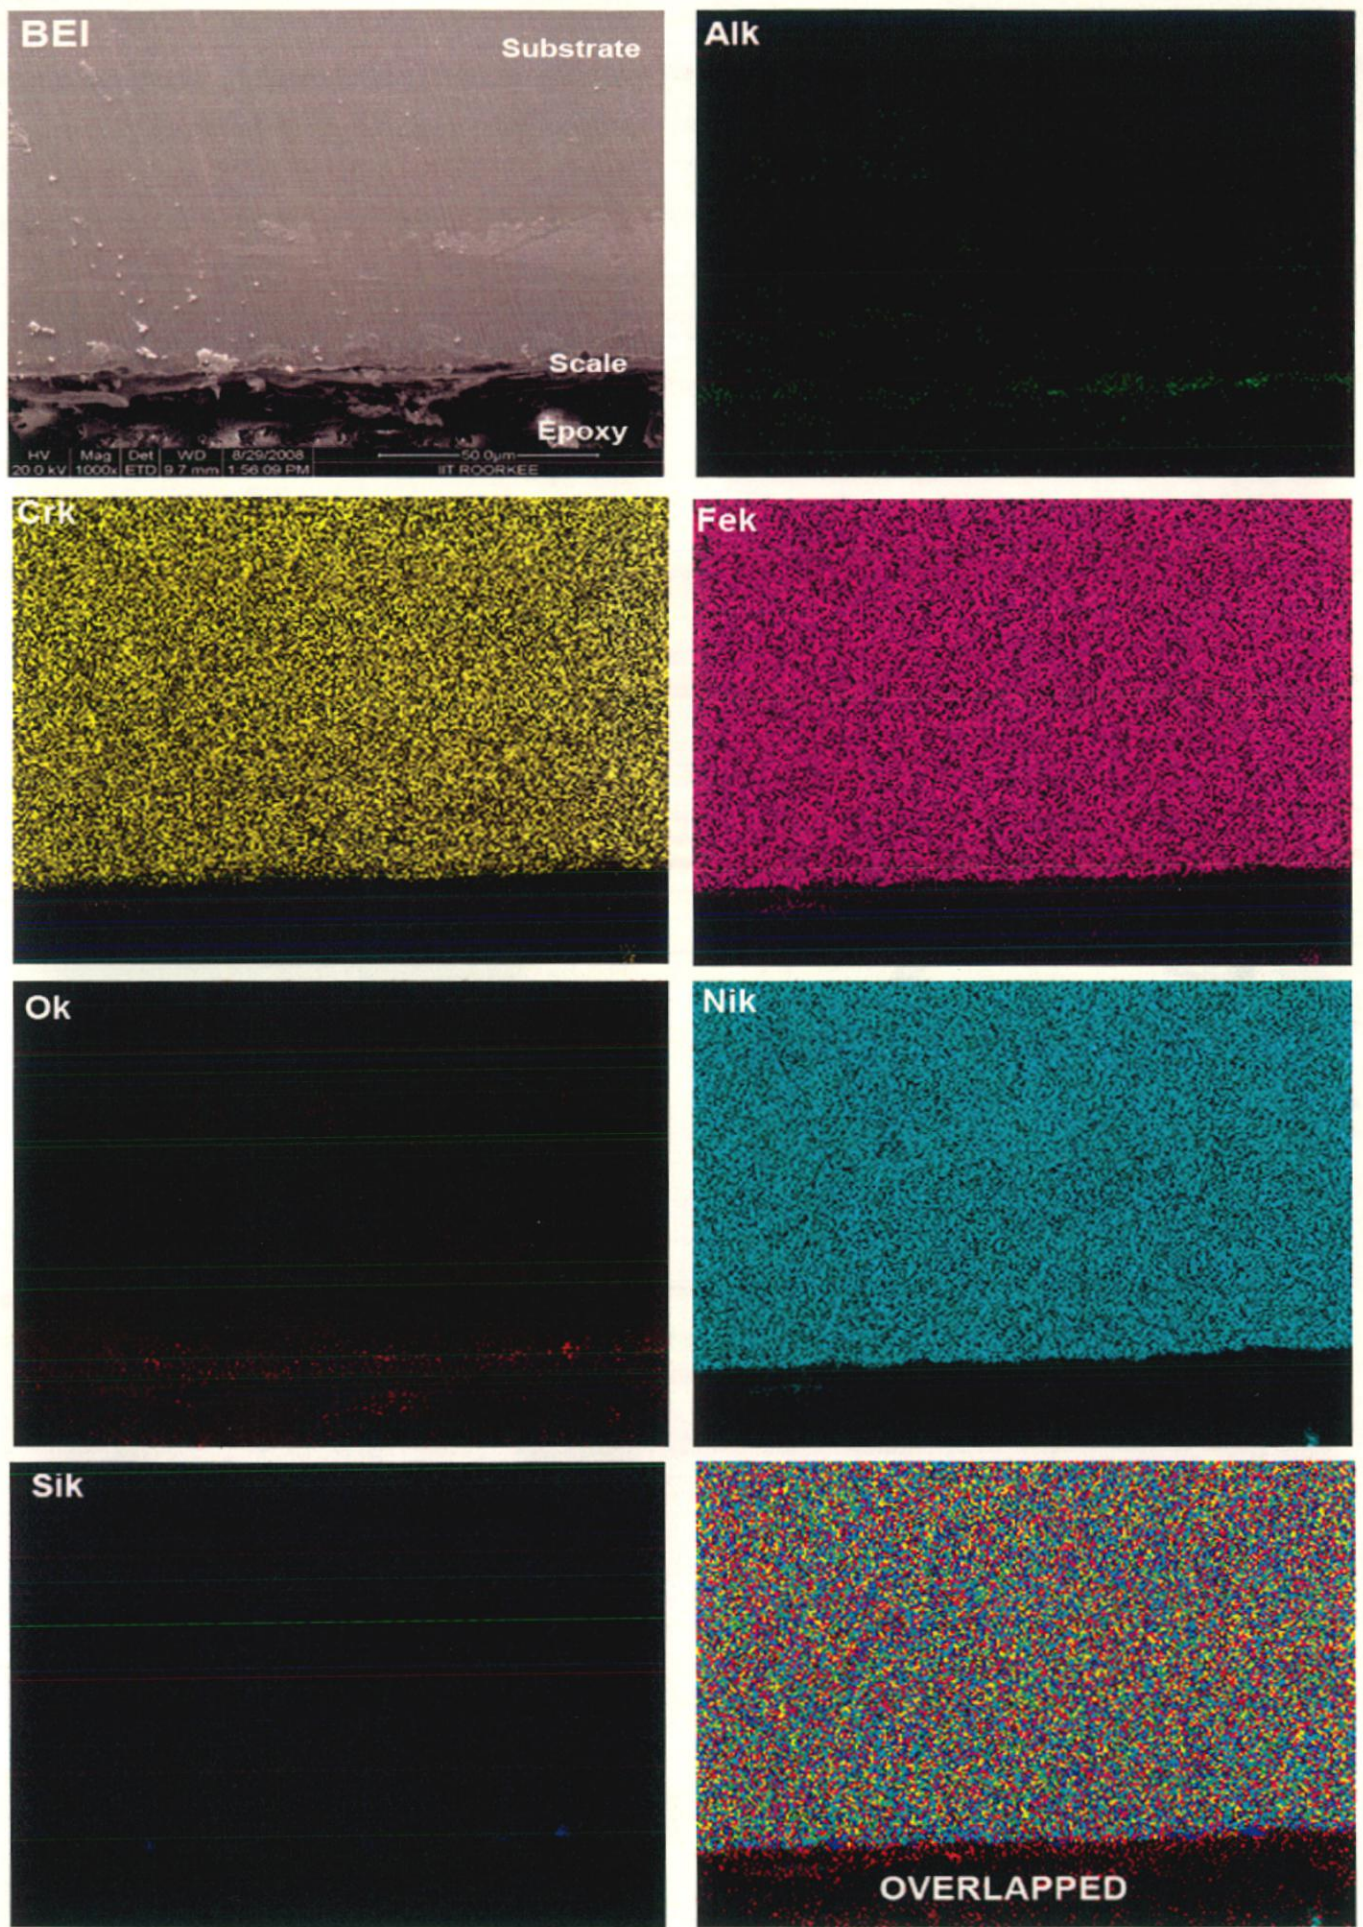
Fig. 7.20: Back scattered electron image and the corresponding x -ray mappings of cross section of uncoated superalloy Superni 718 after 1500 hours exposure in boiler.

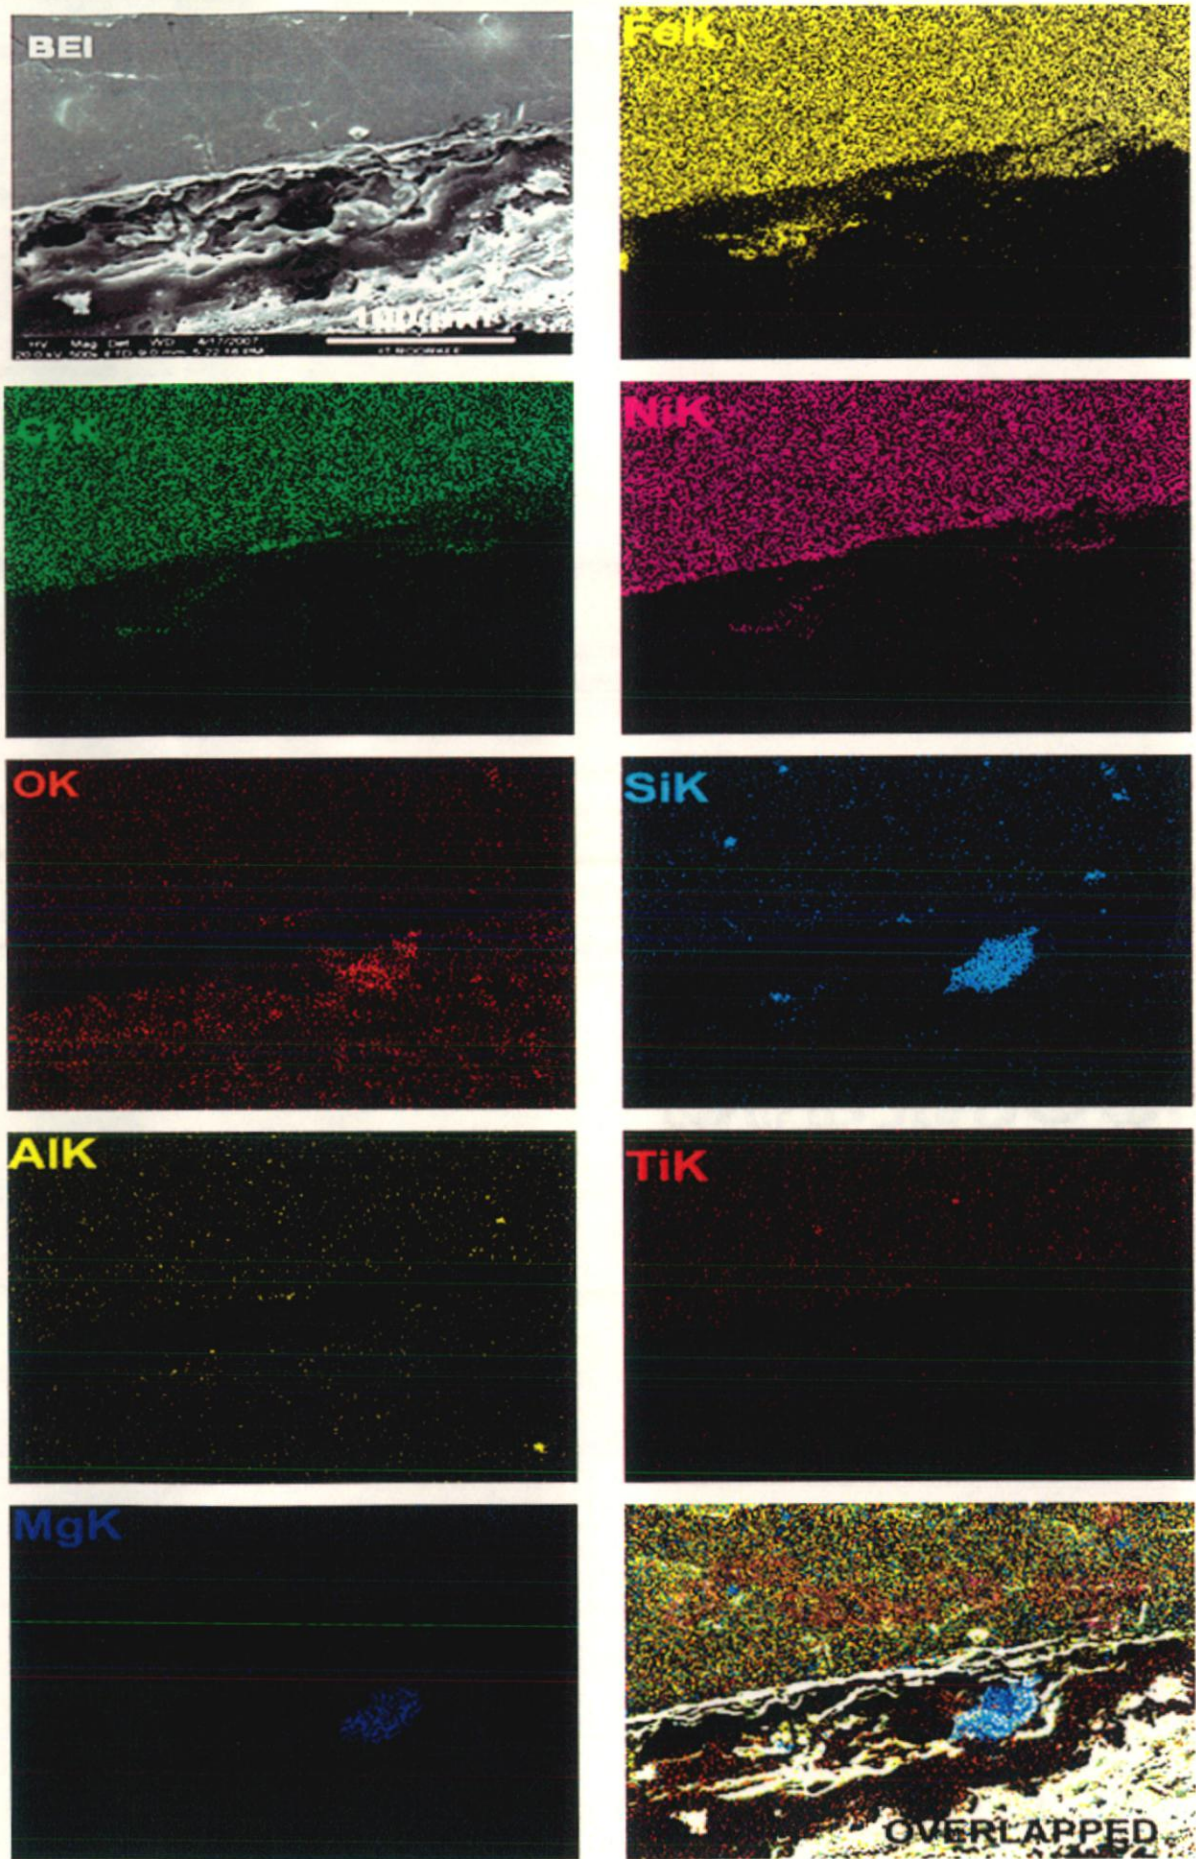
Fig. 7.21: Back scattered electron image and the corresponding x -ray mappings of cross section of uncoated superalloy Superfer 800 after 1500 hours exposure in boiler.
