STUDY OF DETONATION GUN COATED ALLOYS FOR RESISTANCE TO EROSION AND CORROSION

A THESIS

METALLURGICAL AND MATERIALS ENGINEERING

This thesis investigates the erosion and corrosion performance of Al_2O_3 -3 wt % TiO_2 thermal spray coatings deposited by detonation gun technique. As-sprayed coatings were characterized by using the combined techniques of optical microscopy, microhardness testing, X-ray diffractometry (XRD) and scanning electron microscopy/energy-dispersive analysis (SEM/EDX). The corrosion performance was evaluated in oxidising and molten salt environment and also in actual working conditions of boiler. The erosion performance was evaluated at room temperature conditions as well as under high temperature conditions, high erodent velocity, and actual boiler conditions. The corrosion behavior and morphological development were investigated by weight change kinetics, metallographs, depths of attack, metal thickness losses, and XRD analyses.

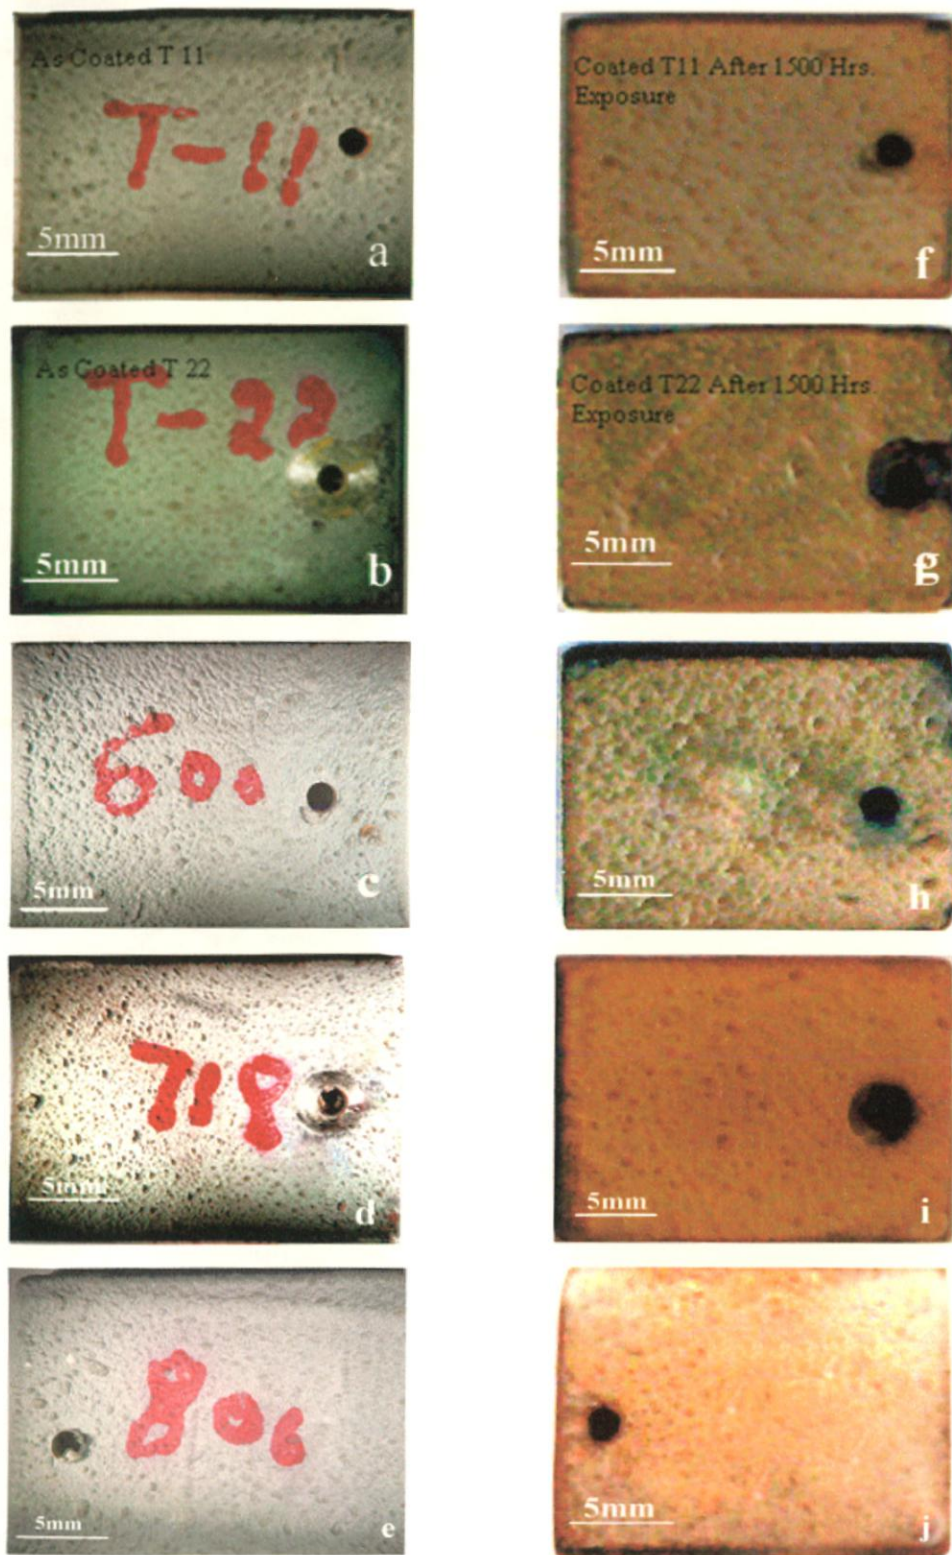
Fig.7.22: Macrographs of $\text{Al}_2\text{O}_3\text{-3wt\%TiO}_2$ coated substrate alloys before and after 1500 hours exposure to boiler environment:
 (a) T11 (b) T22 (c) Superni 600 (d) Superni718 (e) Superfer 800 (f) T11 after 1500 Hrs Exposure (g) T22 after 1500 Hrs Exposure (h) Superni 600 after 1500 Hrs Exposure (i) Superni 718 after 1500 Hrs Exposure (j) Superfer 800 after 1500 Hrs Exposure

The macrographs of Al₂O₃ - 3 wt% TiO₂ coated T11, T22, Superni 600, Superni 718 and Superfer 800 substrate alloys before and after 1500 hours exposure in the superheater area of coal fired boiler are shown in Fig.7.22. In the visual examination, it was observed that after the first cycle (100 hrs exposure) to the boiler environment, in Al₂O₃-3TiO₂ coated samples, the colour of the coatings changed from grey to cream as shown and with further cycles no appreciable change was observed. Coating remained intact throughout the study.

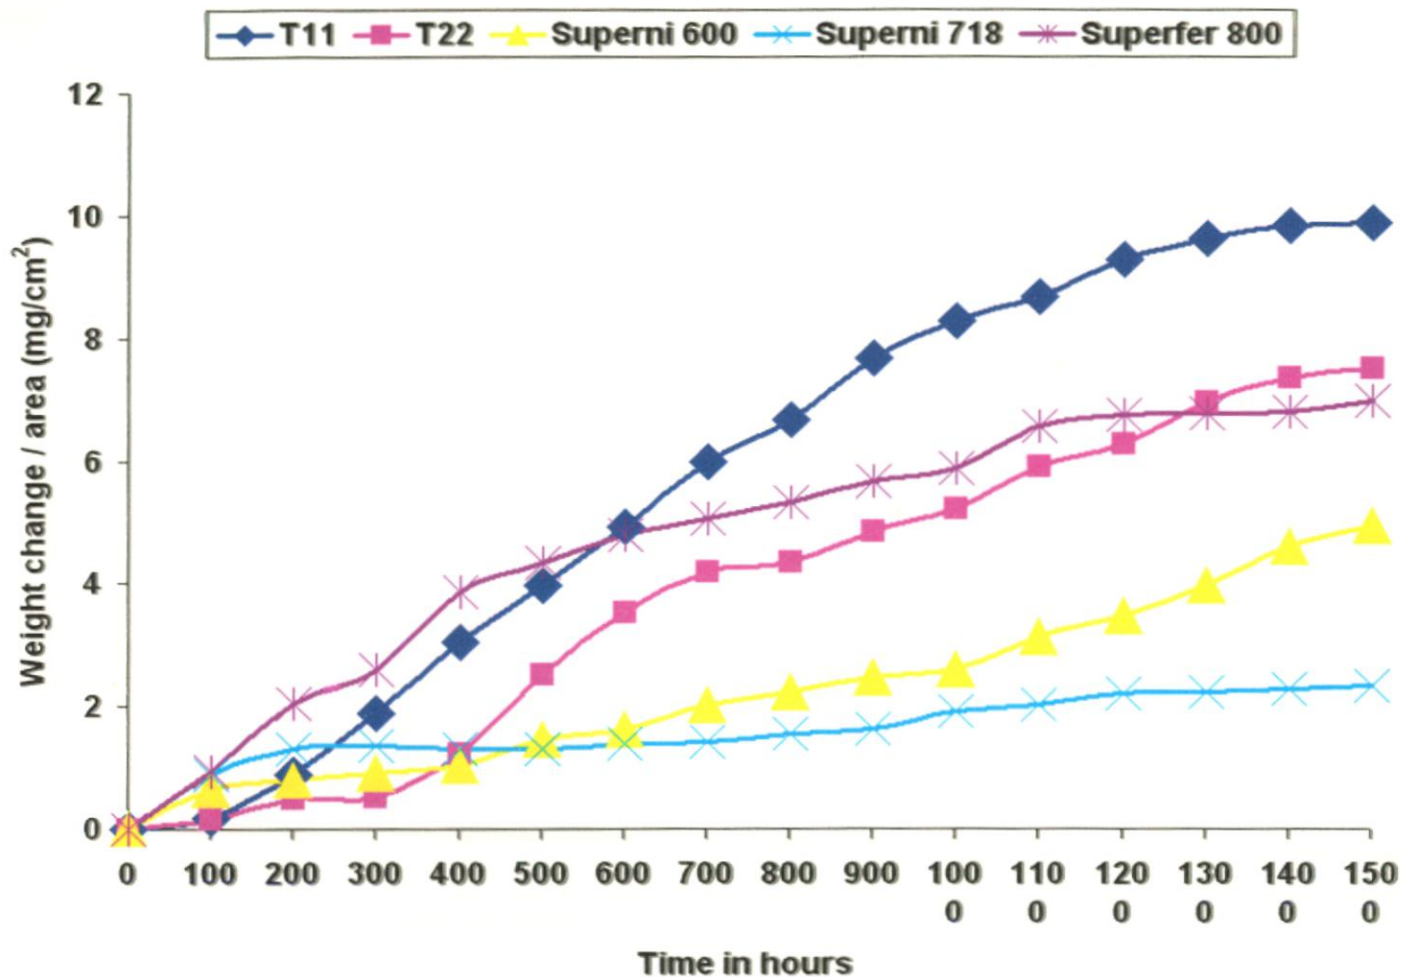
Fig.7.23: Weight change plot for $\text{Al}_2\text{O}_3\text{-3wt\%TiO}_2$ coated alloys exposed to platen superheater of the coal fired boiler for 1500 hours at 700°C .

Weight change per unit area expressed in mg/cm² has been plotted as a function of time expressed in hours for Al₂O₃ - 3 wt% TiO₂ coated alloys and is shown in Fig. 7.23. All the coated alloys have shown increase in weight. The extent of erosion-corrosion has been measured in terms of thickness lost due to scaling and surface degradation after 1500 hours exposure. The thickness lost of the coating was 0.1548, 0.1279, 0.1319, 0.1361, 0.1981 mm in T11, T22, superni 600, superni 718 and superfer 800 respectively as indicated in Fig.7.24. The thickness is lost due to continuous impact of fly ash and other particles entrapped in the air blast. The corresponding degradation rates expressed in mills per year (mpy) are found to be 35.61, 29.42, 30.35, 31.31 and 45.57 for Al₂O₃ - 3 wt% TiO₂ coated T11, T 22, Superni 600, Superni 718 and Superfer 800 respectively.

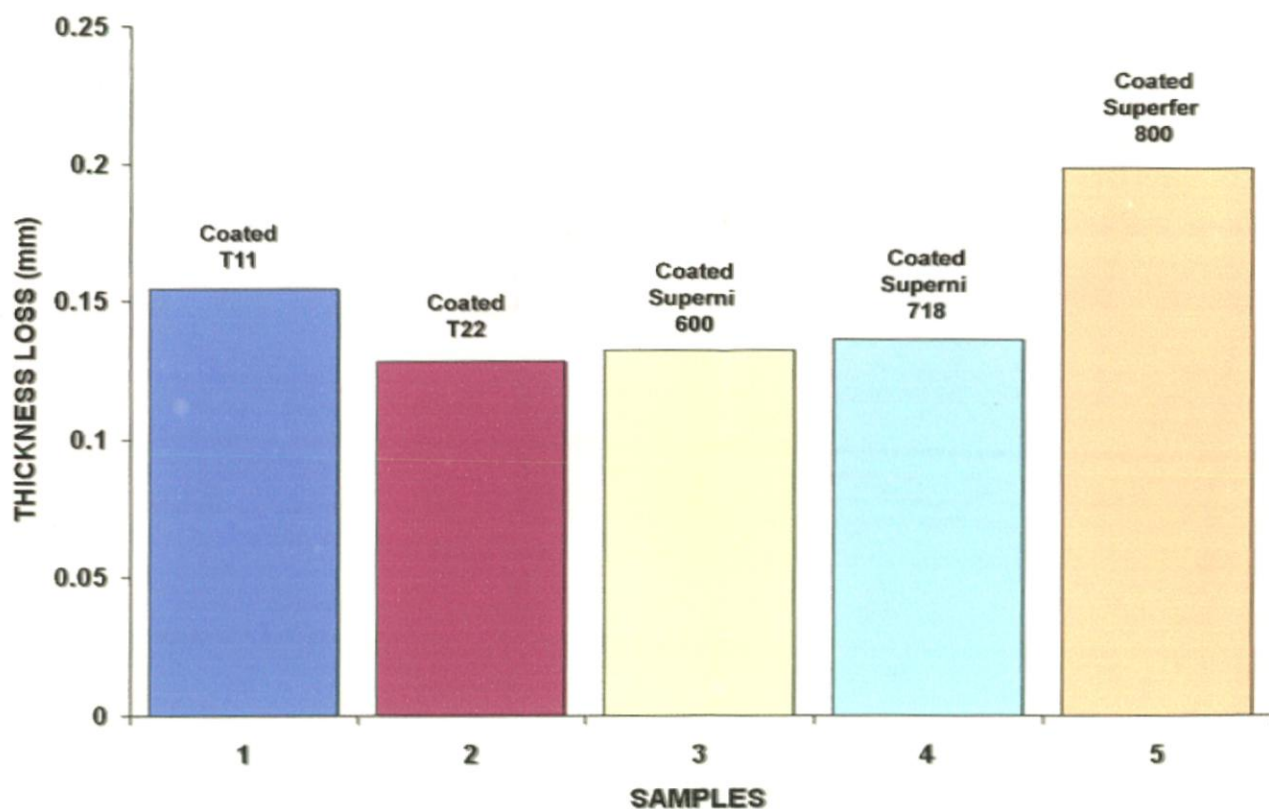
Fig.7.24: Bar chart indicating the thickness lost in mm by the $\text{Al}_2\text{O}_3\text{-3 wt\% TiO}_2$ coated alloys after 1500 hours exposure to the coal fired boiler at 700°C .

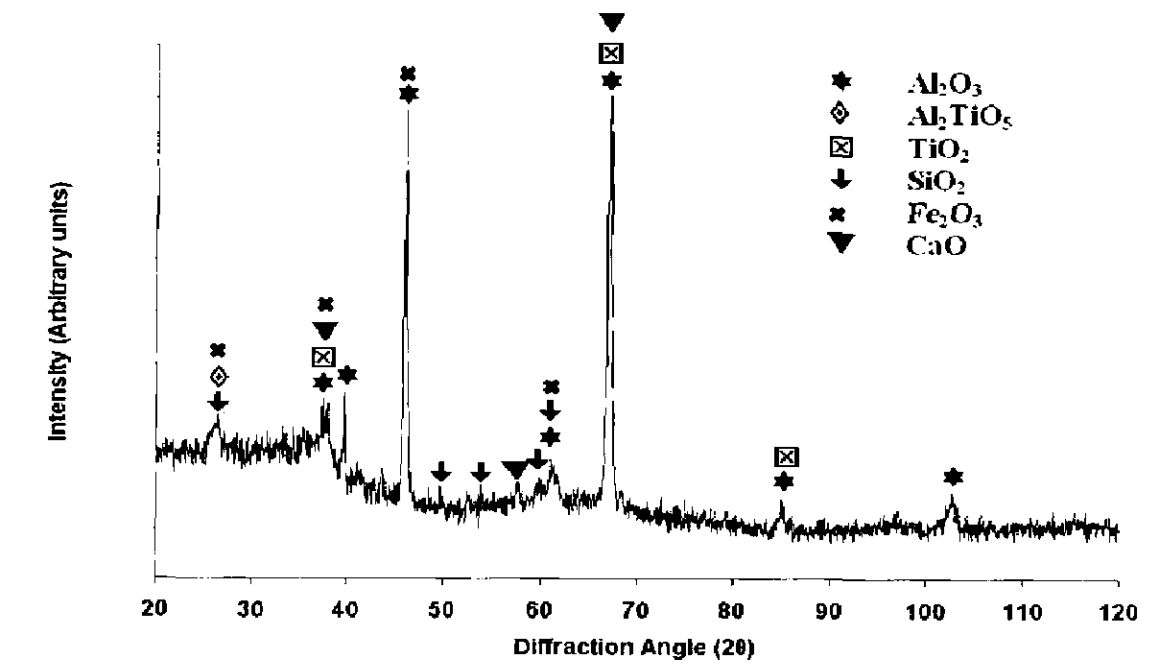
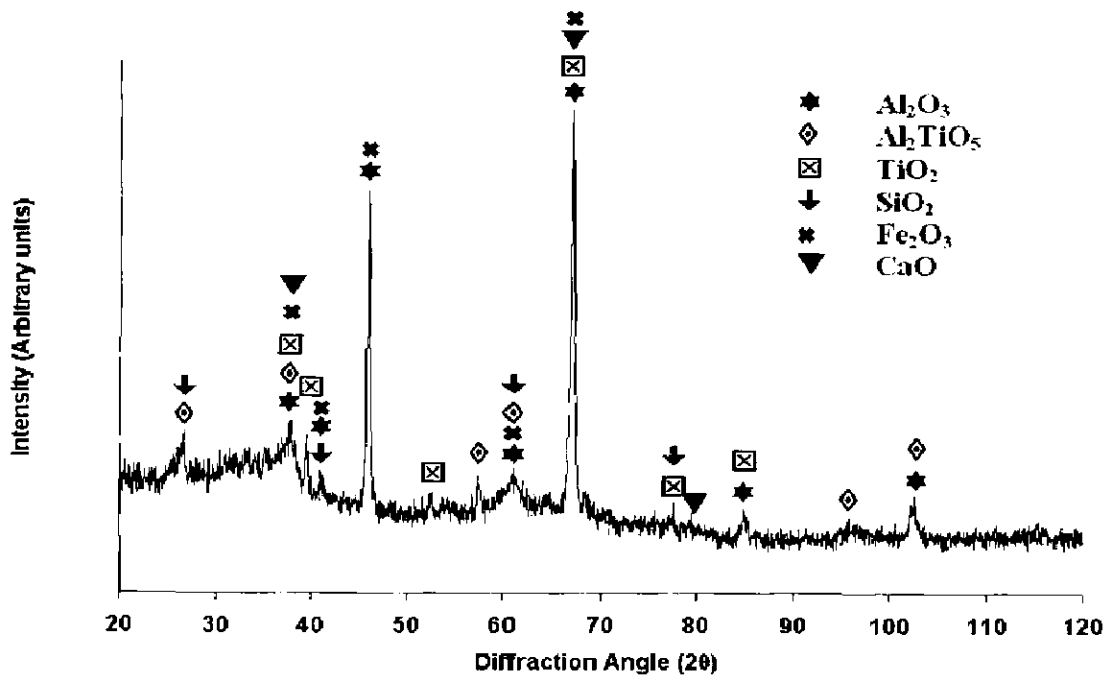
Fig. 7.25: X-ray diffraction profiles for Al_2O_3 -3 wt% TiO_2 coated boiler steels exposed to superheater of the coal fired boiler for 1500 hours at 700°C
 (a) T11 (b) T22

compact and less porous the coating, the higher is its erosion-corrosion resistance (Wang et al, 1992). Main phases identified in all the coated specimens are Al_2O_3 , Al_2TiO_5 , TiO_2 , SiO_2 , CaO and Fe_2O_3 after 1500 hours exposure to the coal fired boiler environment. The formation of iron oxide in the top scale of few coated alloys after exposure to boiler environment might be due to ash deposition. The Al_2O_3 -3 wt% TiO_2 composite coating was no longer oxidized and acted as an effective inert barrier to improve the isothermal and cyclic oxidation resistance of alloys exposed to boiler environment for 1500 hours. The composite coating possessed very dense structure, high thermal stability and excellent cracking/spallation resistance.

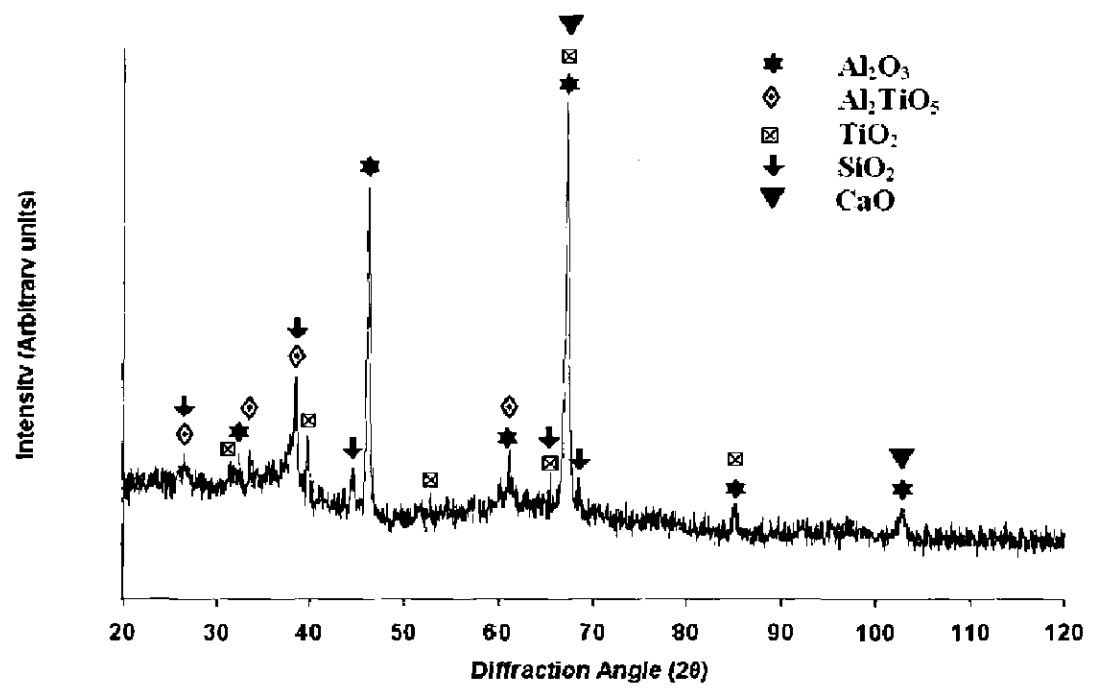
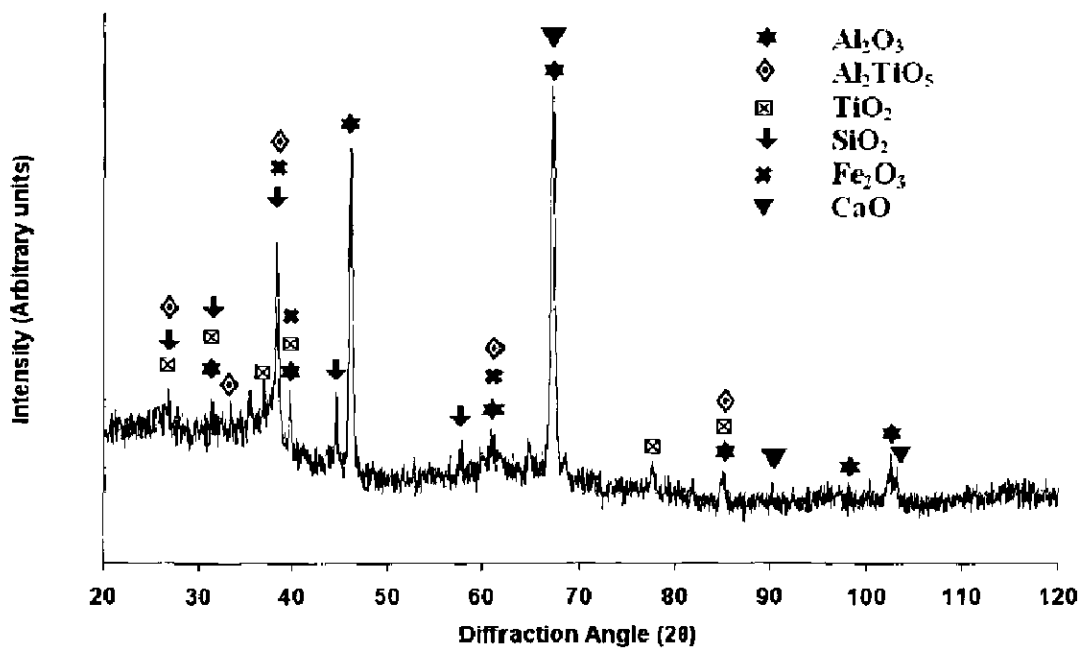
Fig. 7.26: X-ray diffraction profiles for Al_2O_3 -3 wt% TiO_2 coated superalloys exposed to superheater of the coal fired boiler for 1500 hours at 700°C
 (a) Superni 600 (b) Superni 718

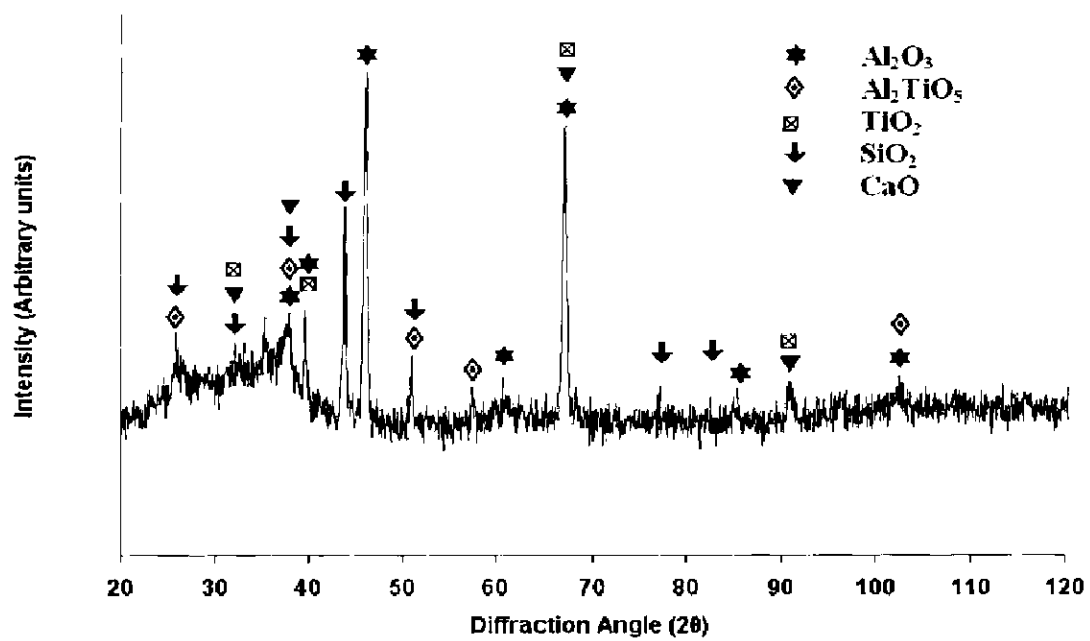
Fig. 7.27: X-ray diffraction profiles for Al₂O₃-3 wt% TiO₂ coated superalloy Superfer 800 exposed to superheater of the coal fired boiler for 1500 hours at 700°C

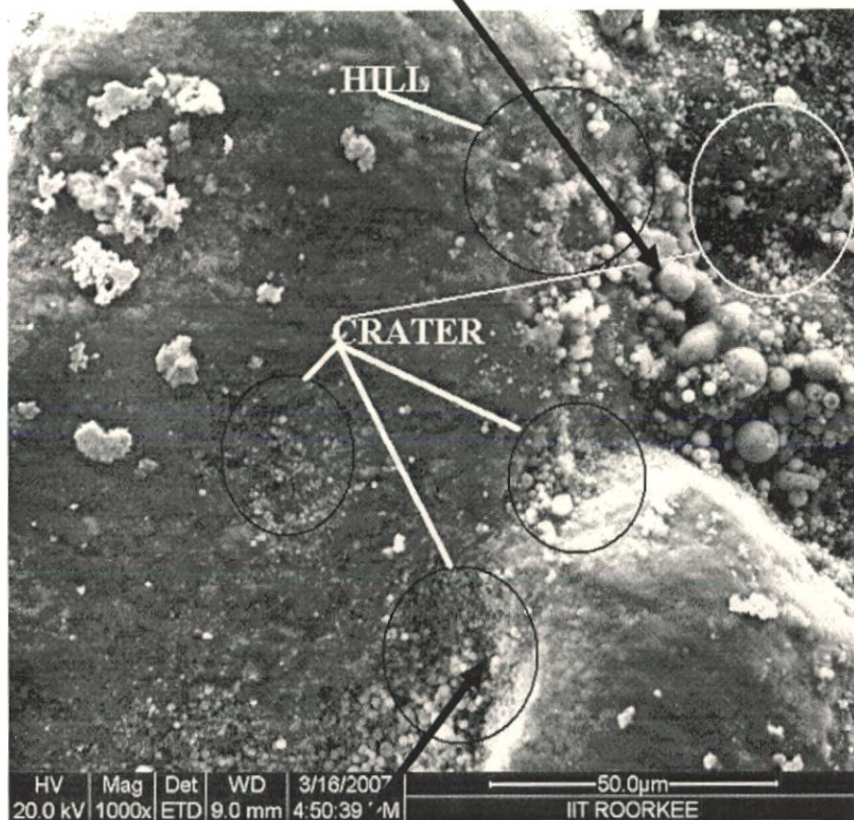
Element	Wt %
O	36.22
Al	32.13
Si	24.23
Ca	02.08
Ti	03.11
Fe	02.23

Element	Wt %
O	39.63
Al	28.81
Si	22.52
Mo	02.09
Ca	02.89
Ti	01.95
Fe	02.11

Fig.7.30: Surface scale morphology and EDX analysis for $\text{Al}_2\text{O}_3\text{-3\%TiO}_2$ coated superalloy Superni 600 exposed to superheater of the coal fired boiler for 1500 hours at 700°C.

Surface degradation and scale development and the effect of boiler conditions on the surface were studied using SEM/EDX analysis. The surface scale morphology and the EDX analysis for Al_2O_3 - 3 wt% TiO_2 coated alloys exposed to superheater region of coal fired boiler after 1500 hrs is shown in Fig.7.28 -7.32. From SEM/EDX analysis it has been revealed that the main constituents of scale are Al, Ti and Si along with oxygen. The presence of Si, Ca, Na, Mo and Fe along with oxygen, is an indication of embedded ash. There is a presence of pits and cracks on the surface and also hills and craters are formed which is a clear indication of combined effect of erosion and corrosion caused by combined action of flue gases and fly ash. There is no evidence of formation oxides from the substrate alloys though there is a presence of minor cracks on the surface and also there is an indication of erosion with the formation of hills and craters on the surface but these could not expose the surface of the substrate alloys and coating has protected the surface very well. This may be due to the fact that Al_2O_3 probably hinders the grain boundary diffusion of the elements. As a consequence, there is no oxide scale growth. The compact and protective Al_2O_3 layer separated the metal substrate from the boiler environment. As a result, the coating improved the hot corrosion resistance.

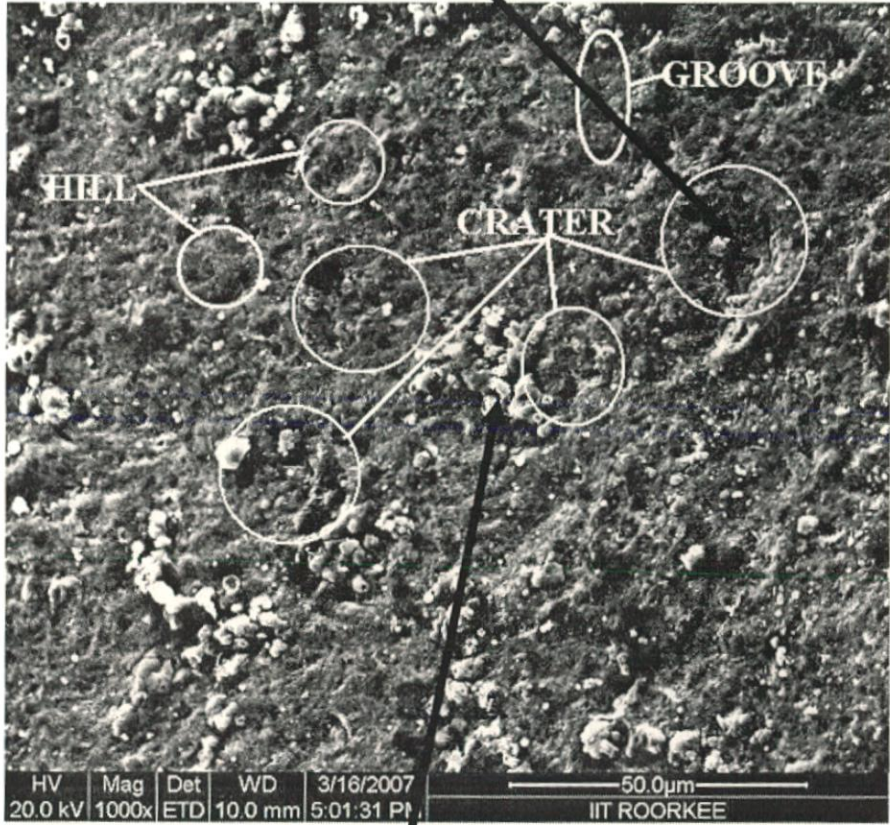
Element	Wt %
O	29.37
Al	40.85
Si	25.58
Ca	02.47
Cr	01.08
Mn	00.24
Y	00.41

Element	Wt %
O	40.83
Al	34.73
Si	18.10
Ti	03.17
Ca	02.05
Ag	01.12

Fig.7.31: Surface scale morphology and EDX analysis for $Al_2O_3-3\%TiO_2$ coated superalloy Superni 718 exposed to superheater of the coal fired boiler for 1500 hours at 700°C.

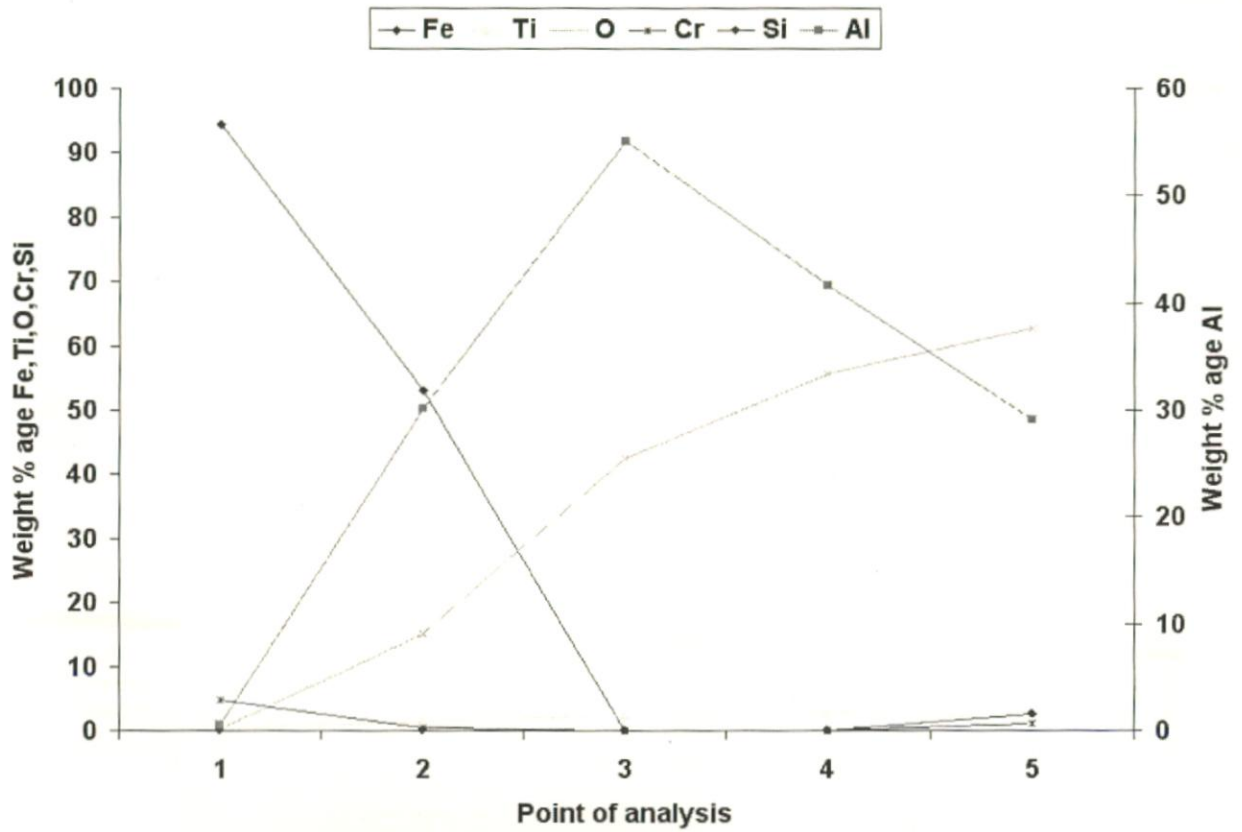
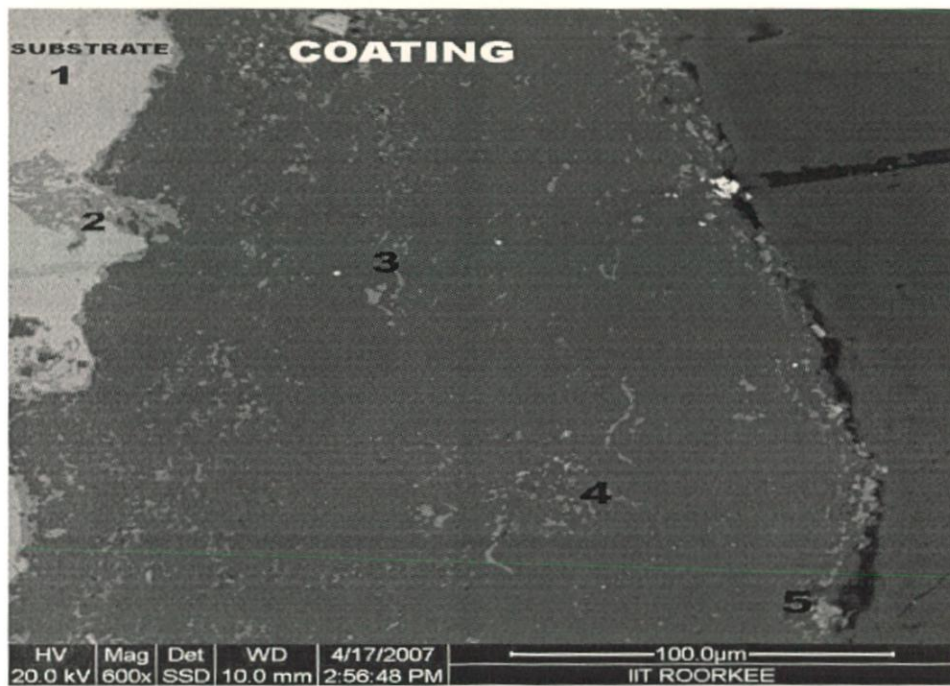
Fig. 7.33: Cross sectional morphology and elemental composition variation across the cross-section of Al_2O_3 -3 wt% TiO_2 coated T11 boiler steels exposed to superheater of the coal fired boiler for 1500 hours at 700°C.

The BSE image and the EDX analysis across the cross section on Al_2O_3 - 3 wt% TiO_2 coated alloys is shown in Fig.7.33 to Fig. 7.37. In all the coated alloys the coating was quite intact and there was no crack development in the coating. Throughout the coating thickness, the composition is entirely of Alumina and Titania.

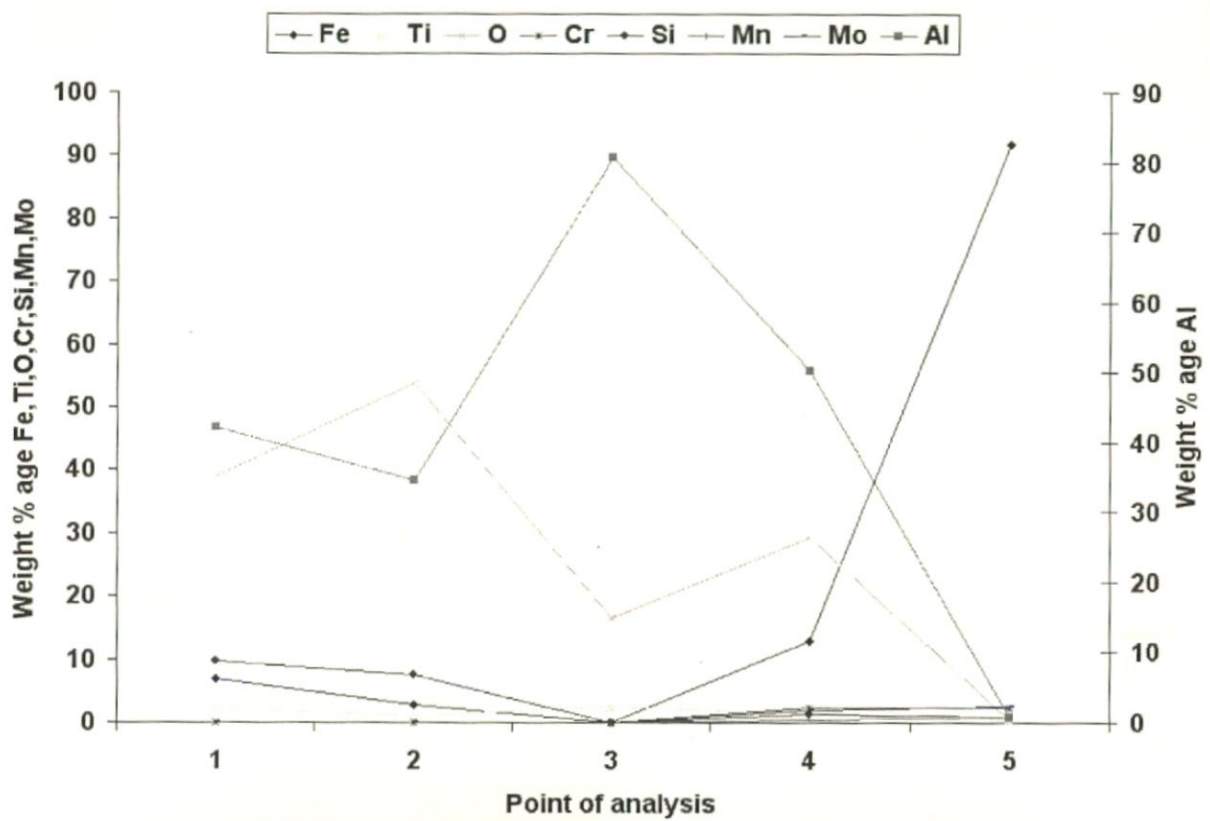
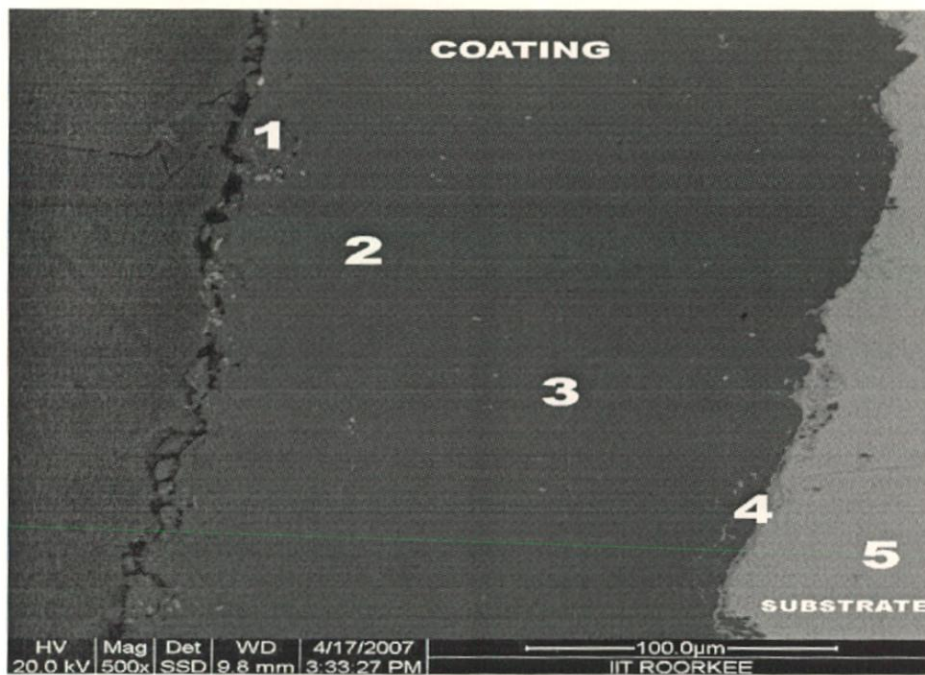
Fig. 7.34: Cross sectional morphology and elemental composition variation across the cross-section of Al_2O_3 -3 wt% TiO_2 coated T22 boiler steel exposed to superheater of the coal fired boiler for 1500 hours at 700°C.

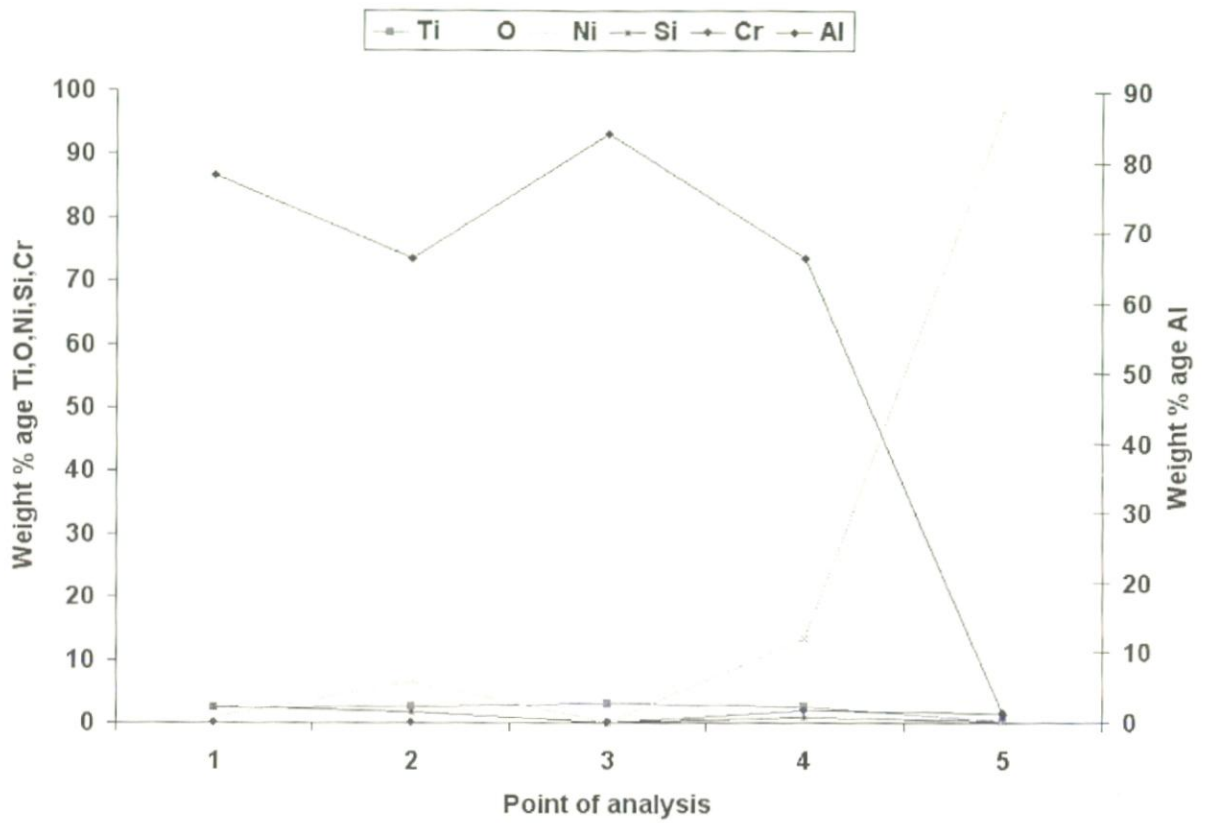
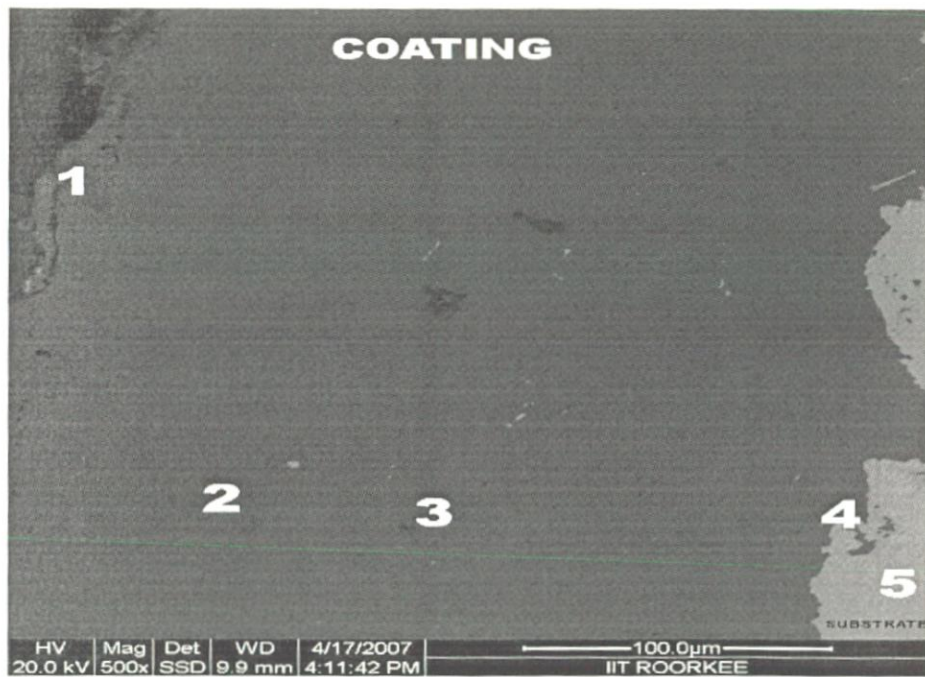
Fig. 7.35: Cross sectional morphology and elemental composition variation across the cross-section of $\text{Al}_2\text{O}_3\text{-3wt\%TiO}_2$ coated Superni 600 superalloy exposed to superheater of the coal fired boiler for 1500 hours at 700°C .

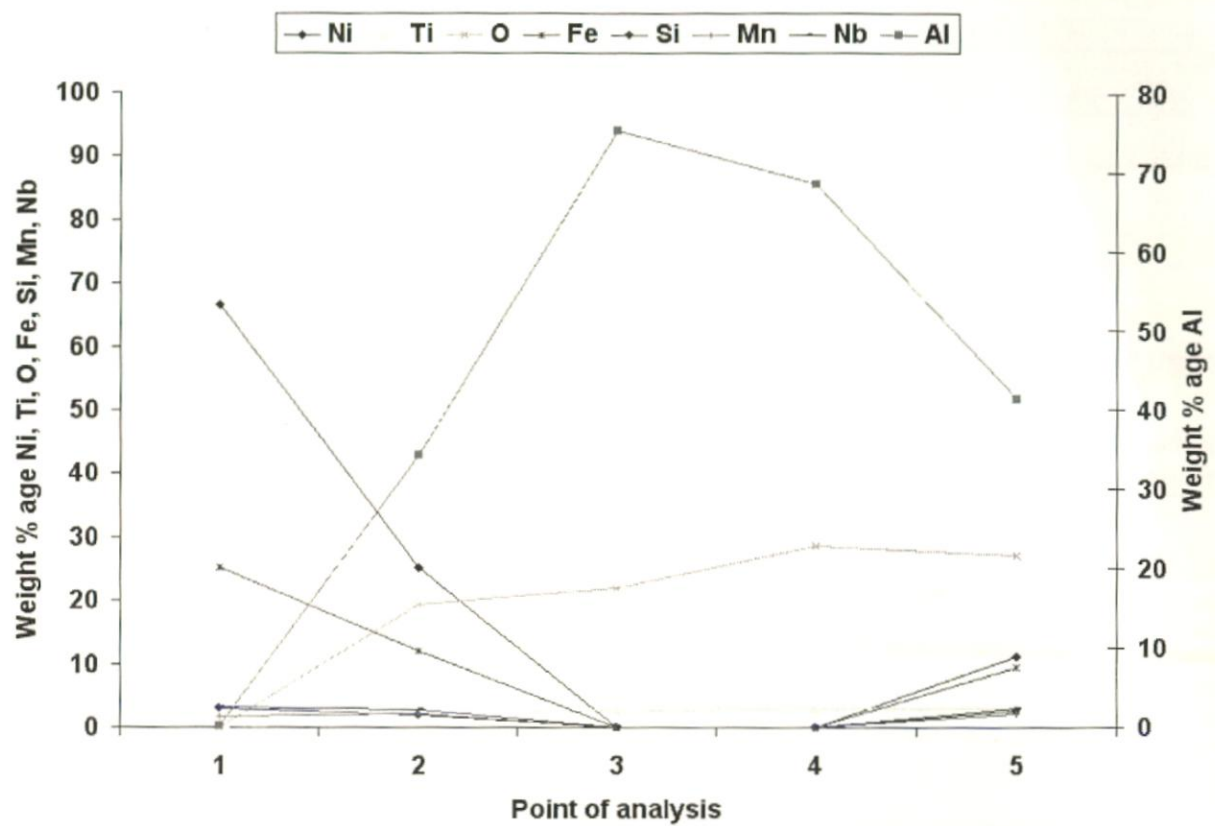
Fig. 7.36: Cross sectional morphology and elemental composition variation across the cross-section of $\text{Al}_2\text{O}_3\text{-3wt\%TiO}_2$ coated Superni 718 superalloy exposed to superheater of the coal fired boiler for 1500 hours at 700°C .

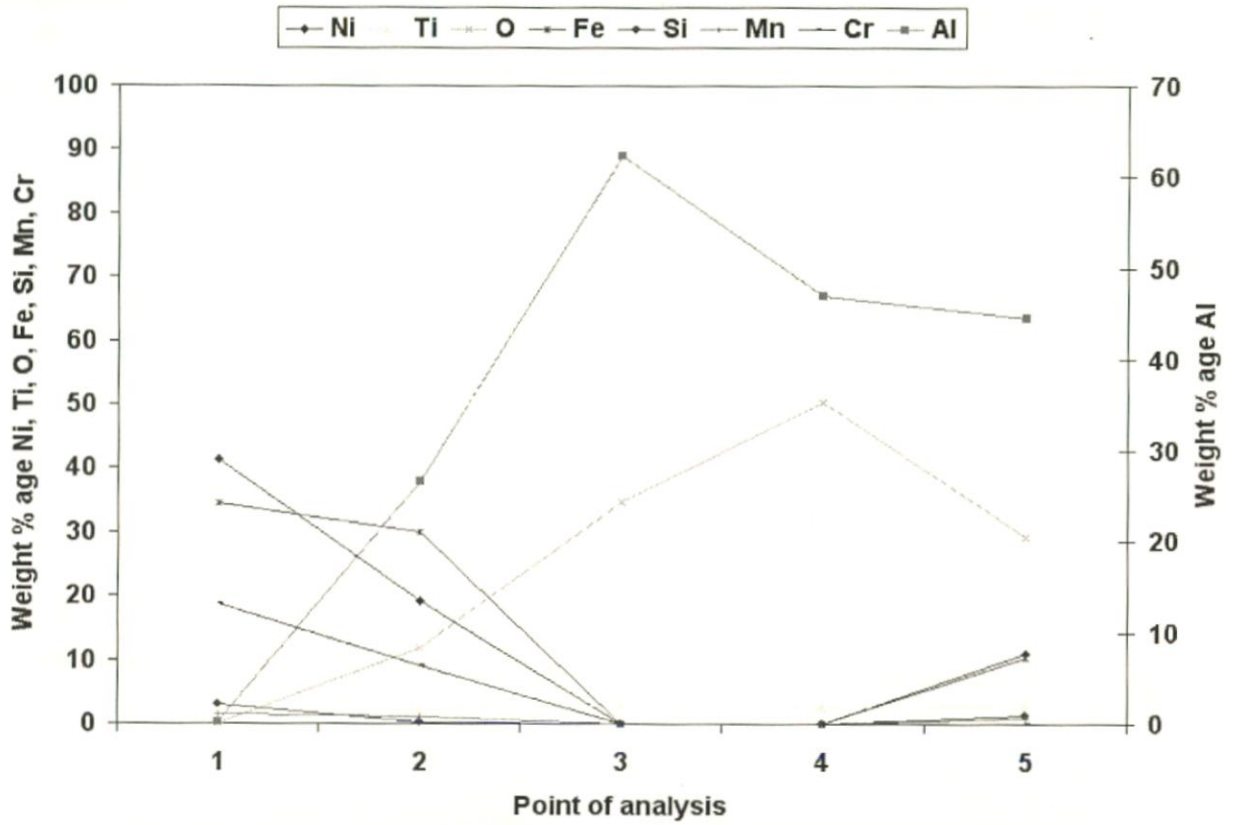
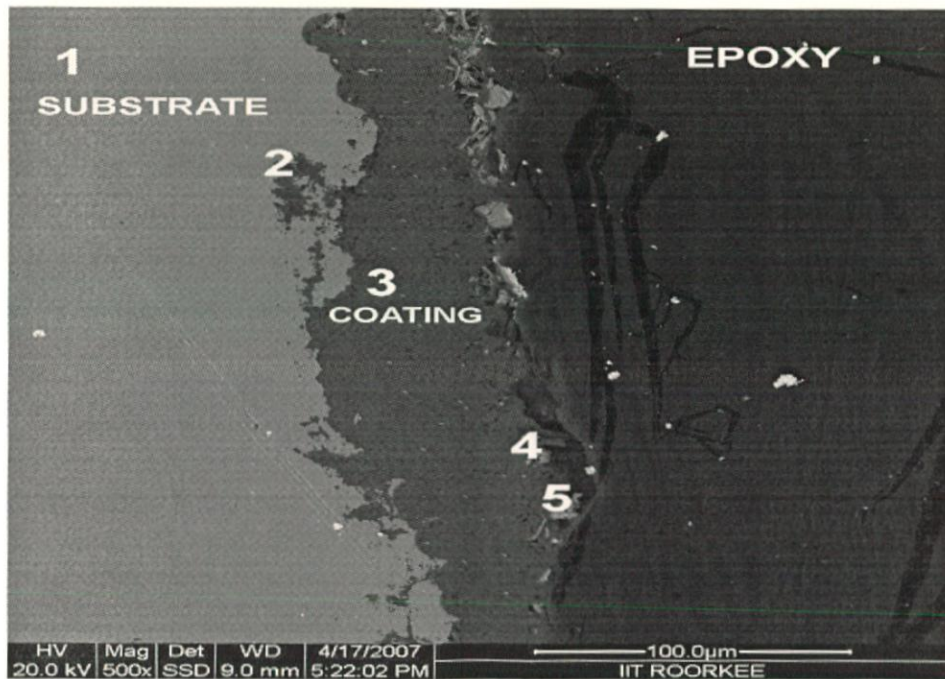
Fig. 7.37: Cross sectional morphology and elemental composition variation across the cross-section of $\text{Al}_2\text{O}_3\text{-3wt\%TiO}_2$ coated Superfer 800 superalloy exposed to platen superheater of the coal fired boiler for 1500 hours at 700°C .

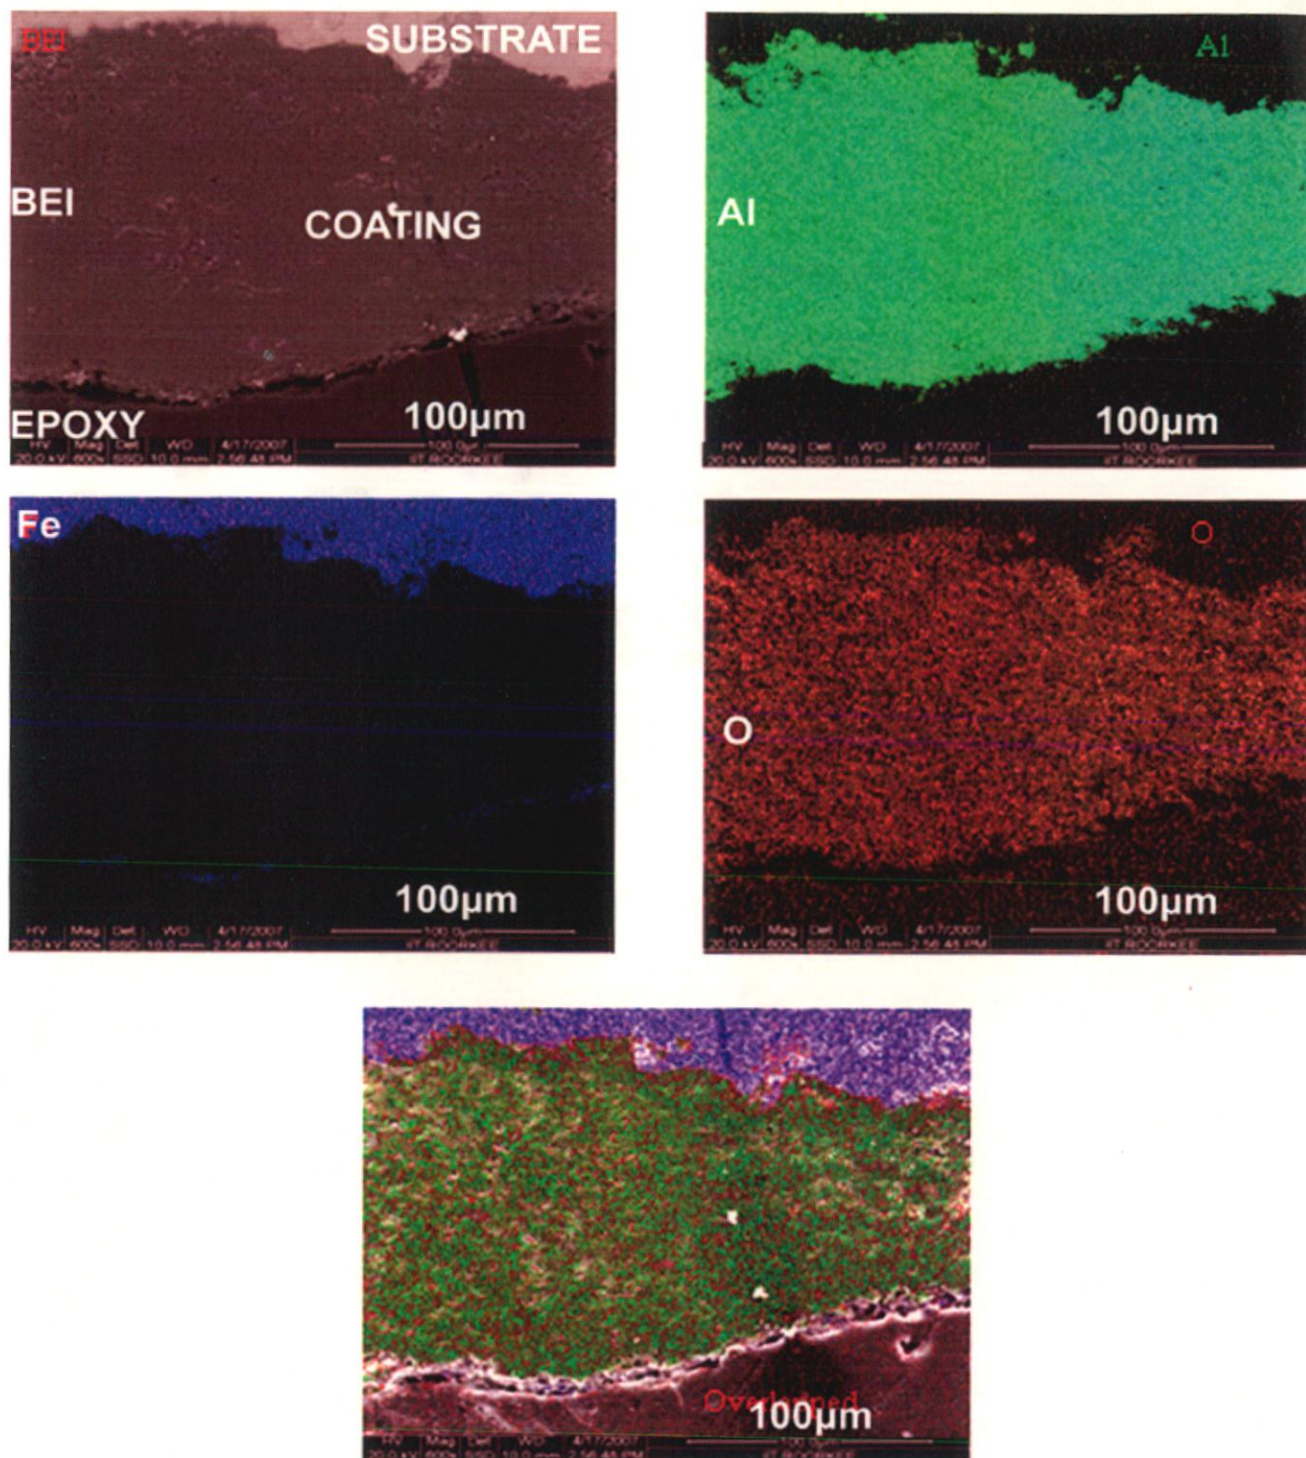
Fig. 7.38: Back scattered electron image and the corresponding x-ray mappings of cross section of $\text{Al}_2\text{O}_3 - 3 \text{ wt}\% \text{ TiO}_2$ coated T11 steel after 1500 hours exposure in boiler.

Back scattered electron image of cross-section of coated substrate alloys (T11, T22, Superni 600, Superni 718 and Superfer 800) and corresponding X-ray mapping after 1500 hours exposure to boiler environment is shown in Fig.7.38 to 7.42 respectively. Ti is present in the form of thin streaks. Alumina coating is intact with all substrate alloys.

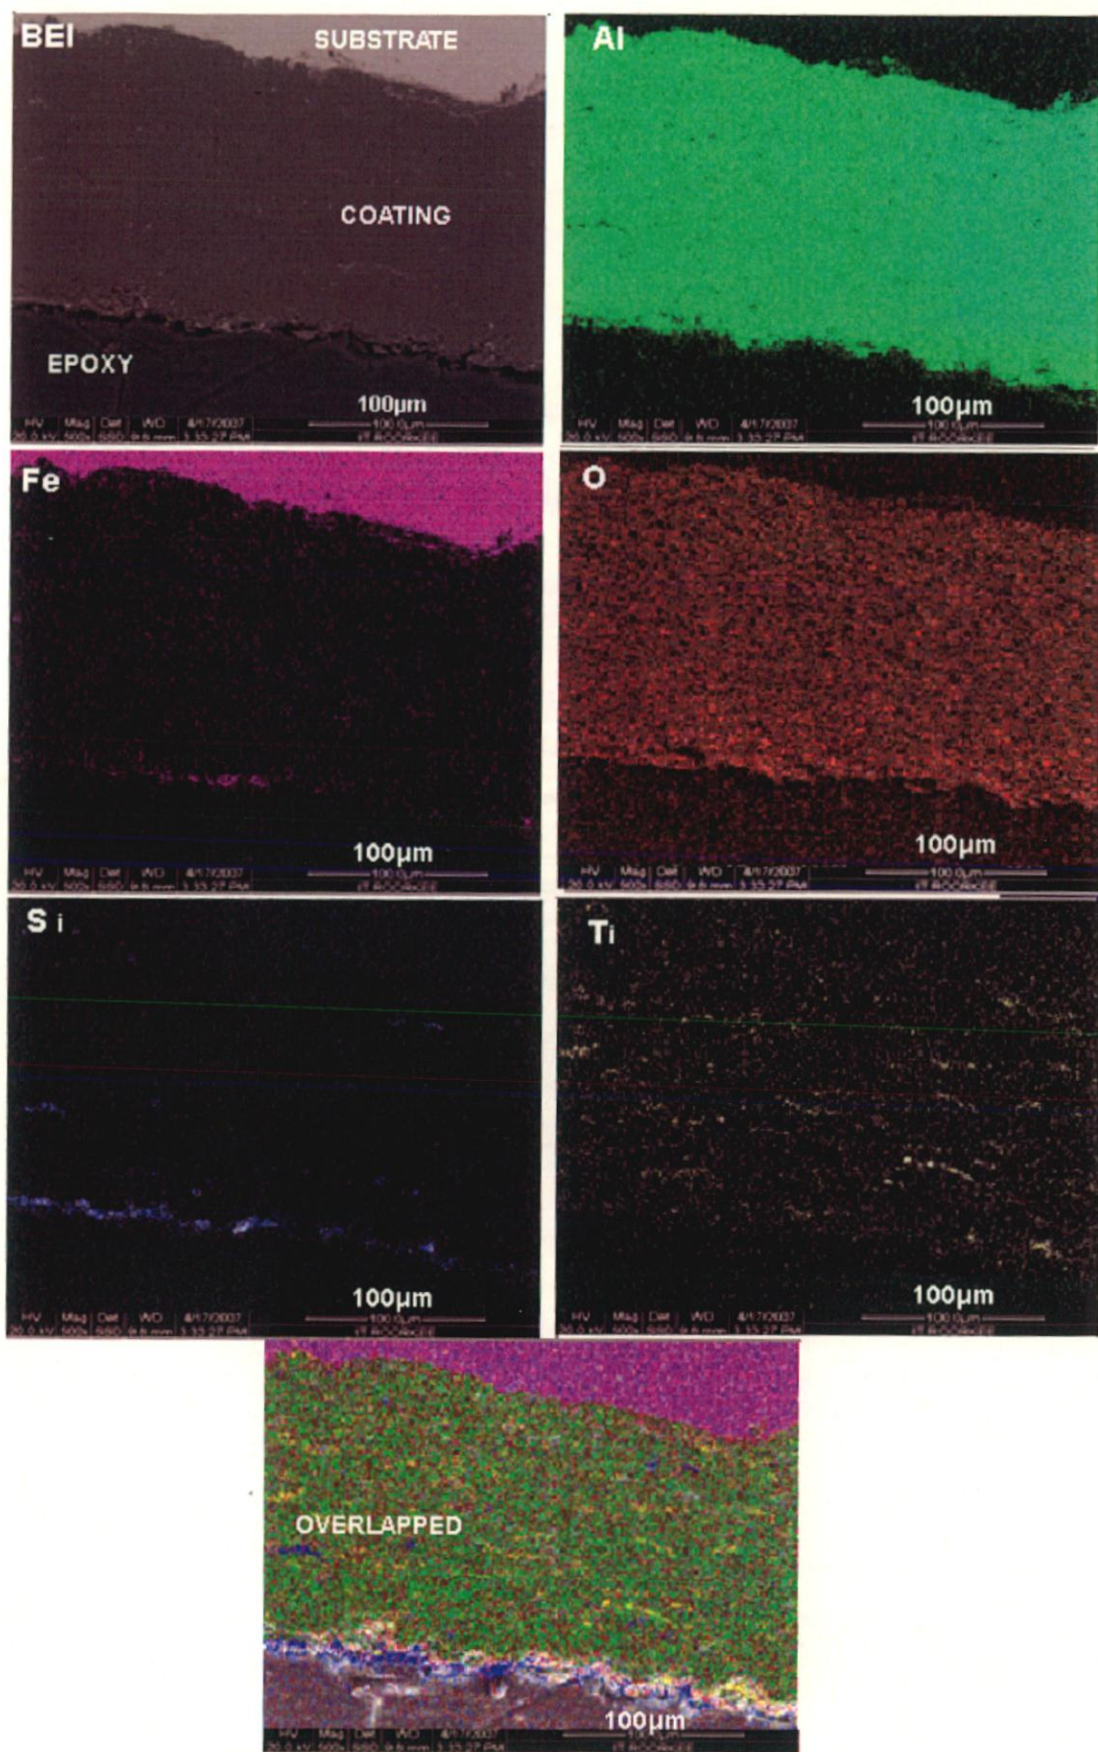
Fig. 7.39: Back scattered electron image and the corresponding x -ray mappings of cross section of $\text{Al}_2\text{O}_3 - 3 \text{ wt}\% \text{ TiO}_2$ coated T22 steel after 1500 hours exposure in boiler.
