STUDY OF DETONATION GUN COATED ALLOYS FOR RESISTANCE TO EROSION AND CORROSION

A THESIS

METALLURGICAL AND MATERIALS ENGINEERING

This thesis investigates the erosion and corrosion performance of Al_2O_3 -3 wt % TiO_2 thermal spray coatings deposited by detonation gun technique. As-sprayed coatings were characterized by using the combined techniques of optical microscopy, microhardness testing, X-ray diffractometry (XRD) and scanning electron microscopy/energy-dispersive analysis (SEM/EDX). The corrosion performance was evaluated in oxidising and molten salt environment and also in actual working conditions of boiler. The erosion performance was evaluated at room temperature conditions as well as under high temperature conditions, high erodent velocity, and actual boiler conditions. The corrosion behavior and morphological development were investigated by weight change kinetics, metallographs, depths of attack, metal thickness losses, and XRD analyses.

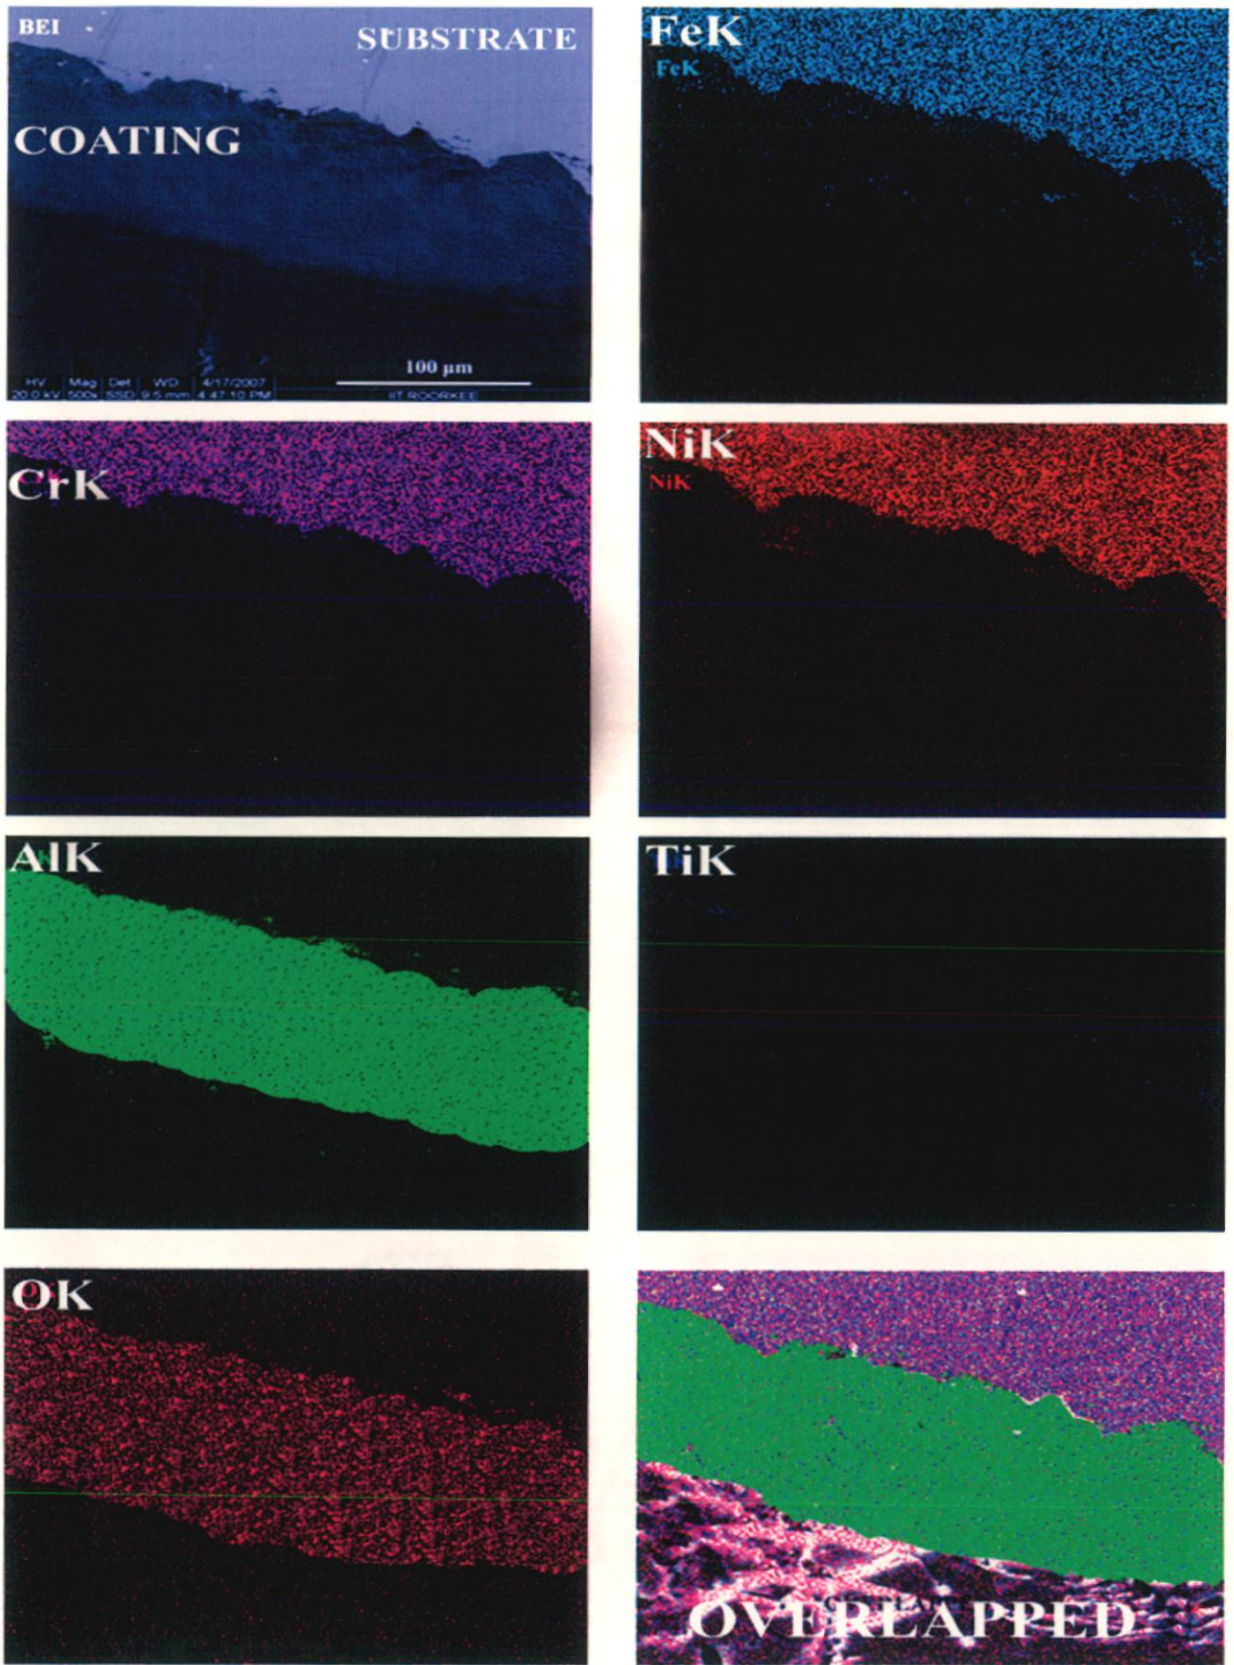
Fig. 7.41: Back scattered electron image and the corresponding x -ray mappings of cross section of Al_2O_3 - 3wt% TiO_2 coated superalloy superni 718 after 1500 hours exposure in boiler.

Back scattered electron image of cross-section of coated substrate alloys (T11, T22, Superni 600, Superni 718 and Superfer 800) and corresponding X-ray mapping after 1500 hours exposure to boiler environment is shown in Fig.7.38 to 7.42 respectively. Ti is present in the form of thin streaks. Alumina coating is intact with all substrate alloys.

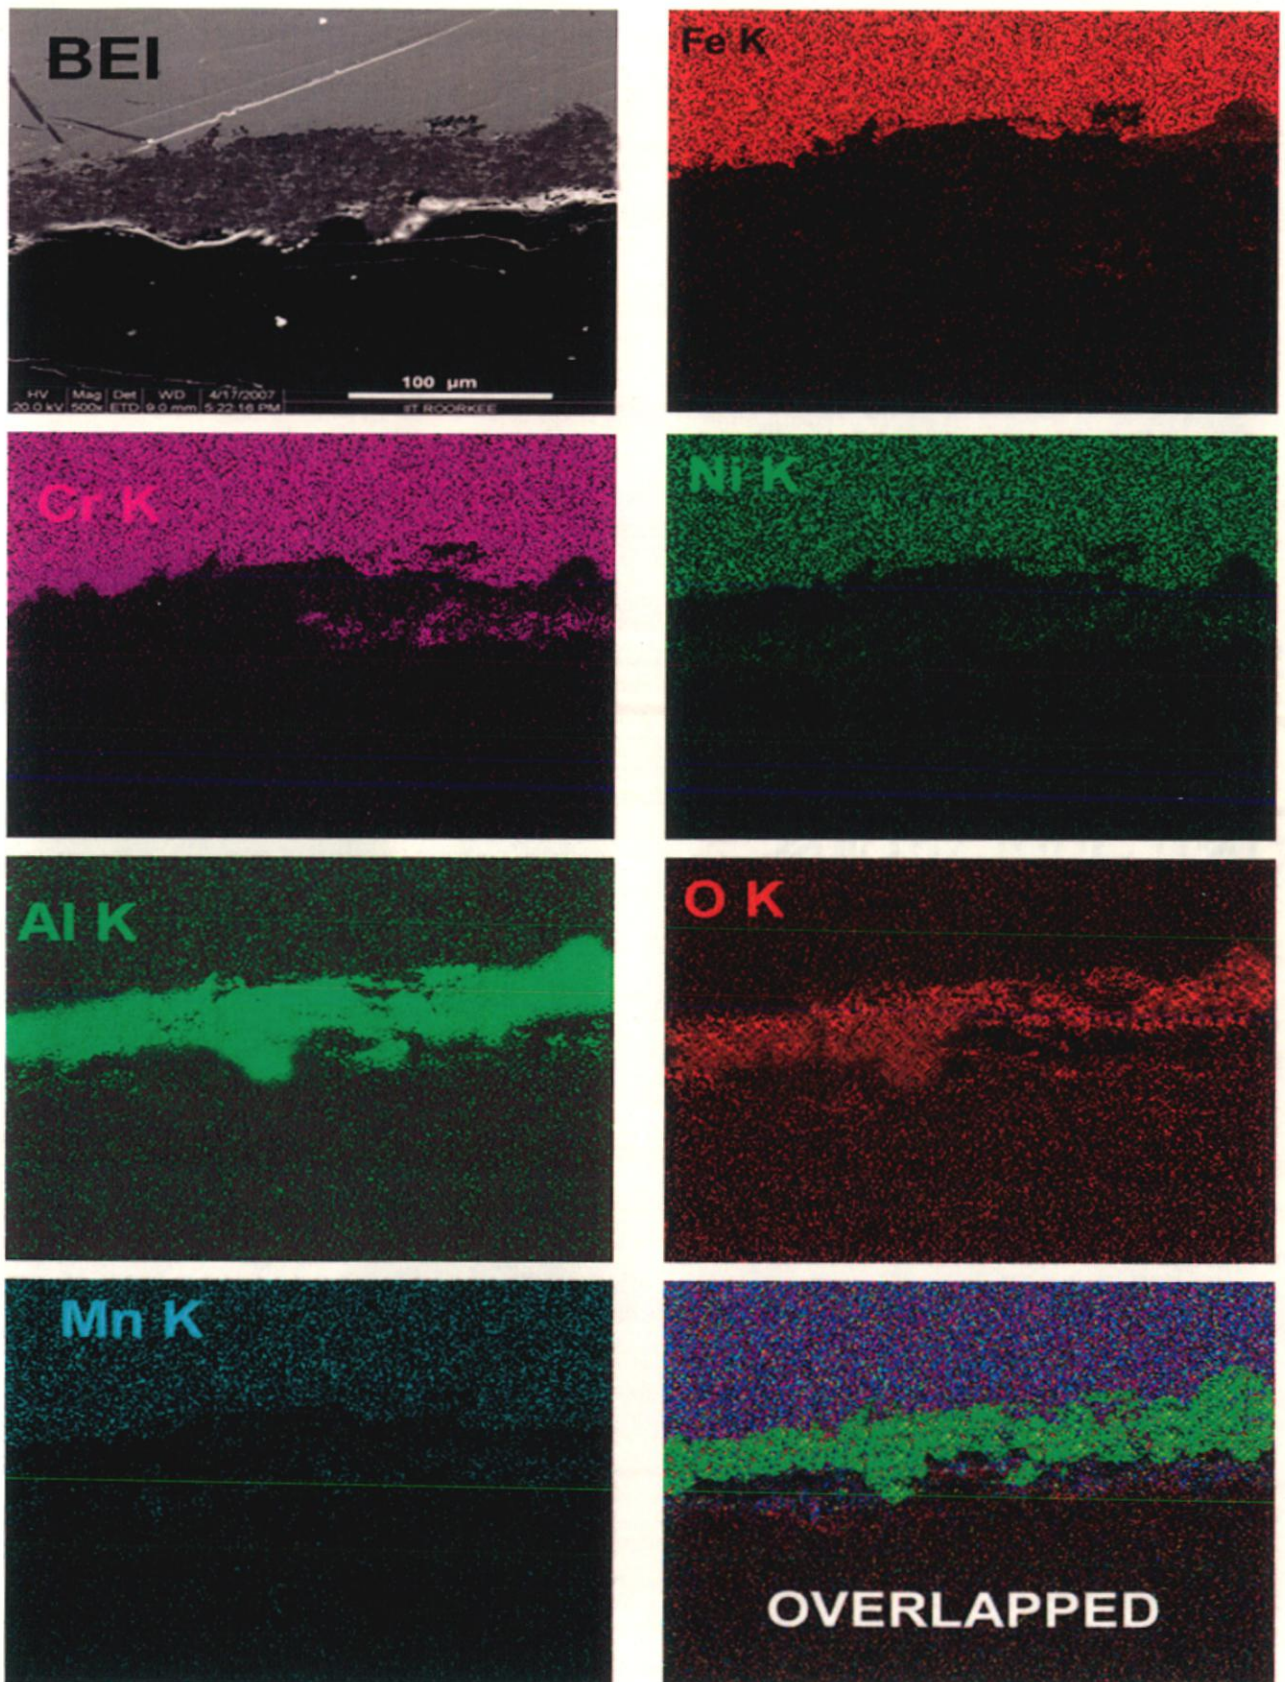
Fig. 7.42: Back scattered electron image and the corresponding x -ray mappings of cross section of Al_2O_3 - 3 wt% TiO_2 coated superalloy superfer 800 after 1500 hours exposure in boiler.

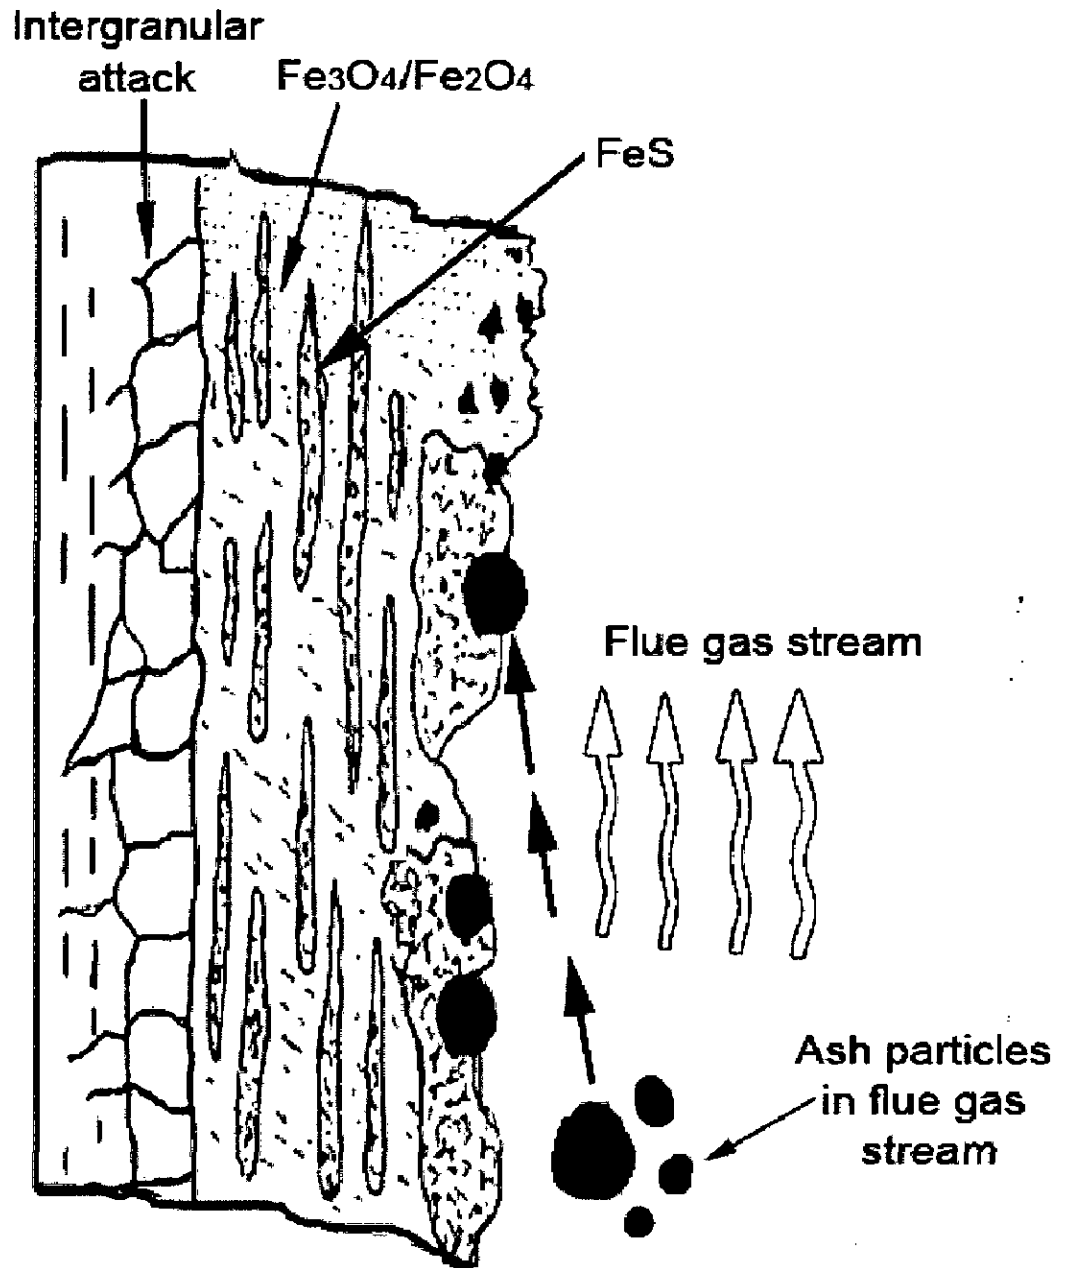
Fig. 7.43: Schematic diagram showing scale growth and probable erosion corrosion mechanism for the uncoated boiler steel exposed to actual boiler environment at 700°C for 1500 hours.

In boiler conditions an oxide layer of Fe₃O₄ and or Fe₂O₃ is formed on the surface as shown in Fig. 7.43. This hard oxide layer protects the tube from metal

wastage. However inefficient combustion at times creates localised reducing conditions or allows direct contact of chlorine and carbon with the oxide layer. At high temperature and high heat flux, complex chemical reactions takes place, leading to the formation of iron sulphide (FeS), which owing to its higher molar volume may crack the protective layer. Also low melting compounds may be formed, wasting the metal. If chlorine is present in the flue gas, it diffuses through the oxide layer, making the protective layer porous and therefore less protective (Basu et al, 2000). Also with the deposition of ash, volatile alkali sulphates (Na_2SO_4) and sulphur trioxide (SO_3) produced during combustion diffuse through the ash to initiate corrosion. These compounds and the iron oxide from the oxide scale from the tube wall or from ash deposit itself react to form complex alkali metal trisulphates.

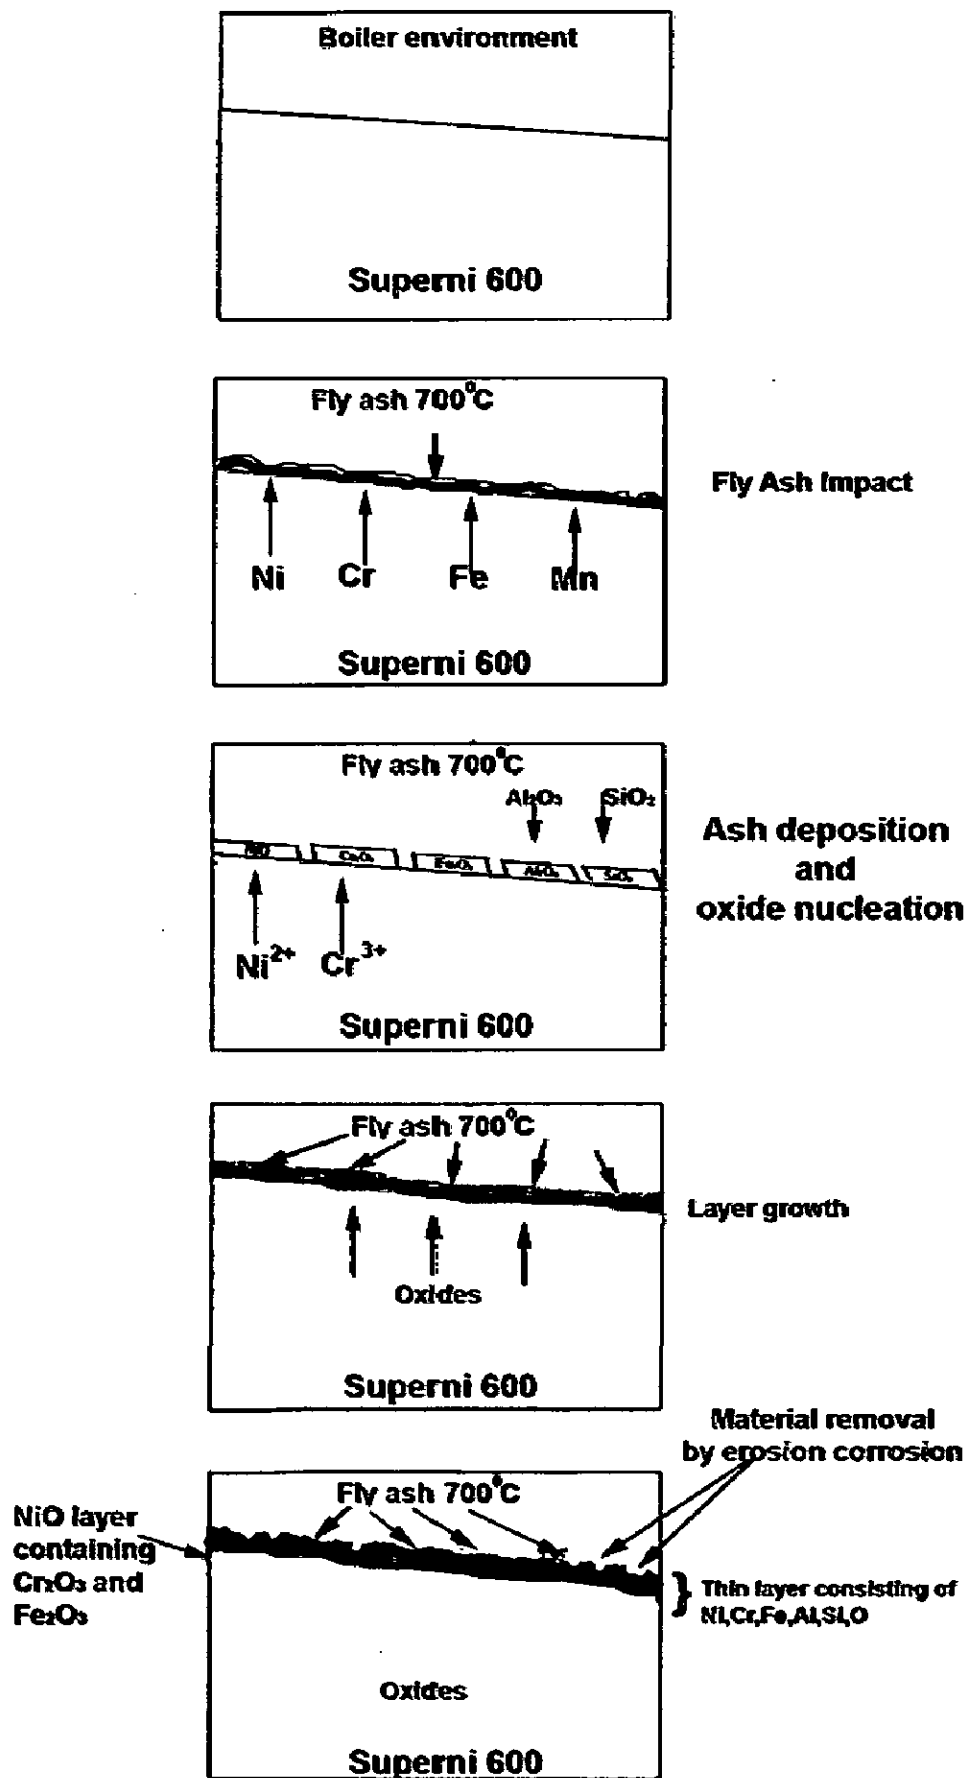
Fig. 7.44: Schematic diagram showing probable erosion corrosion mechanism for the uncoated superalloy Superni 600 exposed to actual boiler environment at 700°C for 1500 hours.

In cross sectional analysis, in case of Superni 600, there is thin Ni rich band in the substrate from which Cr has depleted as shown in Fig. 7.19. Also there is presence of embedded silica particle. While in case of Superni 718, (Fig. 7.20) a thin scale was observed on the surface. From X-ray mapping, Fe, Ni and Cr are coexisting with oxygen as very thin layers at the top most scale. Fig 7.44 shows the schematic diagram showing probable erosion corrosion mechanism for the uncoated superalloy Superni 600 exposed to actual boiler environment at 700°C for 1500 hours. As compared to other superalloys, Superfer 800 has shown thick scale (Fig. 7.21) in which Si, Mg and Al particles can be seen coexisting with oxygen in the elemental maps. Ni rich layer is present in the substrate at the interface. Also Ni and Cr are coexisting with oxygen at the top of the scale. The scale by itself mainly consists of iron along with oxygen which indicates the formation of Fe_2O_3 . Probable erosion corrosion mechanism for the uncoated superalloy Superfer 800 exposed to actual boiler environment at 700°C for 1500 hour is shown in Fig. 7.45. In his study Mishra 2006 has also reported the embedment of fly ash particles on the top layer of the exposed surface.

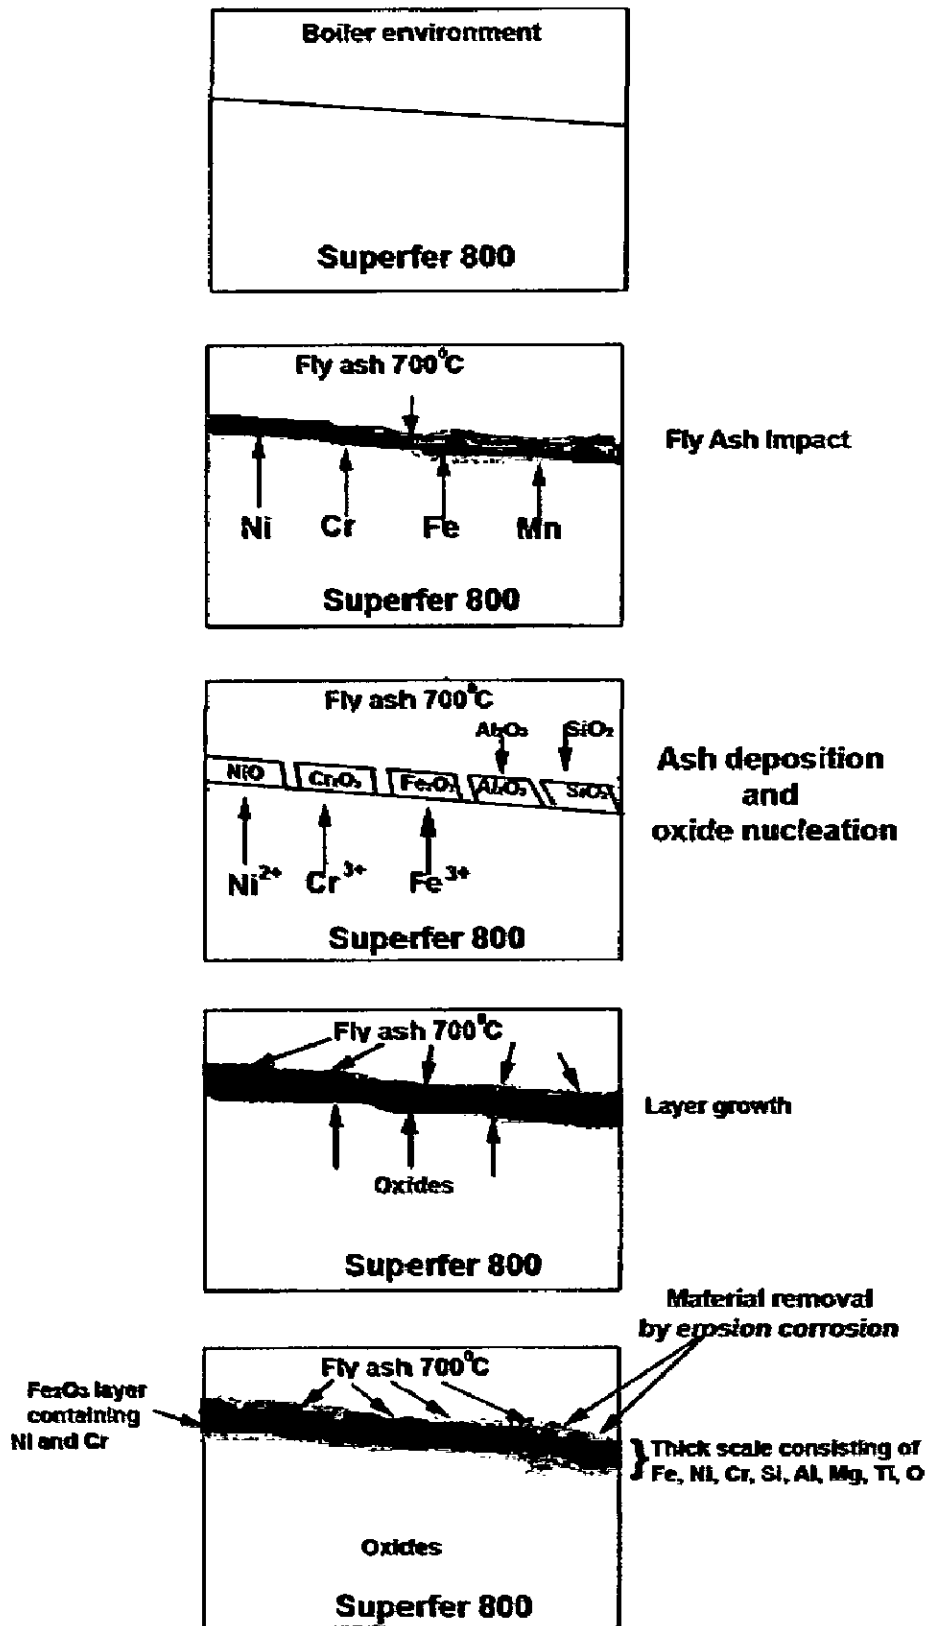
Fig. 7.45: Schematic diagram showing probable erosion corrosion mechanism for the uncoated superalloy Superfer 800 exposed to actual boiler environment at 700°C for 1500 hours.

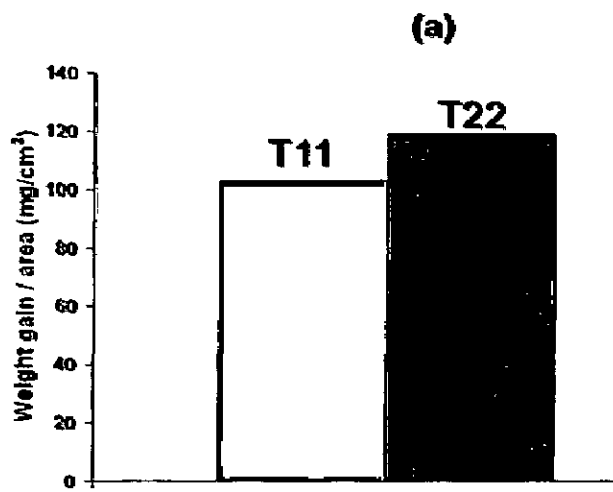
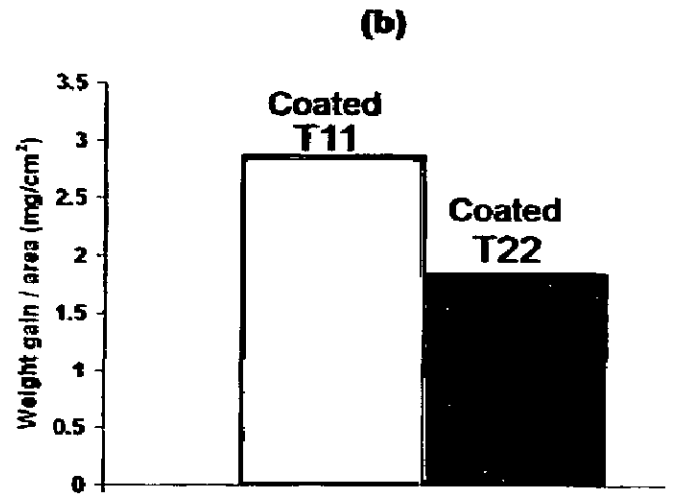
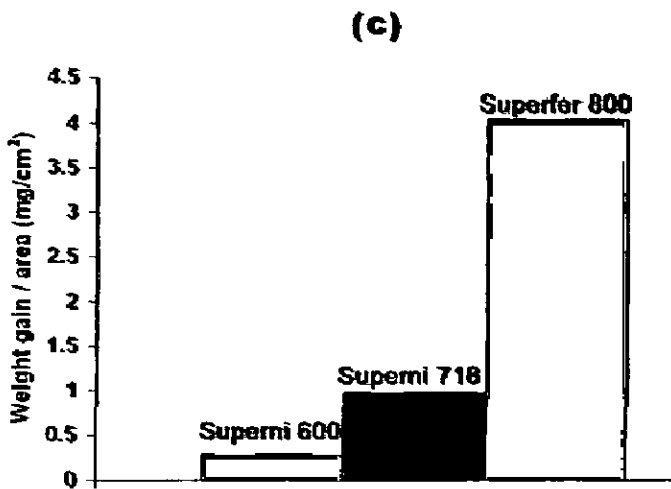
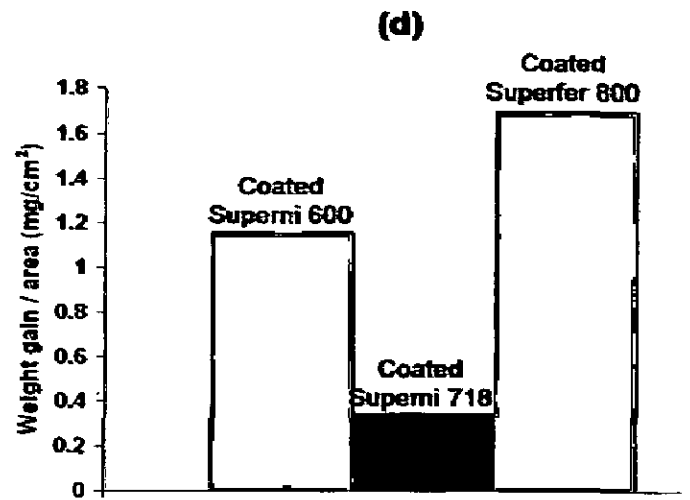
Fig. 8.2: Bar charts showing cumulative weight gain (mg/cm^2) for the uncoated and coated alloys subjected to cyclic oxidation in air at 900°C for 50 cycles.
 (a) Uncoated Boiler steels (b) Coated Boiler steels (c) Uncoated Superalloys (d) Coated Superalloys

The coatings have behaved well and provided the necessary protection to the base metal during testing in air and molten salt environment. The weight change (mg/cm^2) for uncoated and detonation gun coated alloys subjected to cyclic oxidation for 50 cycles at 900°C indicated that weight gains for all the coated alloys are considerably lower than that of uncoated alloys. Bulky and porous scale with continuous network of cracks was observed on the uncoated boiler steels. The uncoated boiler steels suffered intense spalling of the scale. The scale formed on the steel consisted of iron oxide mainly.

Among the boiler steels, T22 steel has shown poor oxidation as well as molten salt resistance than T11 steel at 900°C during cyclic testing. Though T22 steel contained higher amount of chromium (2.5%) relative to T11 steel having only 0.98% chromium. The reason may be due to the presence of higher amount of Mo (1.08%). Further T11 steel showed inferior resistance to Na_2SO_4 -60% V_2O_5 environment which may be attributed to reaction of molten salt with MoO_3 to form lower melting point phase like Na_2MoO_4 which could have led to acidic fluxing of the protective oxide scale as suggested by Fryburg et al (1984) and Pettit and Meier (1984). In superalloys Superni 600 and Superni 718, rapid oxidation rate has not been observed and very small weight gains have been observed and steady state with the progress of exposure time, in spite of the fact that some minor deviations are observed. The bar charts showing the overall weight gains in air and molten salt environments after 50 cycles for the coated and uncoated alloys are presented in Figs. 8.2 and 8.3 respectively. From the bar charts, it can be inferred that among the alloys under

study, boiler steels have shown poor resistance against the oxidation as well as molten salt environment. In superalloys, Superfer 800 has indicated a minimum resistance to air oxidation amongst the superalloys under study. Superni 600 has been found to be most resistant to the air oxidation as well as molten salt corrosion among all the superalloys. Superfer 800 suffered accelerated hot corrosion in the form of intense spalling and sputtering of its scale. On the bare alloys, especially in boiler steels, the oxide scale formed is fragile and irregular, and penetrates deeply into the substrates, thereby reducing the thickness of sound metal. In molten salt environment, the scale formed on the bare superalloys is fragile and irregular. The fluxing action of the molten salt on the surface of the bare alloys is also clearly evident (Figs. 6.49 and 6.50). The EDX analysis and elemental maps obtained after total 50 cycles of exposure to the molten salt environment indicate that all the coatings have protected the base alloys against the penetration of oxygen and other corrosive species, coatings are in good contact with the substrate .

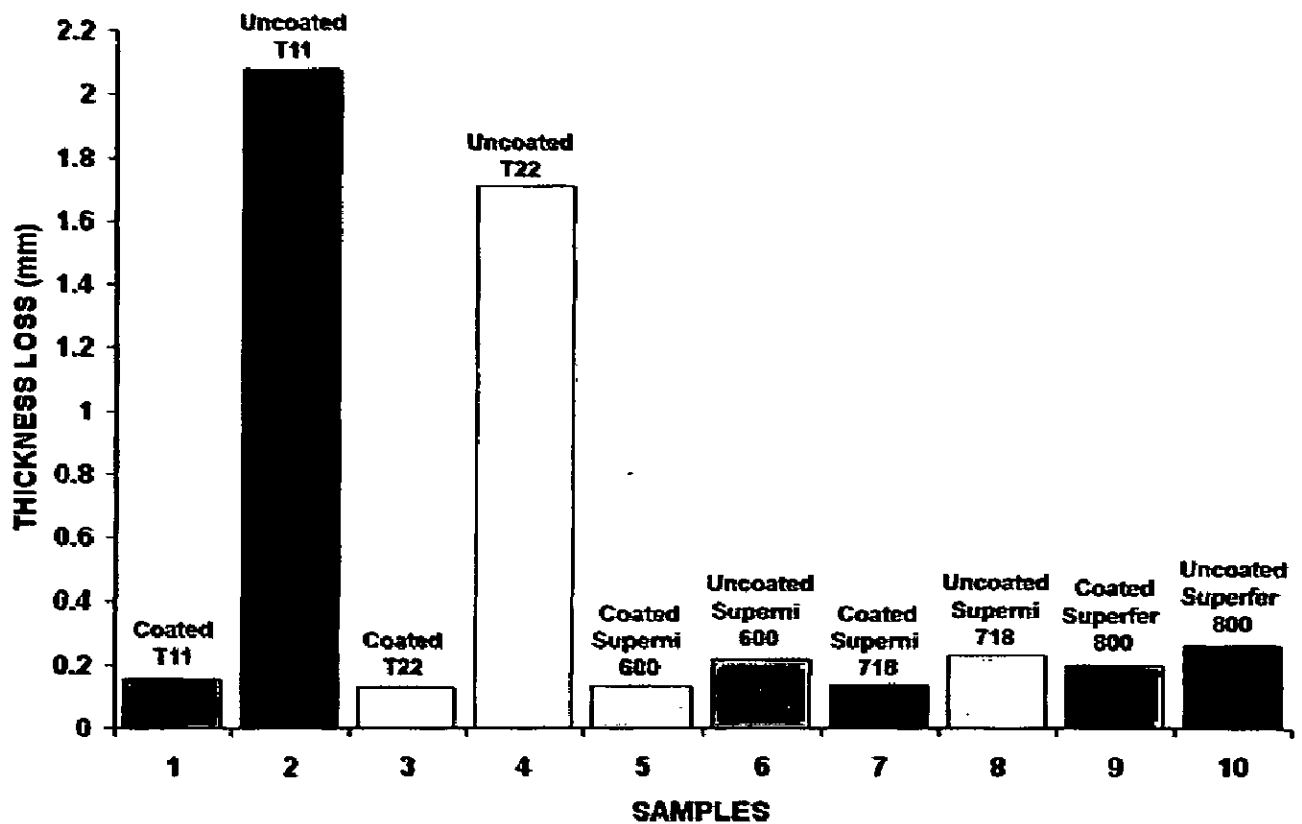
Fig. 8.4: Bar chart indicating the thickness lost in mm for the uncoated and Al₂O₃-3wt%TiO₂ coated alloys after 1500 hours exposure to the coal fired boiler at 700°C.

Al₂O₃-3 wt% TiO₂ coatings, in general, have shown good resistance to the industrial environment consisting of actual working condition of the coal fired boiler and all the coated alloys performed better than the uncoated alloys. The bar chart indicating the total extent of material thickness lost of uncoated and Al₂O₃-3wt%TiO₂ coated alloys after 1500 hours exposure to superheater zone of coal fired boiler at around 700°C is shown in Fig.8.4. From the bar chart it is clear that minimum thickness loss is shown by Superni 600 superalloy among all the uncoated alloys tested while uncoated boiler steels have shown massive thickness loss.

Comparing the erosion corrosion loss of Al_2O_3 -3 wt% TiO_2 coating on different substrate alloys, it can be inferred that the difference in thickness loss with respect to substrate is not much i.e. it is almost same in all the coated alloys irrespective of the substrate alloy. When compared to uncoated alloys thickness loss is very less. There is no evidence of formation of oxides from the substrate alloys though there is a presence of minor cracks on the surface in few cases and also there is an indication of erosion with the formation of hills and craters on the surface but these could not expose the surface of the substrate alloys and coating has protected the surface very well. This may be due to the fact that Al_2O_3 probably hinders the grain boundary diffusion of the elements. As a consequence, there is no oxide scale growth. The compact and protective Al_2O_3 layer separated the metal substrate from the boiler environment. As a result, the coating improved the hot corrosion resistance. X-ray mapping after 1500 hours exposure to boiler environment is shown in Fig.7.38 to 7.42 respectively. The elemental maps of the coated alloys indicated that the substrate alloys are safe from the oxygen and other corrosive species attack. Alumina-titania coating is intact with all substrate alloys. Thus in boiler environment coating has acted as barrier against erosion and corrosion of all the alloys under testing. Also the coating remained intact even after 1500 hours of cyclic study so it can be concluded that the coating will enhance the life of the components in the evaluated environment.
